# Errata Sheet

## SLG46108

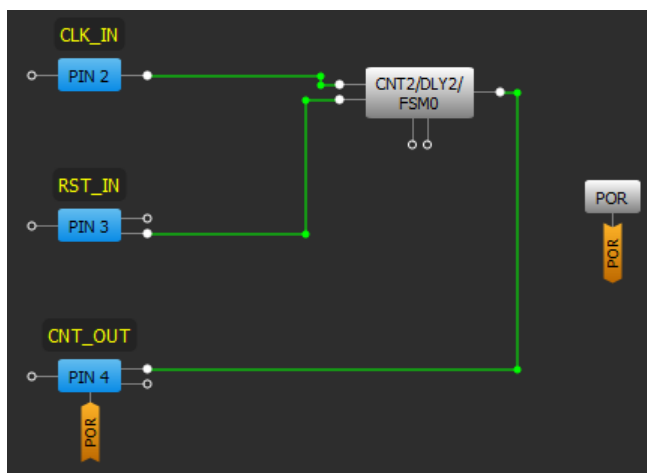
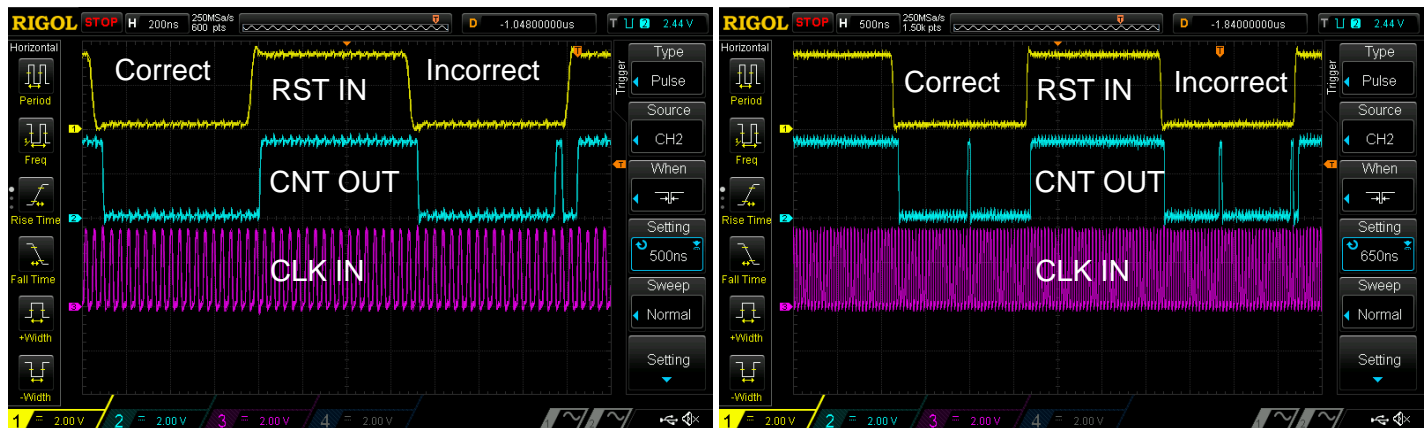
### ISSUE 1: Incorrect Counter Operation after the Reset

If the Counter Reset is asserted at the same time as a rising clock edge, it is possible that the Counter Data will be reset incorrectly and the counter output may appear faster than expected, it doesn't depend on Edge select option. This phenomenon appears more often as the clock frequency increases.

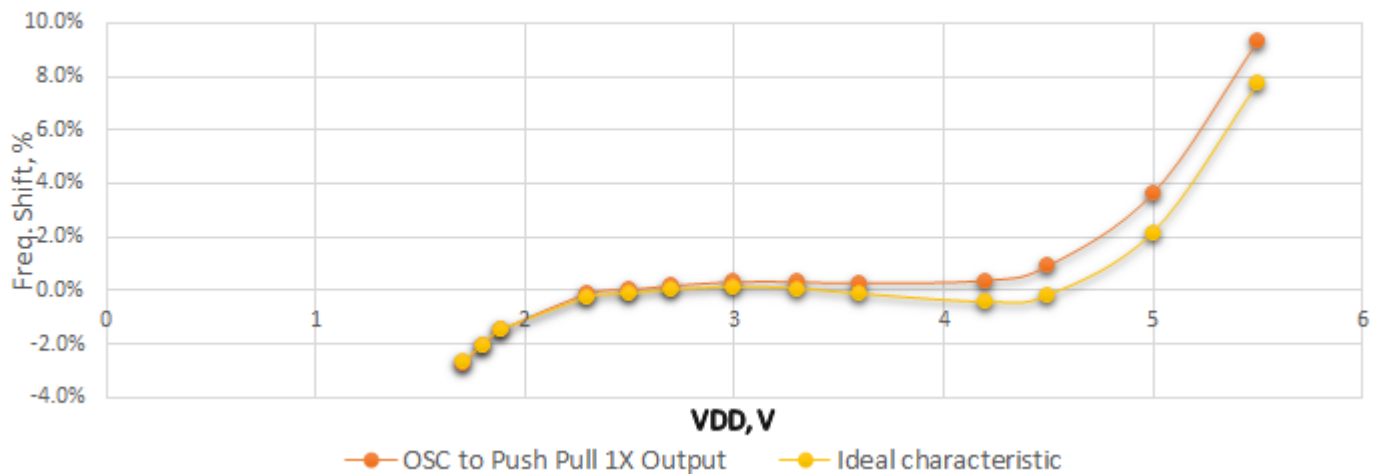
### OSC Accuracy vs VDD

### ISSUE 2: VDD Noise Influences OSC Variation Functional Blocks Affected: OSC, Counter/Delay

While applying some high frequency noise to the VDD, OSC inaccuracy may increase. The same behavior is also present in cases where high frequency switches are outputted from the chip using the Push Pull type driver. See, test results below.

#### Workaround:

Currently there are no viable workarounds for this issue.

However, the issue can be minimized by doing the following:

- Only use frequencies lower than 2 MHz when switching the output.
- Do not use parallel PIN connections to output high speed switching signals.

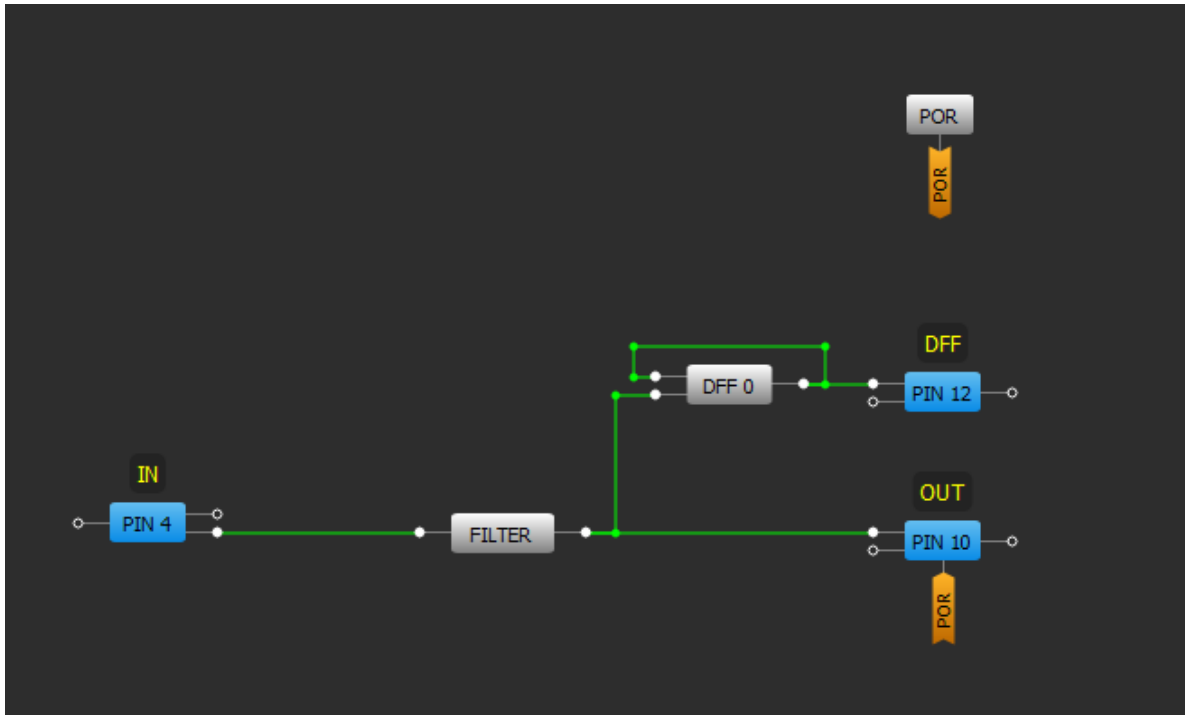
## ISSUE 3: FILTER Cell Does Not Filter Out Glitches

If clock type high frequency input comes in, the FILTER cell may not filter out it. There are several factors like input frequency, duty cycle and LOW duration in such signal that may lead to its passing through FILTER block.

Channel 1 (yellow/top line) – PIN#4 (IN).  
 Channel 2 (light blue/2nd line) – PIN#10 (OUT).  
 Channel 3 (magenta /3rd line) – PIN#12 (DFF).

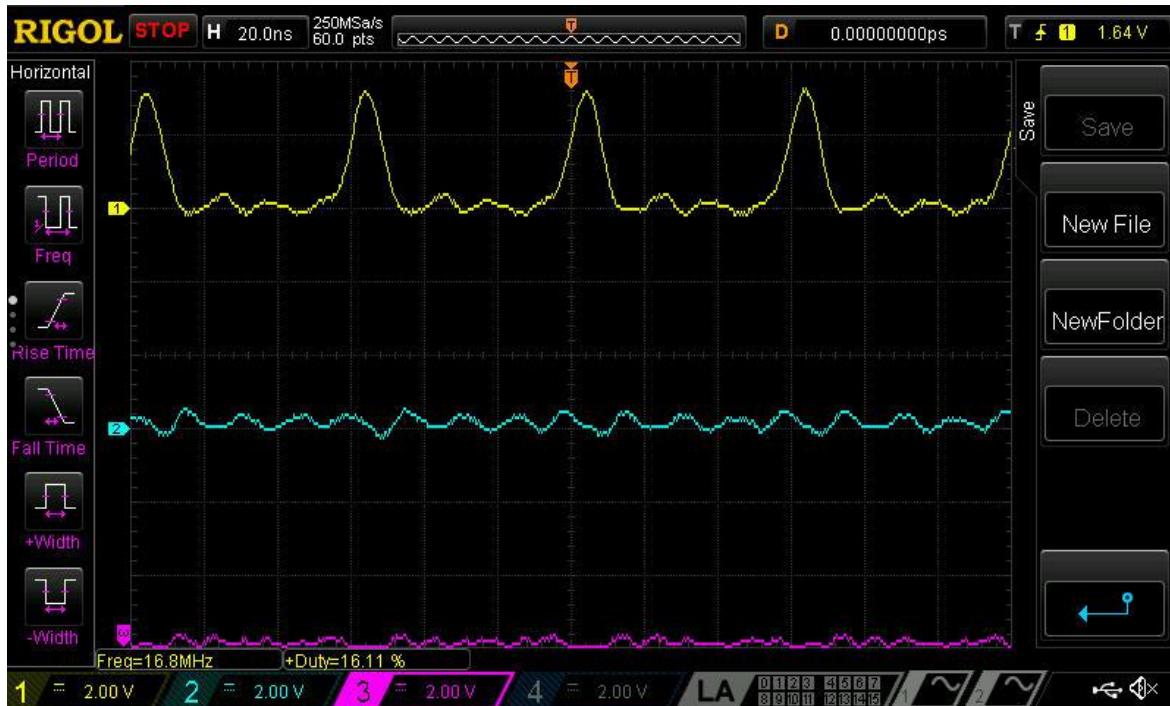
1. Period is 60 ns. Pulse width is 10 ns, DC = 16.7 % (correct functionality).

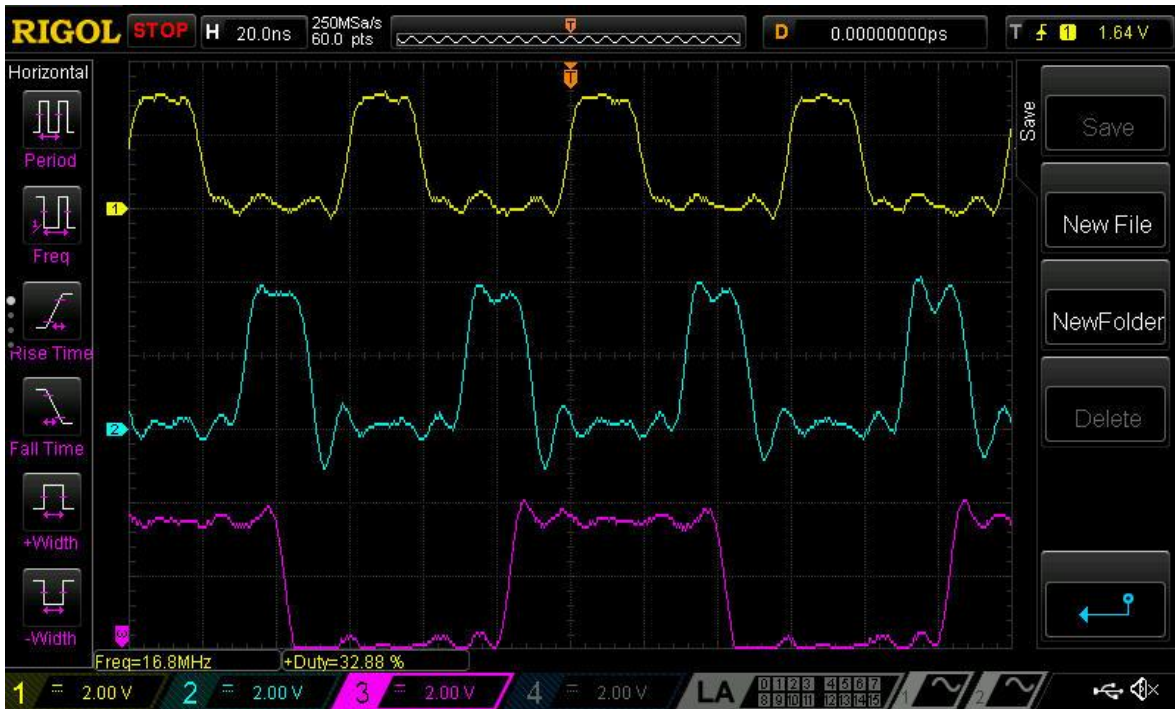
- Period is 60 ns. Pulse width is 20 ns, DC = 33.3 % (incorrect functionality).

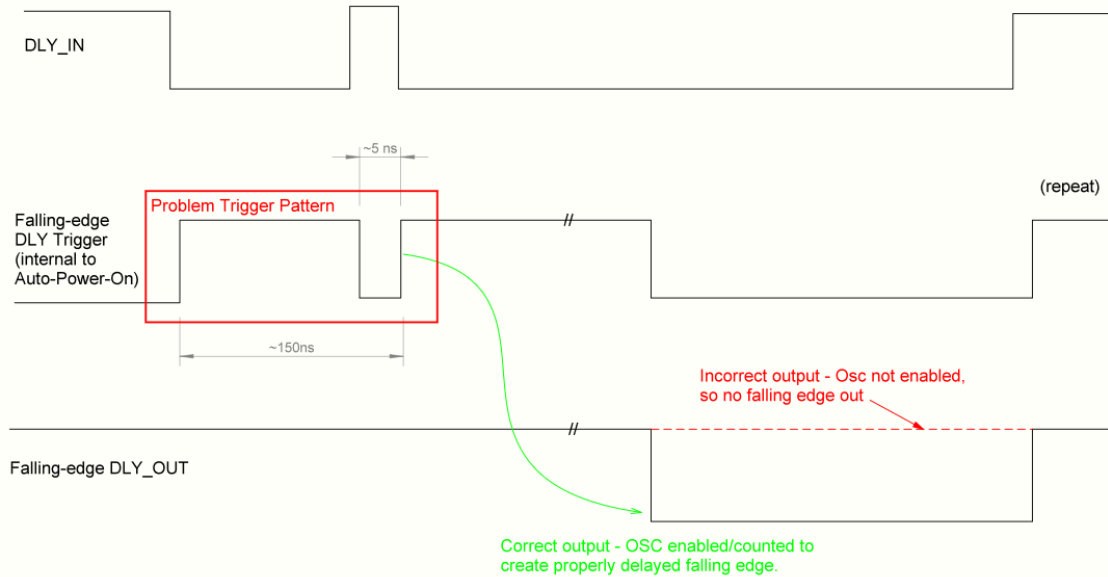
**Figure 1: Problem Trigger Pattern**

For this chip, the Auto Power On circuitry of the 25 kHz/2 MHz generators contains a circuit errata, which can potentially fail to power on the OSC for a specific pattern and timing of the OR of all related DLY trigger signals. The pattern is shown in [Figure 1](#) (boxed in red) and consists of a relatively longer pulse (~145 ns) followed by a shorter (~5 ns) glitch of opposite polarity.

1. Use signal conditioning circuits to prevent glitch on DLY inputs < 200 ns. Examples:
  - a. ACMP with Hysteresis
  - b. External RC in front of Digital Input with Schmitt Trigger
  - c. Filter cell.
2. Set OSC power mode to Force Power On mode instead of Auto Power On.
3. Use different oscillator, such as 25 MHz Ring OSC, which does not have Auto Power On issue.

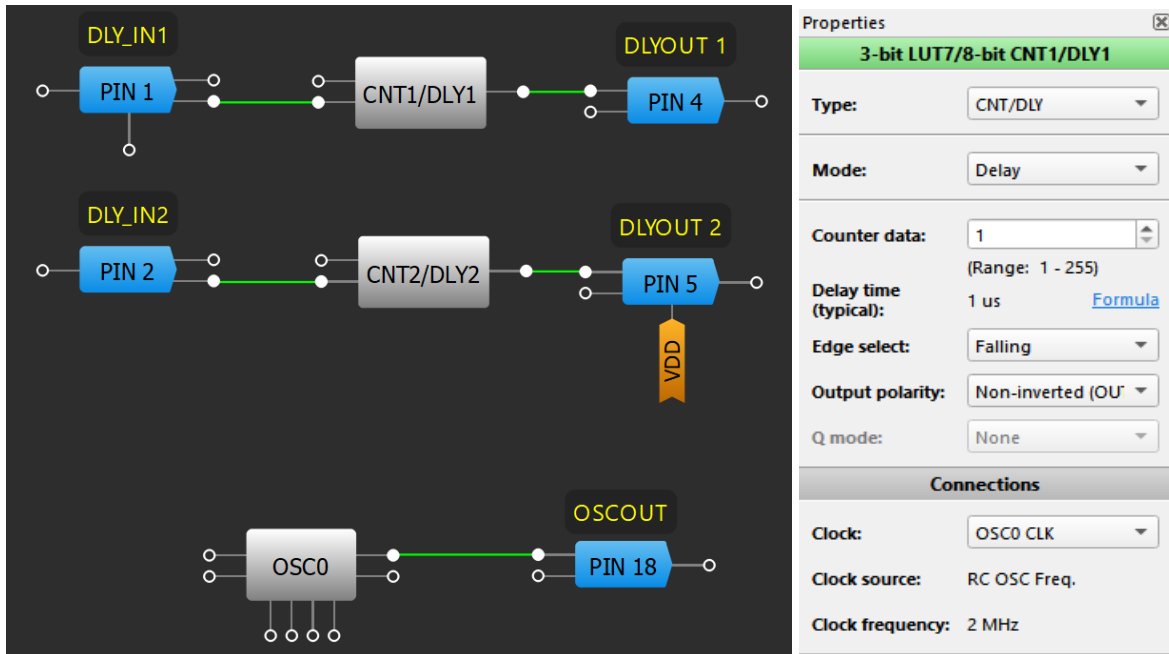
Figure 2: Test Circuit

The error is difficult to capture as the timing must be exact within ns, and short (ns) pulses are difficult to generate glitch precise enough to induce the problem. GPIO naturally filter out ns pulses, so for purposes of errata capture, two simultaneous falling-edge DLY circuits (as shown in [Figure 2](#)) were used. By lining up two delays precisely at a particular timing relationship, we can use the internal Auto Power On (OR logic) to generate the glitch pattern necessary to cause the error.

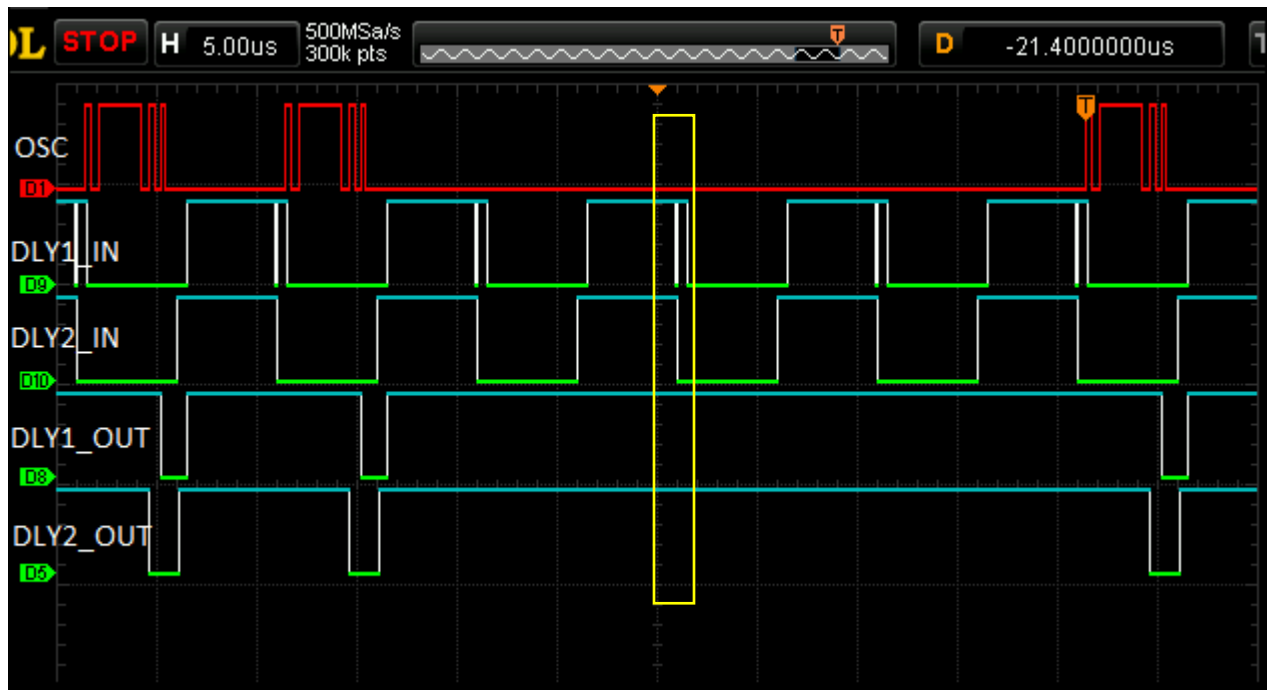
Figure 3: Errata Capture (Zoom Out)

Figure 3 shows a series of DLY output events are missing, where the OSC is correspondingly not triggering when it was supposed to. Figure 4 is a zoom in of the boxed region from Figure 3. The total glitch/chatter time was measured in this case at 152 ns. By using the composite OR of the two delay channels, we can asynchronously strobe with tiny frequency variations, and so tune the timing to induce this errata. Note that the error is not persistent – the system is recovered when all DLYs are returned to inactive state, such as when input of falling edge DLY goes high, thus canceling delay, or after DLY out finishes.
