RENESAS TECHNICAL UPDATE

Product Category	MPU&MCU		Document No.	TN-SH7-A724A/E	Rev.	1.00
Title	Note on Use of SH7763 SIOF Master Mode 2		Information Category	Technical Notification		
Applicable Product	SH7763 Group	Lot No.	Reference Document	SH7763 Hardware Manual Rev.2.00 (REJ09B0256-0200)		
		All lots

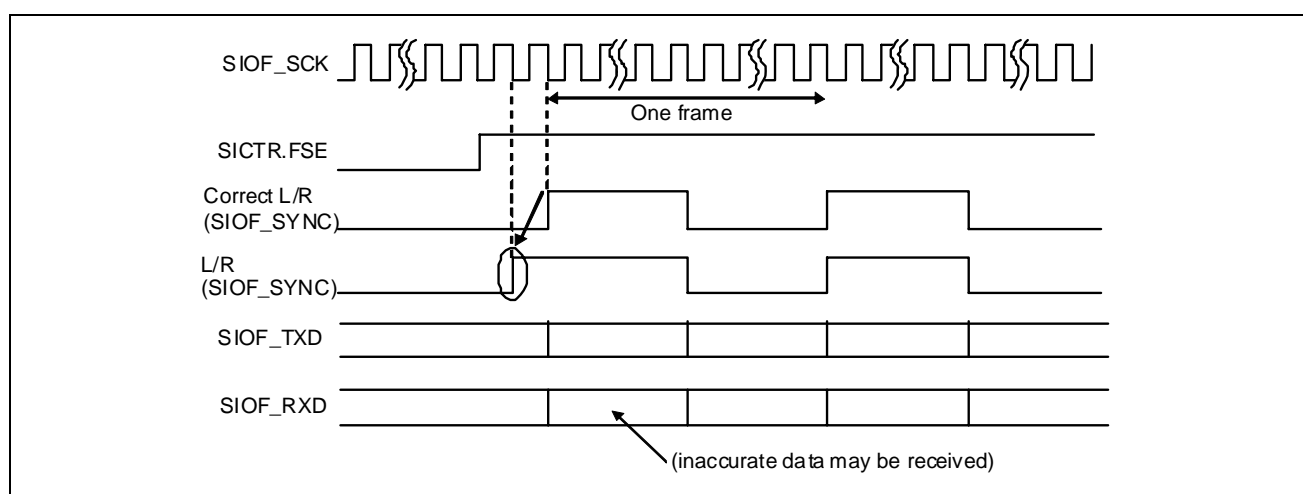
Figure 1. SIOF_SYNC Output Timing in Master Mode 2 (Transfer Started)

When using master mode 2 of the SIOF, if a transfer is started as set SICTR.FSE to 1 after reset, the first L/R signal (SIOF_SYNC) is always asserted early for one clock (see figure 1). And if a transfer is suspended as clear SICTR.FSE to 0 and resumes as set SICTR.FSE to 1 again, the first L/R signal may be asserted one clock late (see figure 2). In any case, an inaccurate data may be received at the first slot of received frame.

1. When the L/R signal asserted early for one clock.

There is no suitable workaround about the SIOF of the SH7763. If this operation is the problem in your system, take the countermeasure on your system for example ignore the first data.

If any countermeasure cannot be used on your system, use the SSI instead of the SIOF.
