## RENESAS TECHNICAL UPDATE

Product Category	MPU / MCU		Document No.	TN-SH7-A758A/E	Rev.	1.00
Title	Notes on usage of the RCAN-ET module		Information Category	Technical Notification		
Applicable Product	SH7286 Group	Lot No.		SH7280 Group Hardware Manual Rev. 1.00 (REJ09B0393-0100)		
		All lots	Reference Document

Please be aware of the following notes on usage of the RCAN-ET module for the SH7286 Group.

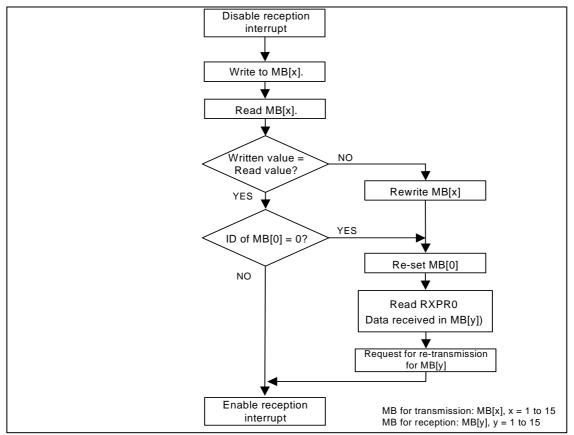
Figure 1 Procedure for Writing Mailbox upon Reception of CAN Data

When writing to a mailbox is attempted upon completion of the 7<sup>th</sup> bit of the EOF for received data, there is a possibility that this will result in clearing of the control 0 register of mailbox 0 and data not being written to the given mailbox, or in the written value not being reflected correctly in the given mailbox. To avoid these phenomena, follow the procedure shown in figure 1 when writing to a mailbox upon reception of CAN data.

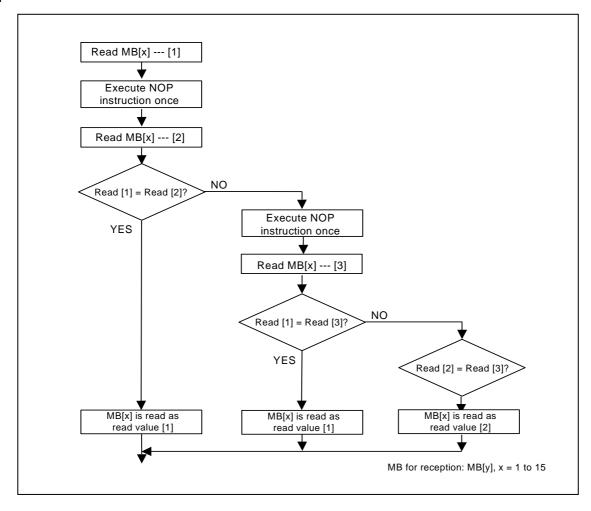
Figure 2 Procedure for Reading Mailbox upon Reception of CAN Data

When reading of a mailbox is attempted upon completion of the 7<sup>th</sup> bit of the EOF for received data, there is a possibility of the value read out being incorrect. To remove this possibility, follow the procedure shown in figure 2 when reading a mailbox upon reception of CAN data.
