## HITACHI SEMICONDUCTOR TECHNICAL UPDATE

Classification of Production	MPU		No	TN-SH7-433A/E	Rev	1
THEME	SH7616 limitation of Ethernet Controller Half-duplex transfer.		Classification of Information	1. Spec change 2. Supplement of Documents ③ Limitation of Use 4. Change of Mask 5. Change of Production Line		
PRODUCT NAME	HD6417616RF	Lot No.	Reference Documents	SH7616 Hardware Manual ADE-602-243 Rev.1.0	Effective Date	
		ALL			Permanent

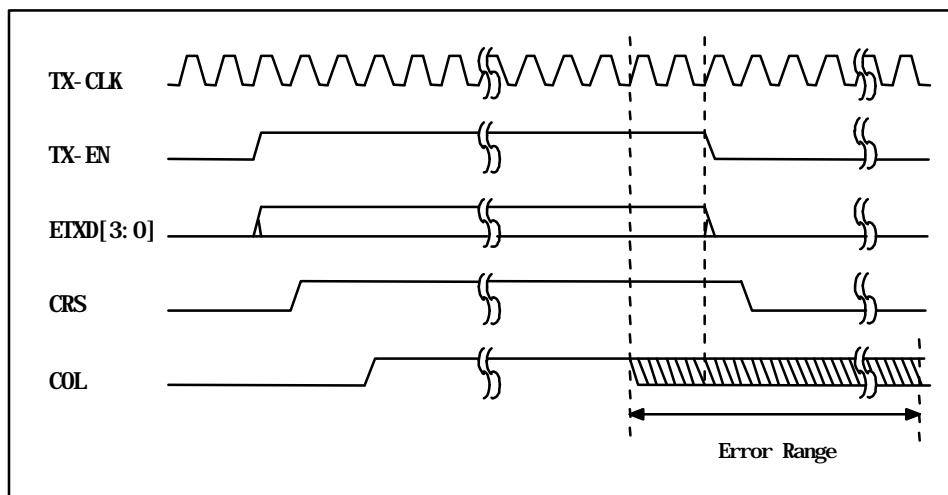
When the following both conditions are met, the SH7616 would transmit a frame with jam as the next re-try frame and move into back-off, even though any collision doesn't occur at the next re-try.

- (1) SH7616 is in Half-duplex transfer mode.
- (2) SH7616 detects a collision, in which the COL from the PHY gets inactive later than 2 TX-CLKs before TX-EN inactive (refer to the figure below).
