Errata

SLG46120

CE-GP-014

This document contains the known errata for SLG46120 and the recommended workarounds.

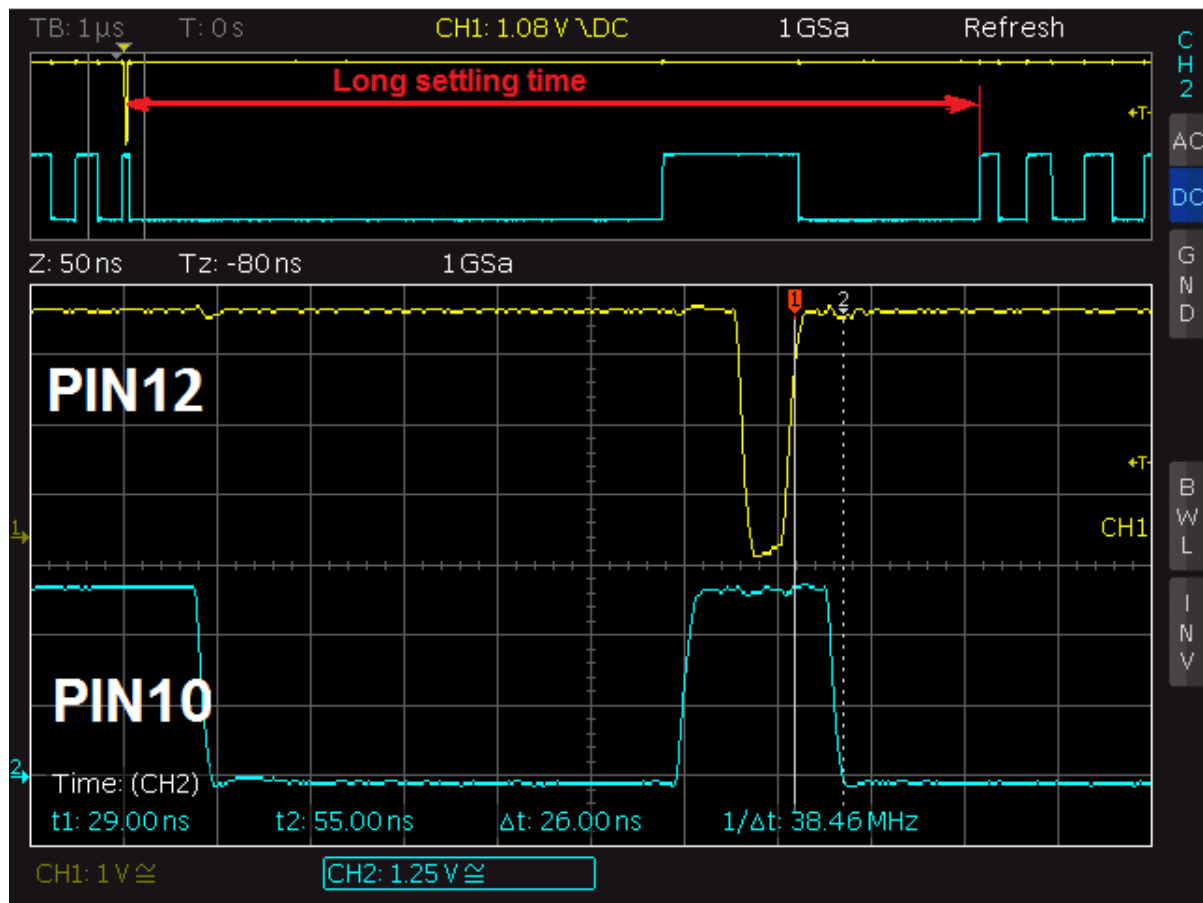
The configuration shown above generates a periodical signal with a frequency defined by the Delay cell and started by a HIGH signal on PIN2. The issue becomes apparent in a longer settling time when the scheme generates short pulses (Delay is configured as a rising edge delay only). See waveform below.

Channel 1 – 2-bit LUT0 output; Channel 2 – RC OSC output

Such behaviour will lead to substantial error in period calculations if the delay time is relatively small.

- In first case use block with longer propagation time.

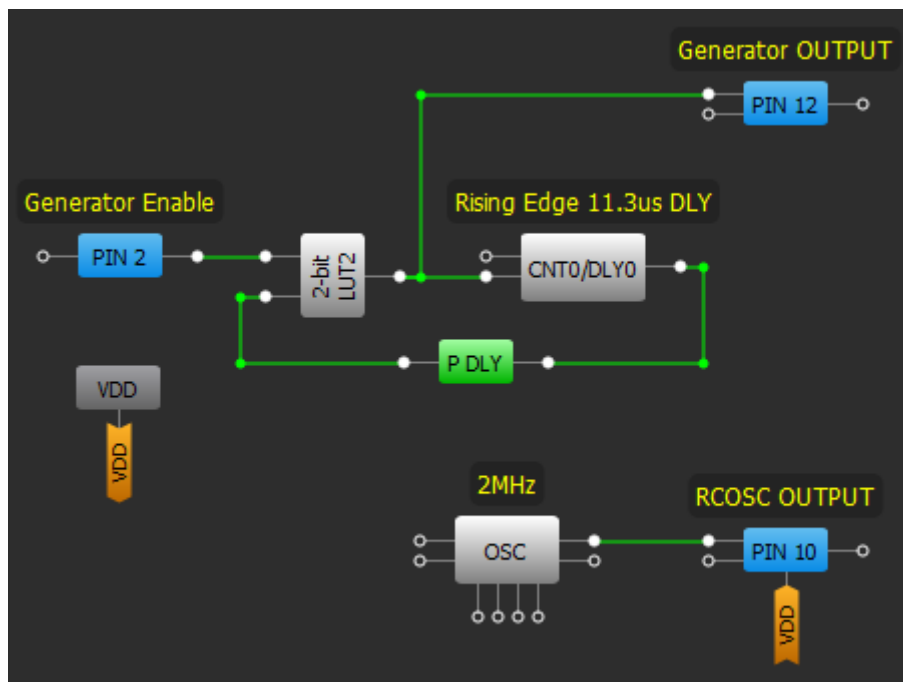
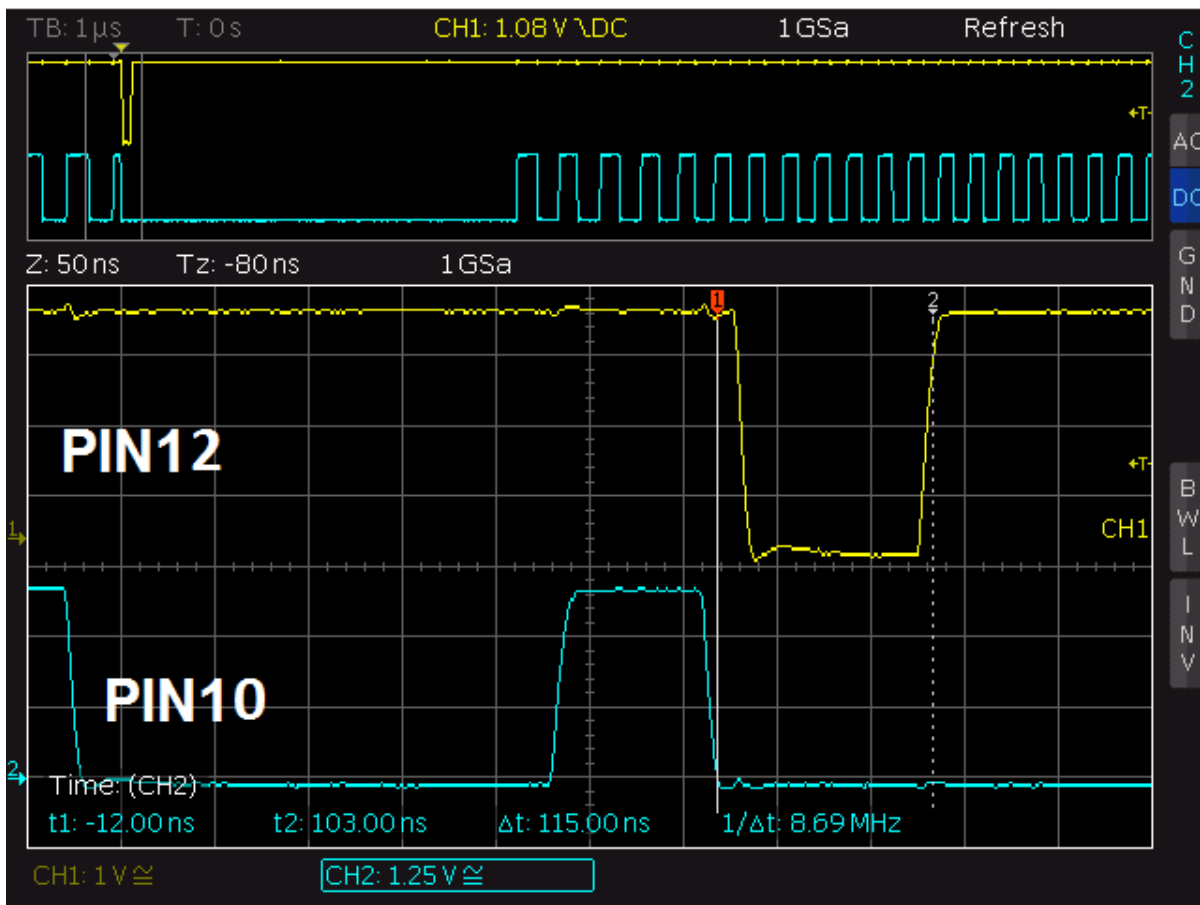
Channel 1 – 2-bit LUT0 output; Channel 2 – RC OSC output

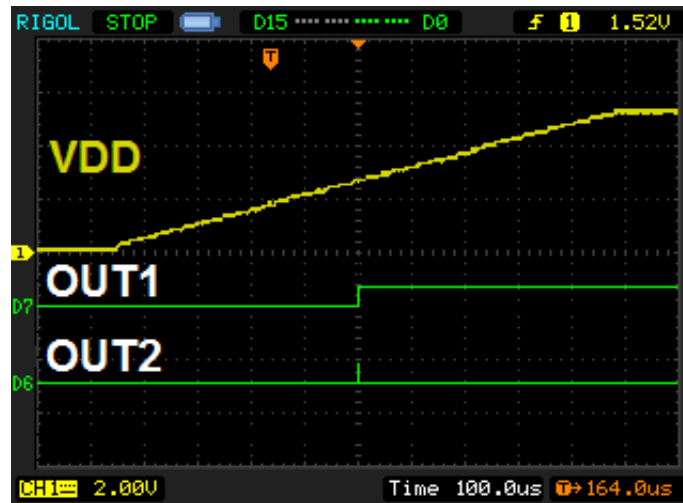
In some cases, ACMP may have short high-level glitches on its output (even if IN+ voltage is less than IN- voltage) after GreenPAK chip being powered up. Such cases may appear when using ACMP with Low Bandwidth mode enabled and Power Up is connected directly to the V_{DD} .

In order to detect such glitches, scheme with additional LUT was used. This LUT detects high level on ACMP output and stays high until chip powers down.

ACMP IN+ is connected to the Ground.

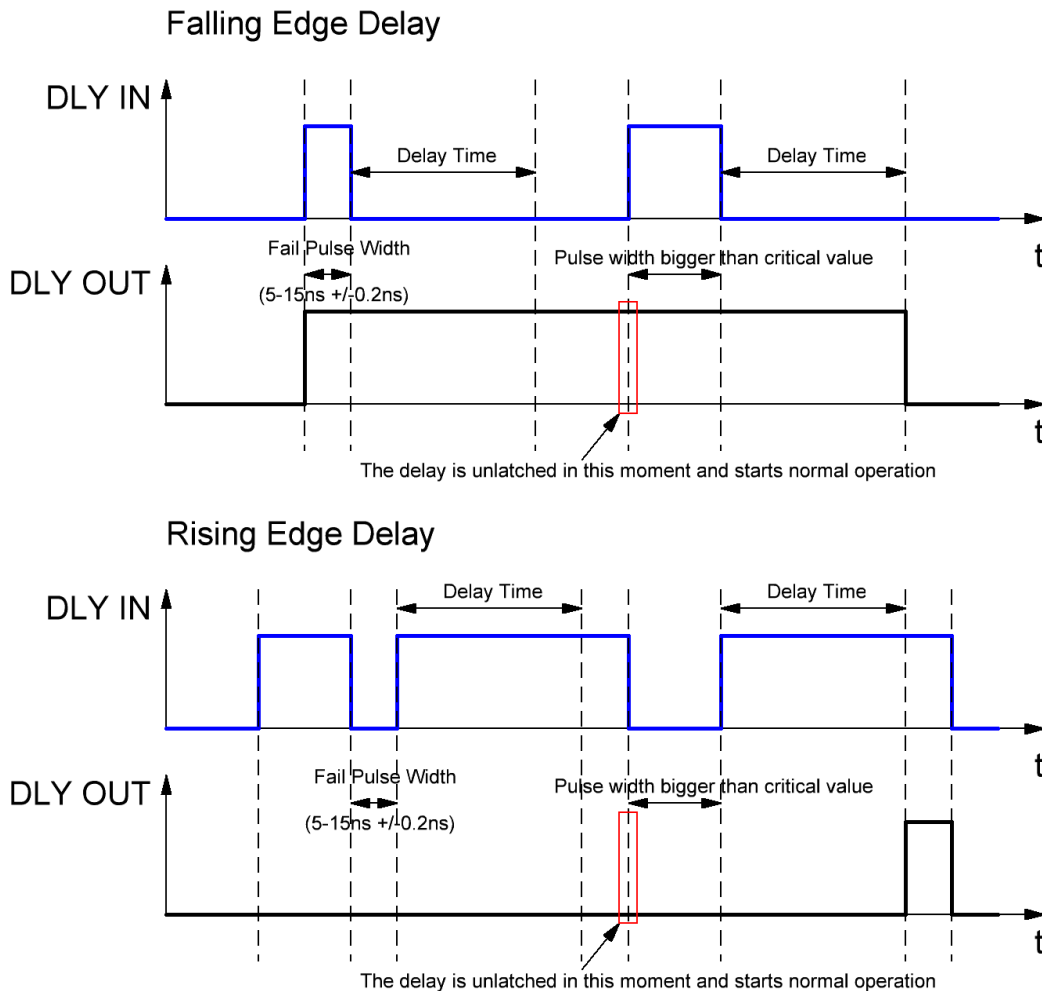
The delay output could be latched despite the input change when a short pulse is input. For example, if the delay cell is configured as a falling edge delay, the short pulse (see NOTE) appears on its input the delay cell output will switch from LOW to HIGH but may not switch from HIGH to LOW even after the delay time has passed.

NOTE: The pulse width varies from chip to chip and with different V_{DD} voltage. It is in range of 5-15ns and in the window $\pm 0.2ns$, so it should be very precise for issue happen.

Use P DLY/FILTER block configured as a both edge delay or FILTER.

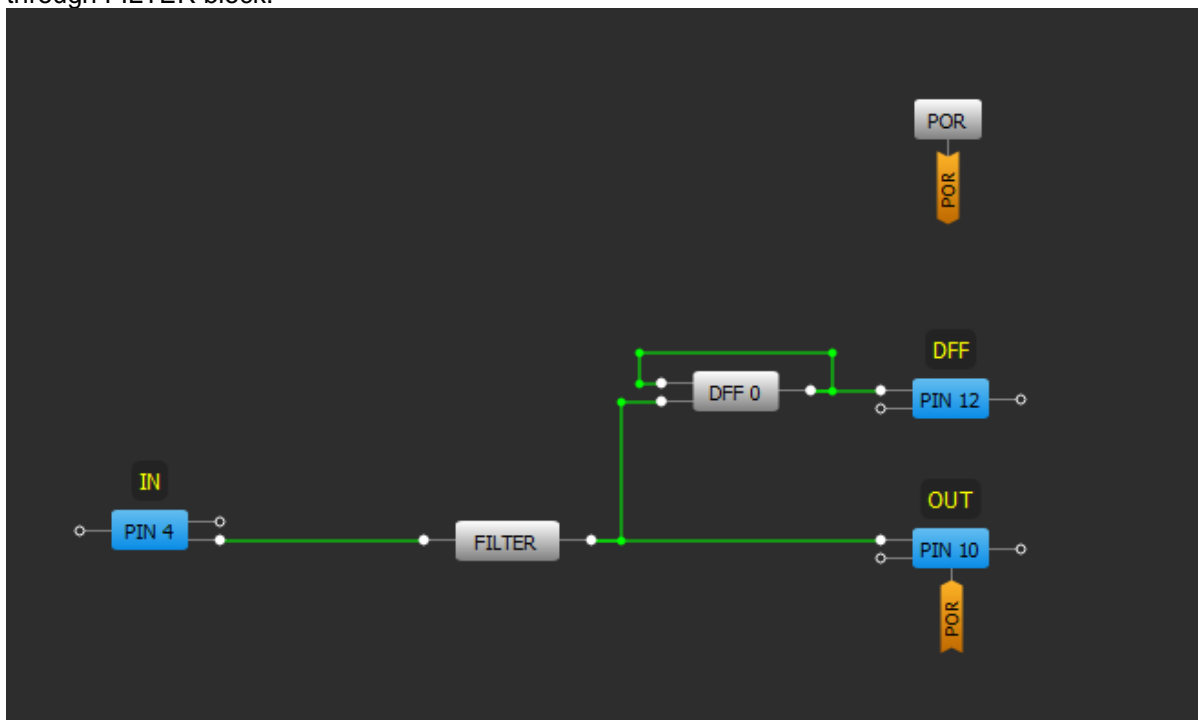
If clock type high frequency input comes in, the FILTER cell may not filter out it. There are several factors like input frequency, duty cycle and LOW duration in such signal that may lead to its passing through FILTER block.

Channel 1 (yellow/top line) – PIN#4 (IN)
 Channel 2 (light blue/2nd line) – PIN#10 (OUT)
 Channel 3 (magenta /3rd line) – PIN#12 (DFF)

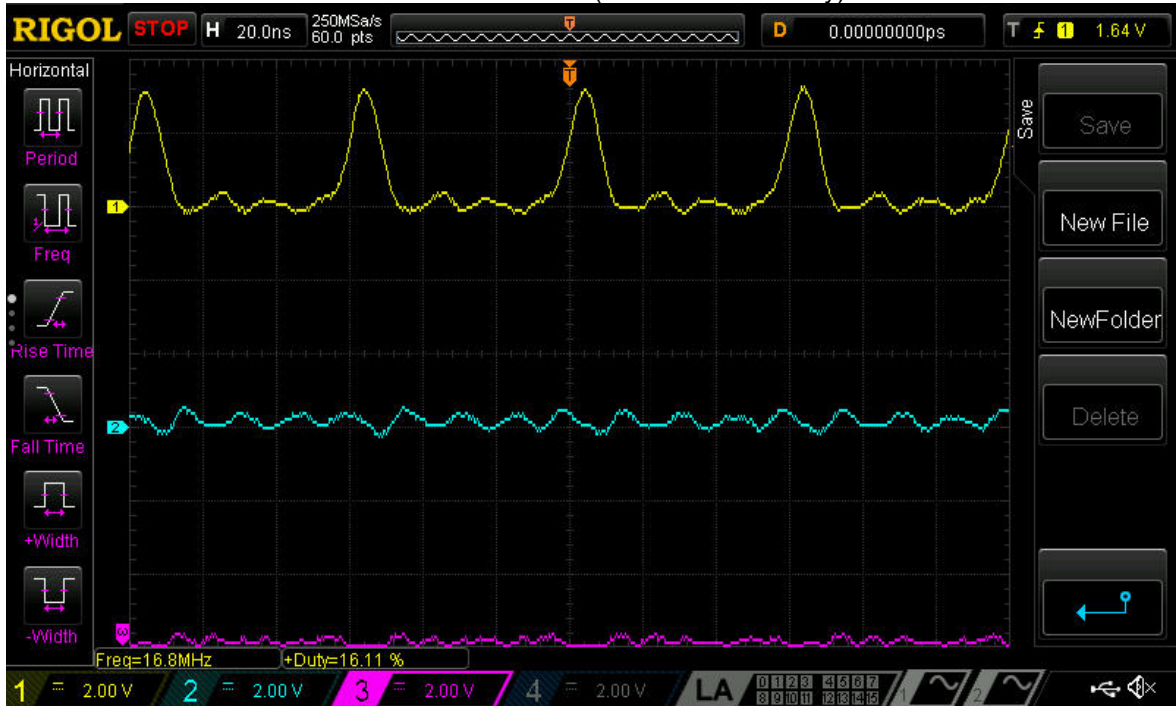
1. Period is 60ns. Pulse width is 10ns DC=16.7% (Correct functionality)

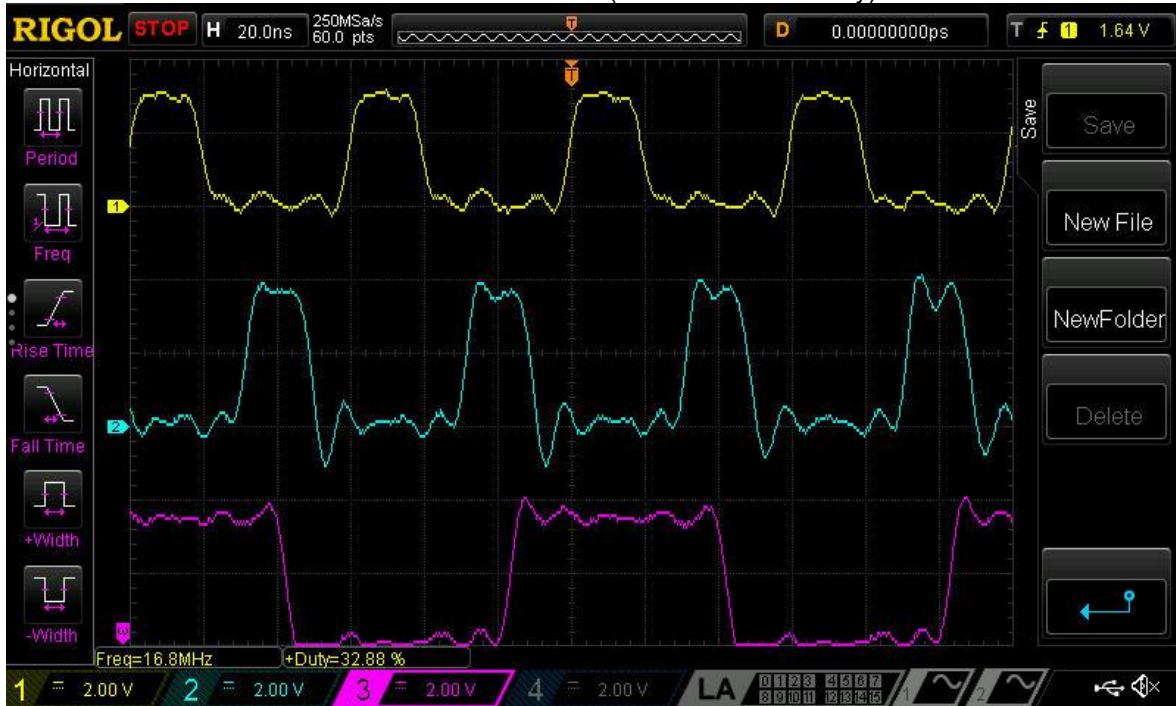
2. Period is 60ns. Pulse width is 20ns DC = 33.3% (Incorrect functionality)

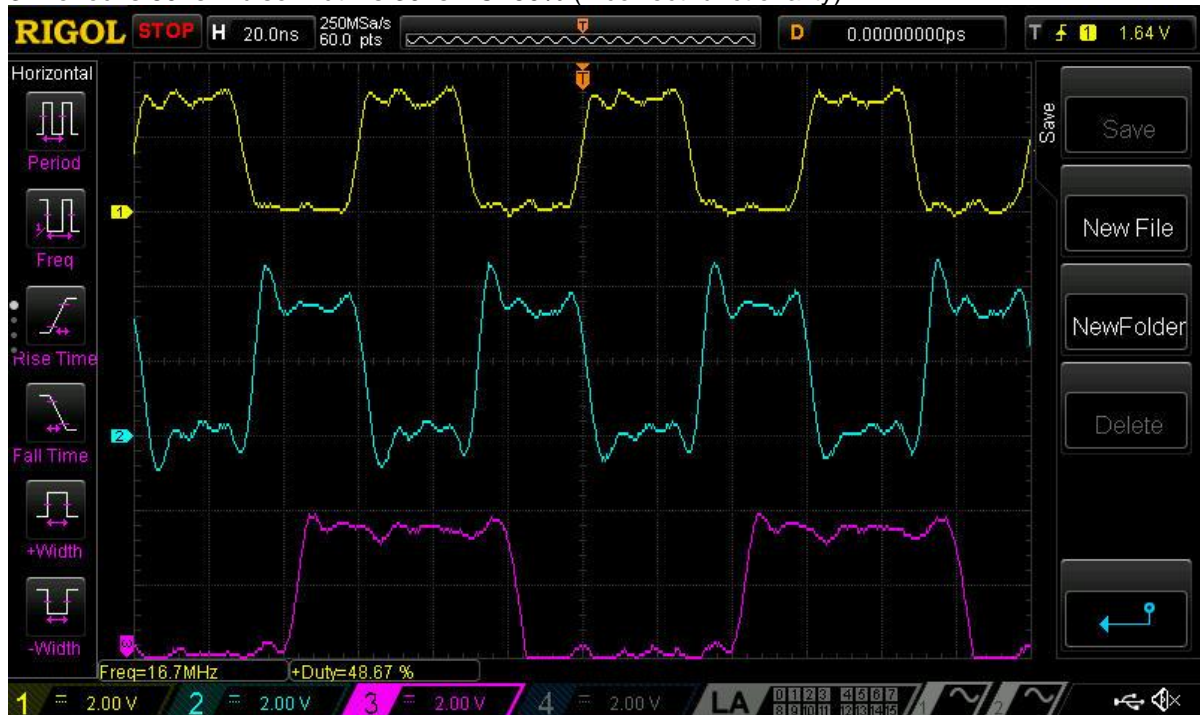
3. Period is 60ns. Pulse width is 30ns DC=50% (Incorrect functionality)

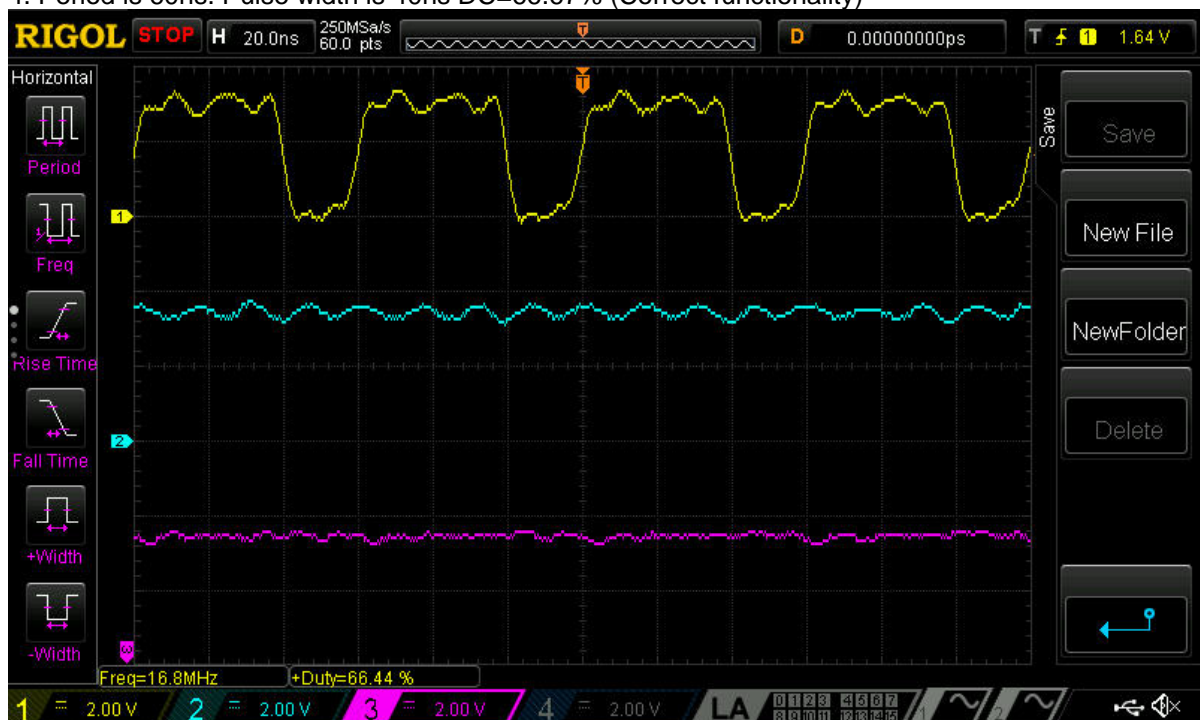
4. Period is 60ns. Pulse width is 40ns DC=66.67% (Correct functionality)

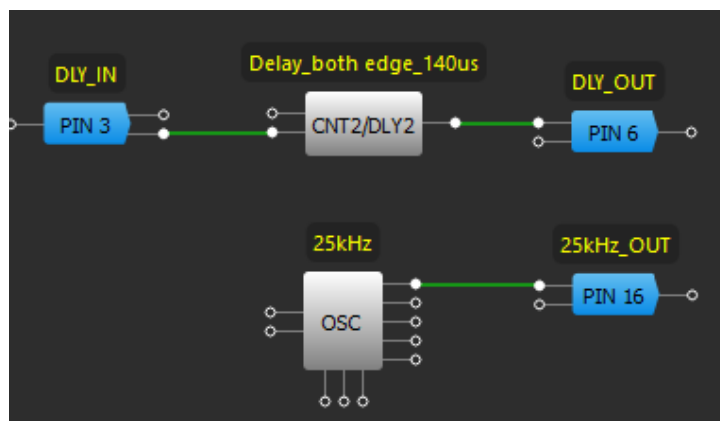
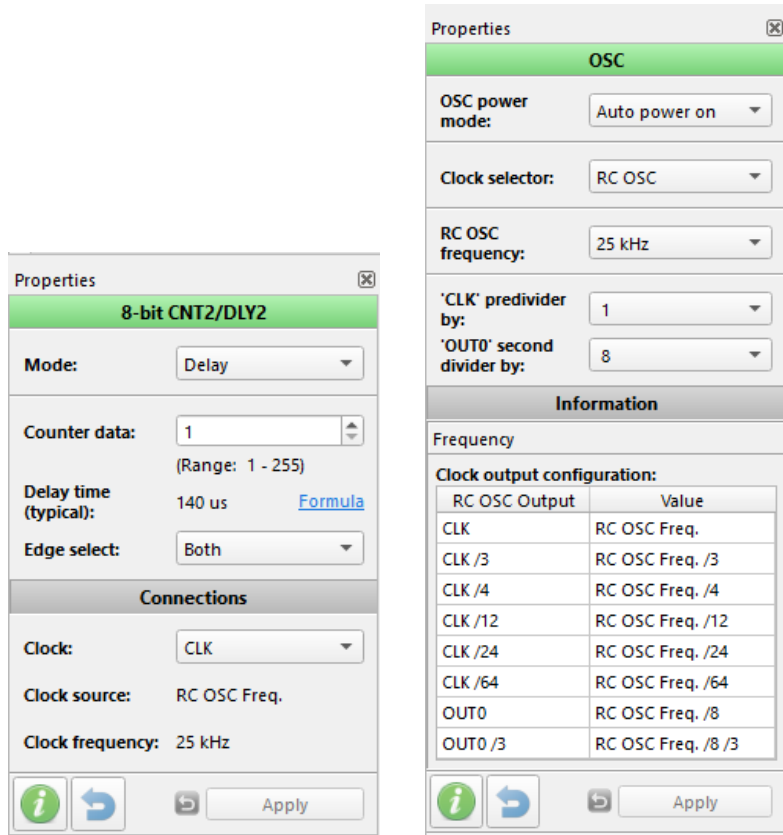
The first period of the RC OSC can be very short when OSC configured as 25 kHz with Auto Power On in the designs. This can be occurred when V_{DD} is above 4.0 V. Critical for CNT/DLY with a low counter data (less than 10) or if it is necessary to use the frequency of the OSC to clock external elements.

An example of such issue is in the following configuration:

- Avoid V_{DD} higher than 4 V
- Force ON OSC

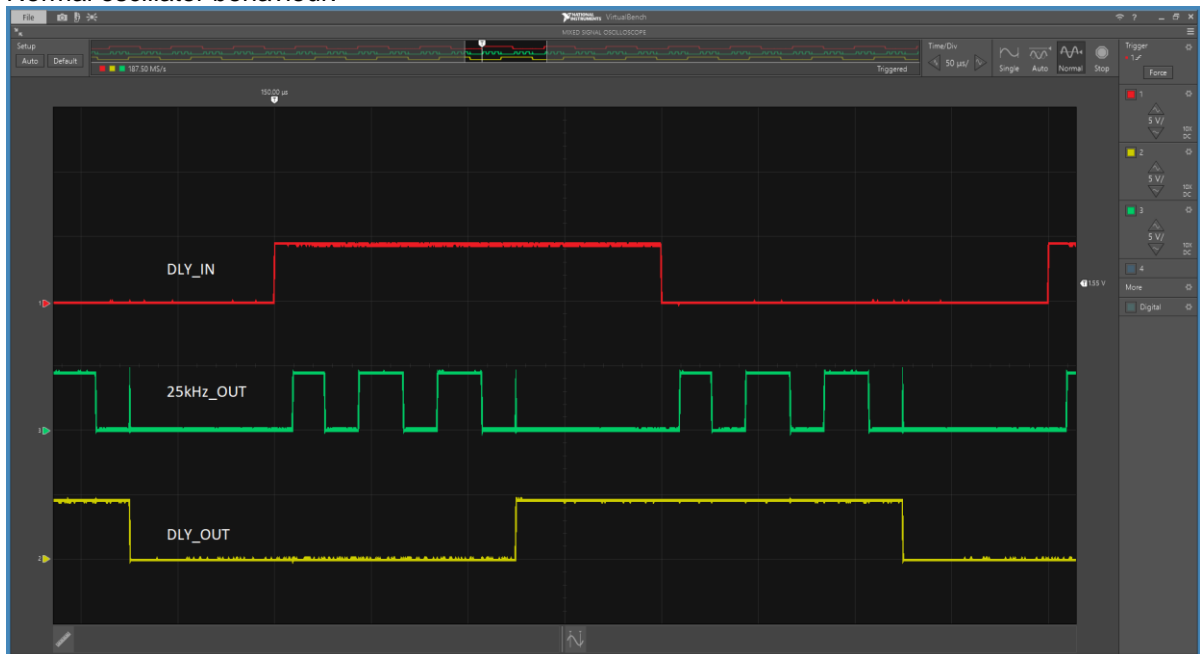
Normal oscillator behaviour.

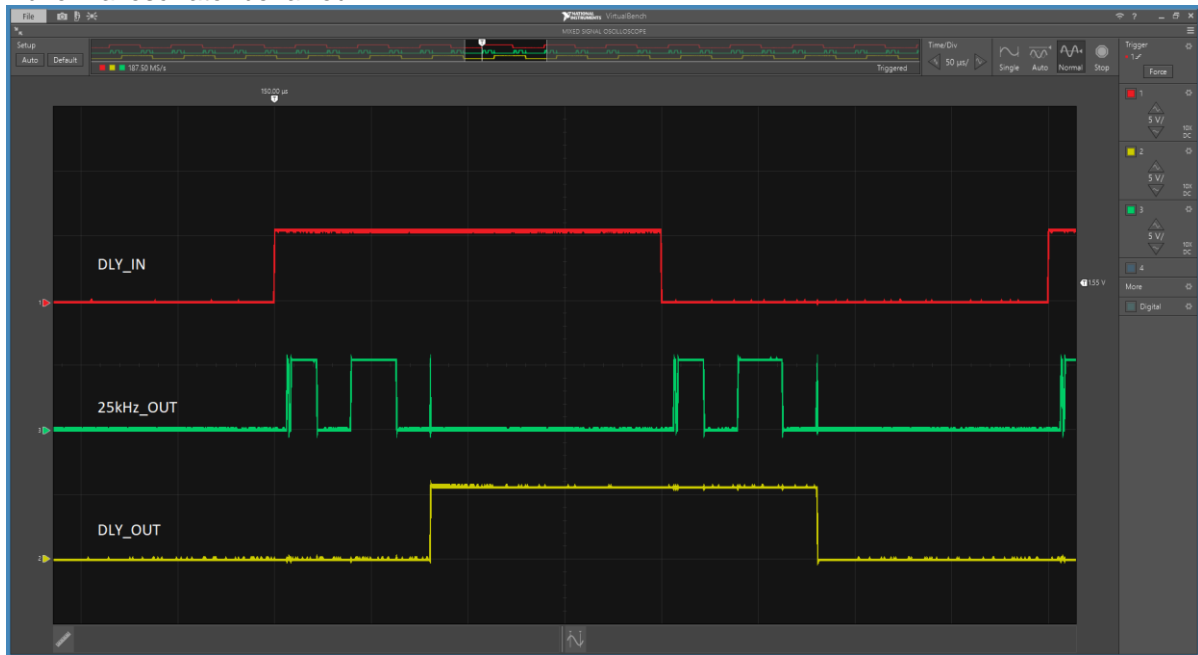
Abnormal oscillator behaviour.
