Errata Sheet

SLG46140

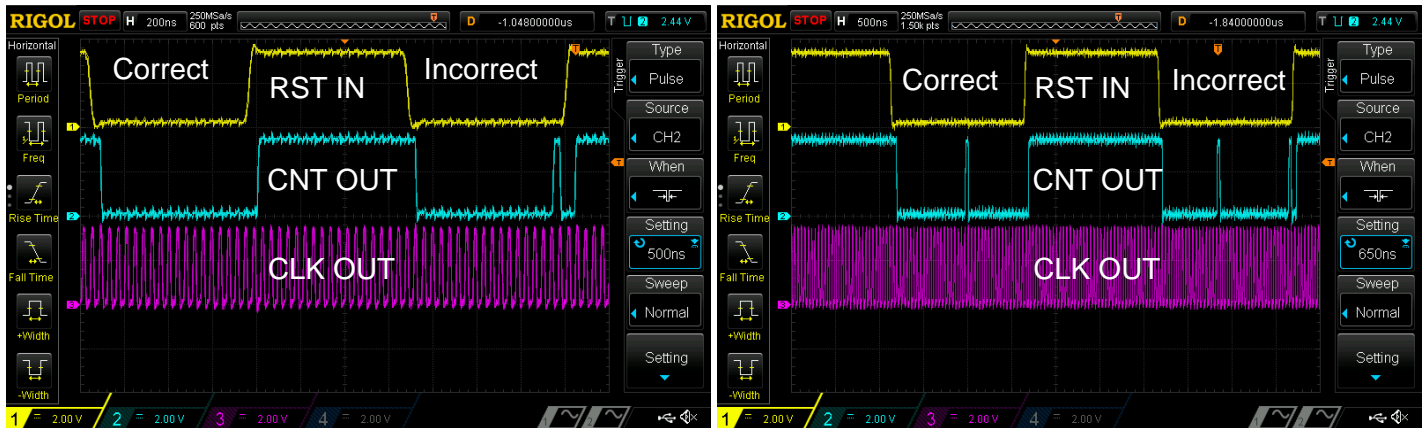
ISSUE 2: Incorrect Counter Operation after the Reset Functional Block Affected: Counter

If the Counter Reset occurs at a time very close to a rising edge of the clock signal during clock signal generation (for example OSC operation), there is a possibility that the Counter Data of the Counter is reset incorrectly and the counter end signal (HIGH pulse) may appear faster than expected. This phenomena appears more frequently the higher the clock frequency is.

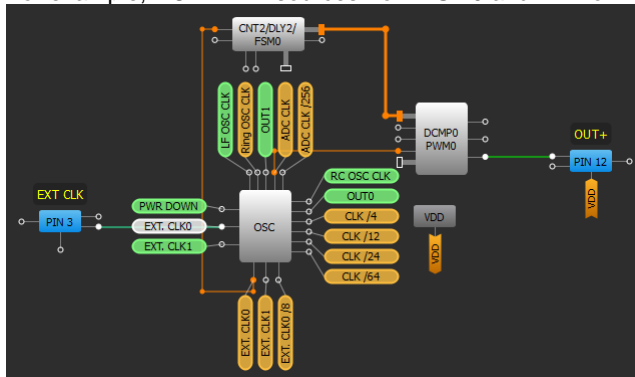
ISSUE 3: DCMP OUT+ Output Glitch
Functional Block Affected: DCMPs

DCMP's OUT+ output may have a glitch when the input data is changed. This issue appears more frequently the higher the DCMP clock is.

For example, DCMP IN+ sources from FSM0 and IN- from Register0. DCMP is clocked from the Ring OSC.

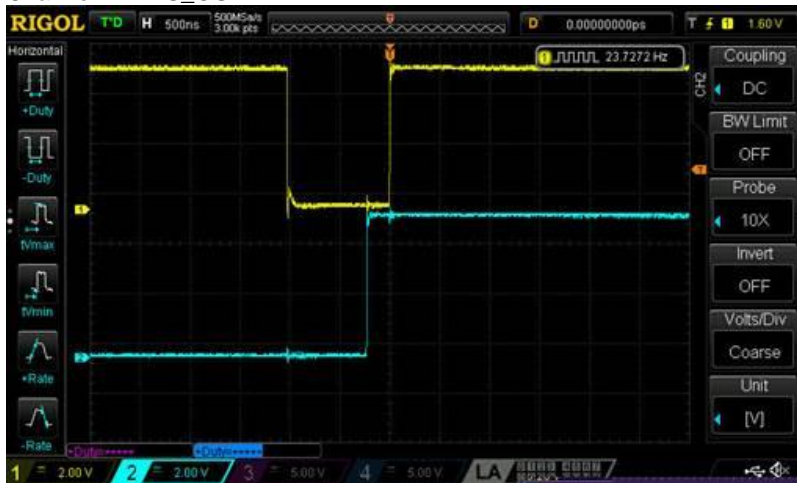
ISSUE 6: ACMP Output Glitch due to Ring OSC Operation

The output of the ACMP incorrectly goes low even when IN+ is greater than IN- if the RING OSC is active when the WS signal rises

Channel 1 – ACMP out

Channel 2 – WS_OUT

- Avoid using the RING OSC with the WS Controller, or add a filtering block on the ACMP output to filter out the glitch.

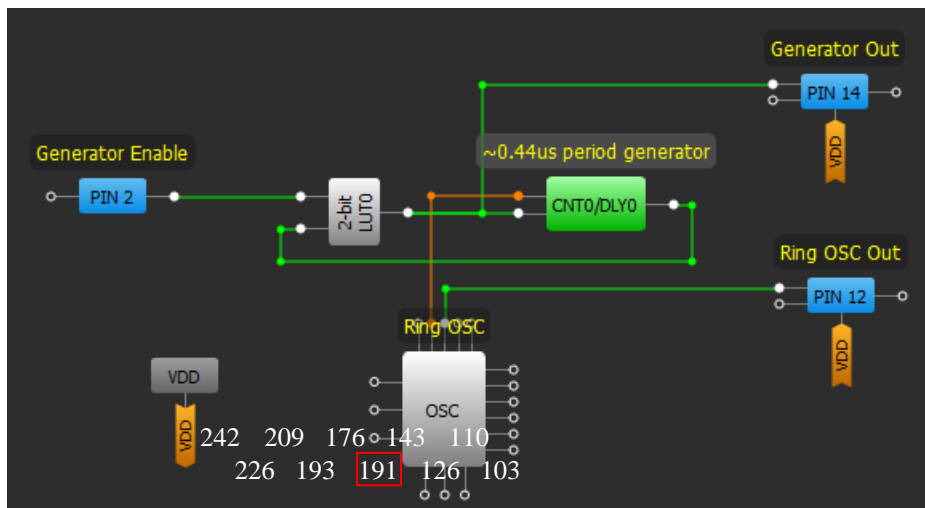
ISSUE 7: Long Ring OSC Settling Time

The Ring OSC has a longer settling time when configured as Auto Power On in the designs that have very short Ring OSC disable time. An example of such issue is in the following configuration:

- Set Ring OSC power mode to “Force Power On”
- or, Set Turn on by register option in BG (Band Gap) block as “Enable”

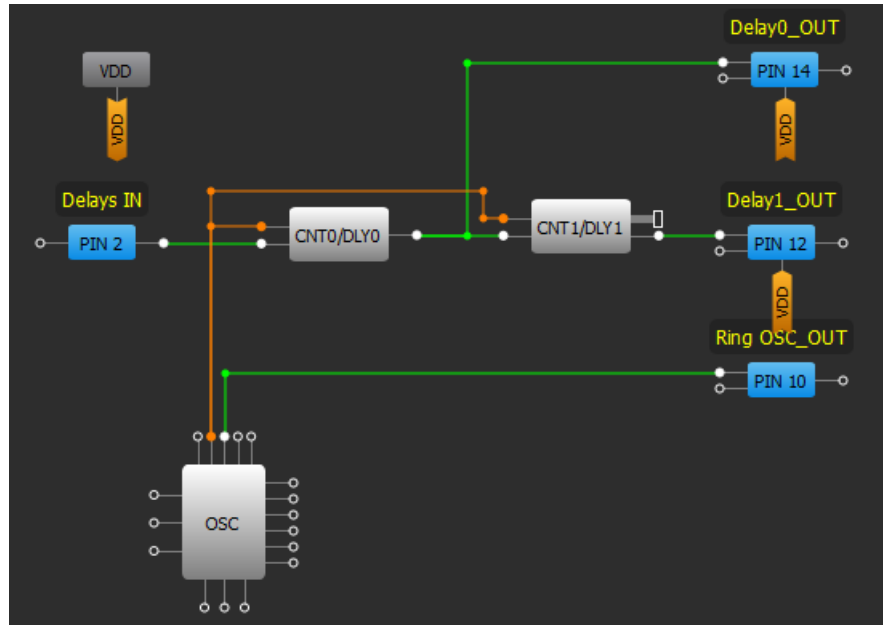
A similar situation occur while using two connected delays (all edge detect types except for a pair “Rising edge DLY – Falling edge DLY”).

In the following example, Delay0 and Delay1 are configured in the same way. However, Delay0 time is 11.4us instead of expected 0.4us (Delay0 time).
