Errata SLG46169 CE-GP-020

This document contains the known errata for SLG46169 and the recommended workarounds.

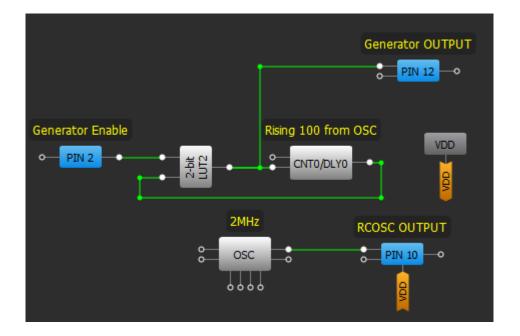
An example of such issue is in the following configuration:

The RC OSC has a longer settling time when configured as 2 MHz with Auto Power On in the designs that have very short RC OSC disable time.

- In first case use block with longer propagation time.

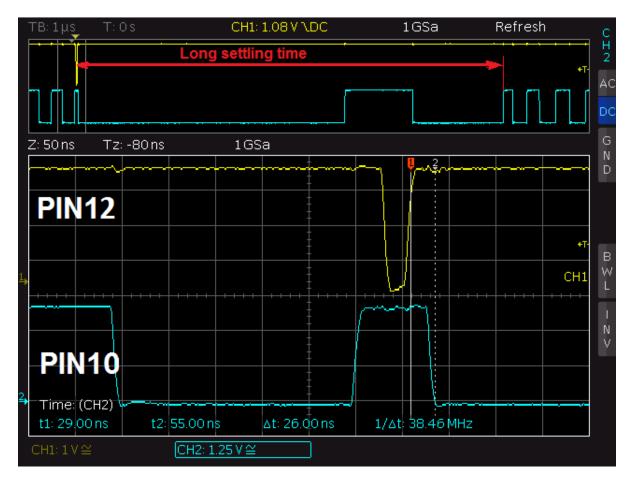
The configuration shown above generates a periodical signal with a frequency defined by the Delay cell and started by a HIGH signal on PIN2. The issue becomes apparent in a longer settling time when the scheme generates short pulses (Delay is configured as a rising edge delay only). See waveform below.

Channel 1 – 2-bit LUT0 output; Channel 2 – RC OSC output

Such behavior will lead to substantial error in period calculations if the delay time is relatively small.

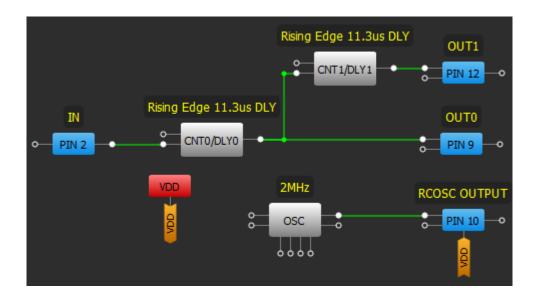
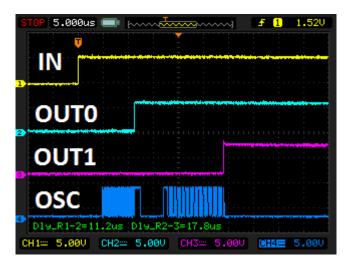
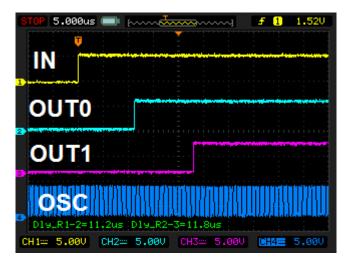
In the following example, Delay0 and Delay1 are configured in the same way. However, Delay1 time is 17.8 us instead of expected 11.3 us (Delay0 time).

If there are some inner blocks which use RC OSC at the moment or RC OSC is forced power on when such error appears, RC OSC will be operational and delay value will be proper.

- using two delays in series (except for a pair "Rising edge DLY – Falling edge DLY") use one Filter cell or P DLY between delay blocks. Using LUTs won't help in this case.

- use the "Force power on" RC OSC power control option to make the RC OSC operate at all times.

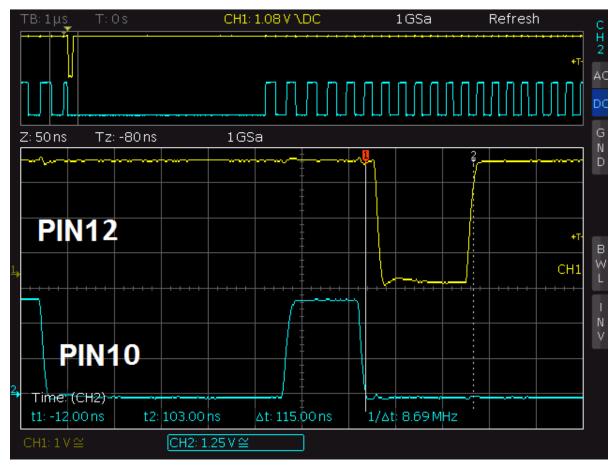
Channel 1 – 2-bit LUT0 output; Channel 2 – RC OSC output

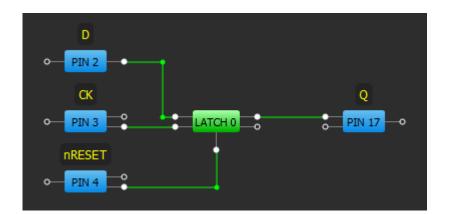
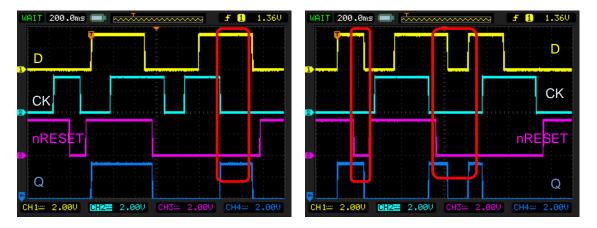
The reset function in LATCH blocks does not operate correctly. This can be described as function failure when nRESET input is set LOW.

The scope shots shown above show the incorrect nRESET function operation marked with red rectangles. From these waveforms can be seen that the reset function operates only when the CK signal is HIGH, in all other cases it is inoperational.

- Avoid using nRESET function in LATCH blocks in SLG46721/722 devices, if possible, use SLG46110/120 devices, where this function operates correctly.

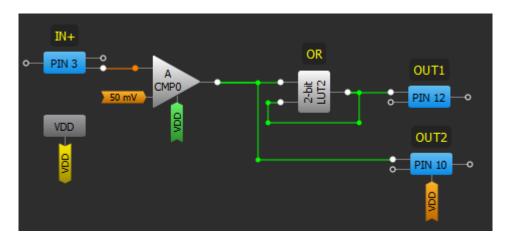
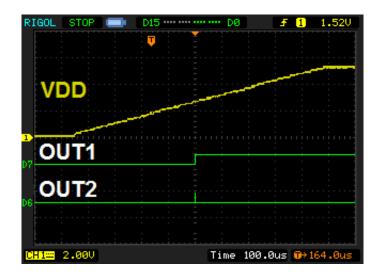
In some cases, ACMP may have short high-level glitches on its output (even if IN+ voltage is less than IN- voltage) after GreenPAK chip being powered up. Such cases may appear when using ACMP with Low Bandwidth mode enabled and Power Up is connected directly to the V_{DD}.

In order to detect such glitches, scheme with additional LUT was used. This LUT detects high level on ACMP output and stays high until chip powers down.

ACMP IN+ is connected to the Ground.

Use POR block, connected to the ACMP's Power-Up pin. However, in this case ACMP will start working with low level output and will be able to go high only after POR goes high + ACMP power on time.

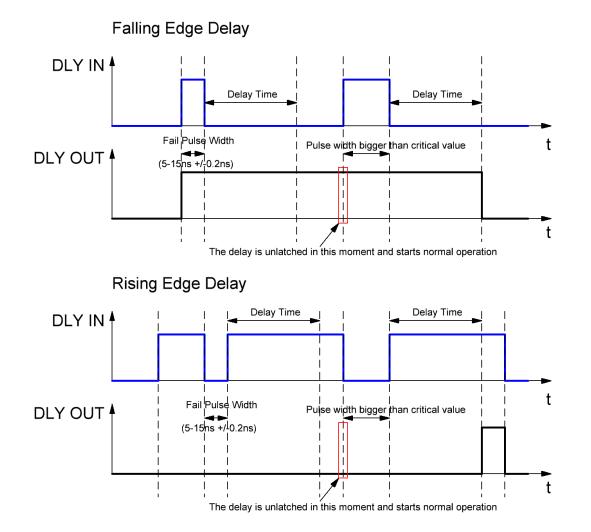
The delay output could be latched despite the input change when a short pulse is input. For example, if the delay cell is configured as a falling edge delay, the short pulse (see NOTE) appears on its input the delay cell output will switch from LOW to HIGH but may not switch from HIGH to LOW even after the delay time has passed.

NOTE: The pulse width varies from chip to chip and with different V_{DD} voltage. It is in range of 5-15 ns and in the window +/-0.2 ns, so it should be very precise for issue happen.

Also, note that both edge delays do not have such issue.

Use P DLY/FILTER block configured as a both edge delay or FILTER.

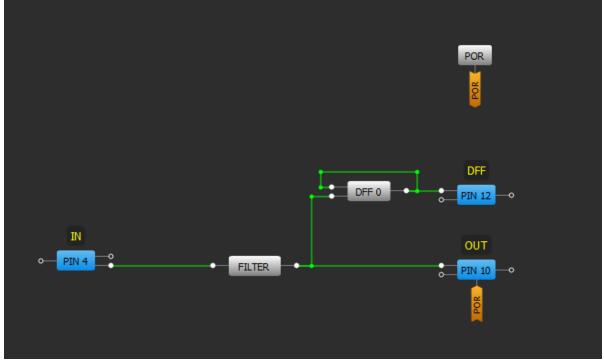
If clock type high frequency input comes in, the FILTER cell may not filter out it. There are several factors like input frequency, duty cycle and LOW duration in such signal that may lead to its passing through FILTER block.

Channel 1 (yellow/top line) – PIN#4 (IN) Channel 2 (light blue/2nd line) – PIN#10 (OUT) Channel 3 (magenta /3rd line) – PIN#12 (DFF)

Currently there is no workaround for this issue. Filter block is good at filtering short spontaneous glitches. It is intended to be used in series connection before the delay cell to avoid its latching (see issue #5).

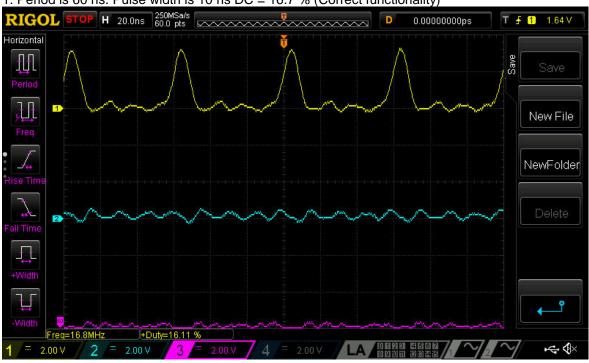
1. Period is 60 ns. Pulse width is 10 ns DC = 16.7 % (Correct functionality)

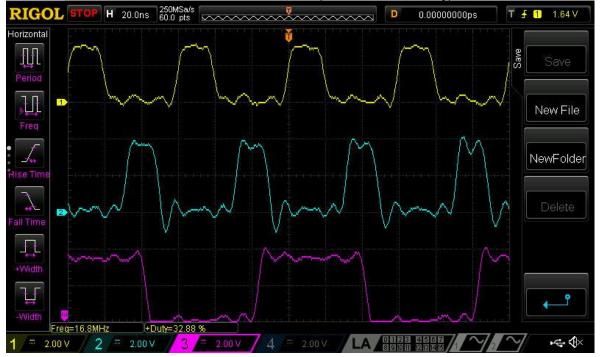
2. Period is 60 ns. Pulse width is 20 ns DC = 33.3 % (Incorrect functionality)

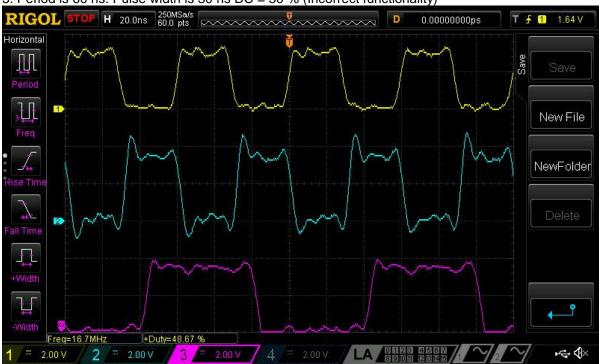
3. Period is 60 ns. Pulse width is 30 ns DC = 50 % (Incorrect functionality)

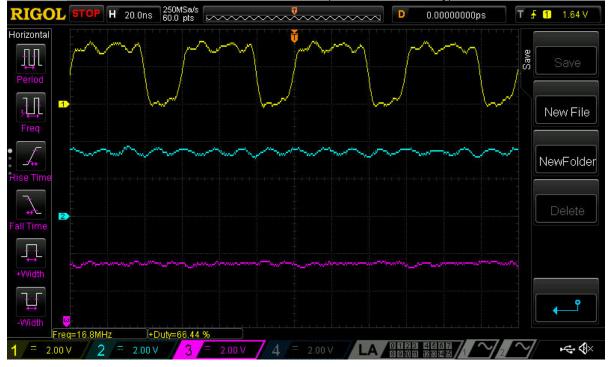
4. Period is 60 ns. Pulse width is 40 ns DC = 66.67 % (Correct functionality)

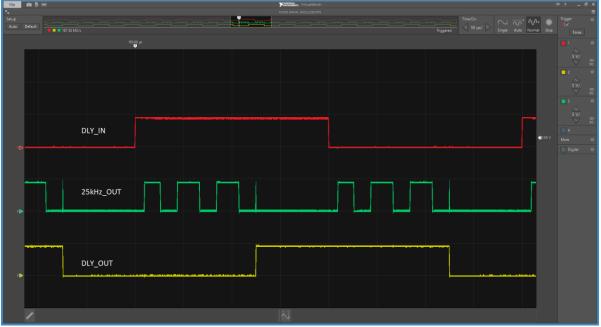
Normal oscillator behavior.

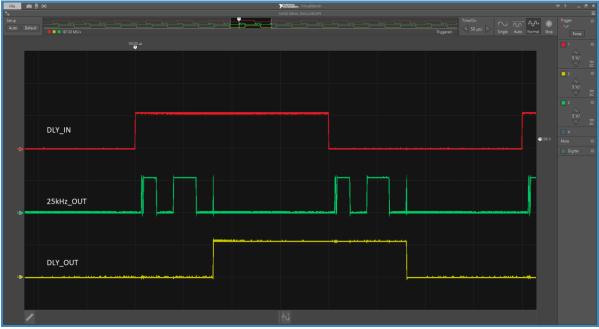
The first period of the RC OSC can be very short when OSC configured as 25 kHz with Auto Power On in the designs. This can occur when V_{DD} is above 4.0 V. Critical for CNT/DLY with a low counter data (less than 10) or if it is necessary to use the frequency of the OSC to clock external elements. An example of such issue is in the following configuration:

Abnormal oscillator behavior.

- Avoid V_{DD} higher than 4 V - Force ON OSC
