## SLG46531

## ISSUE 1: Counter Incorrect Operation after the Reset

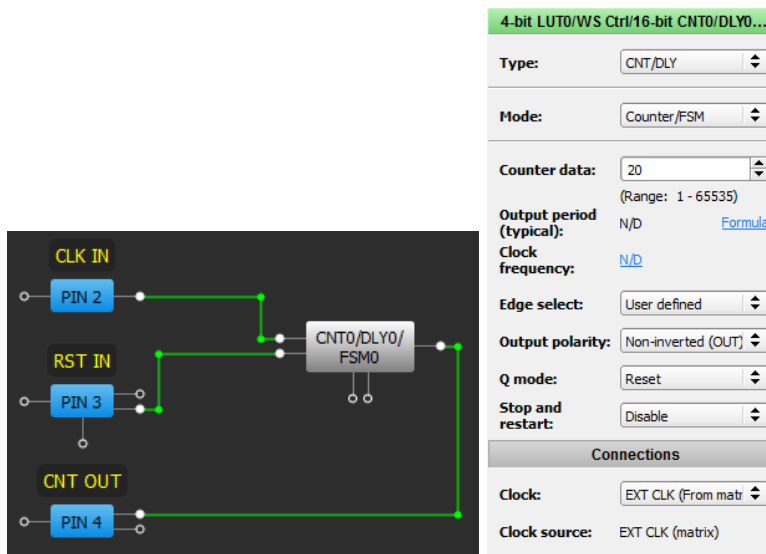
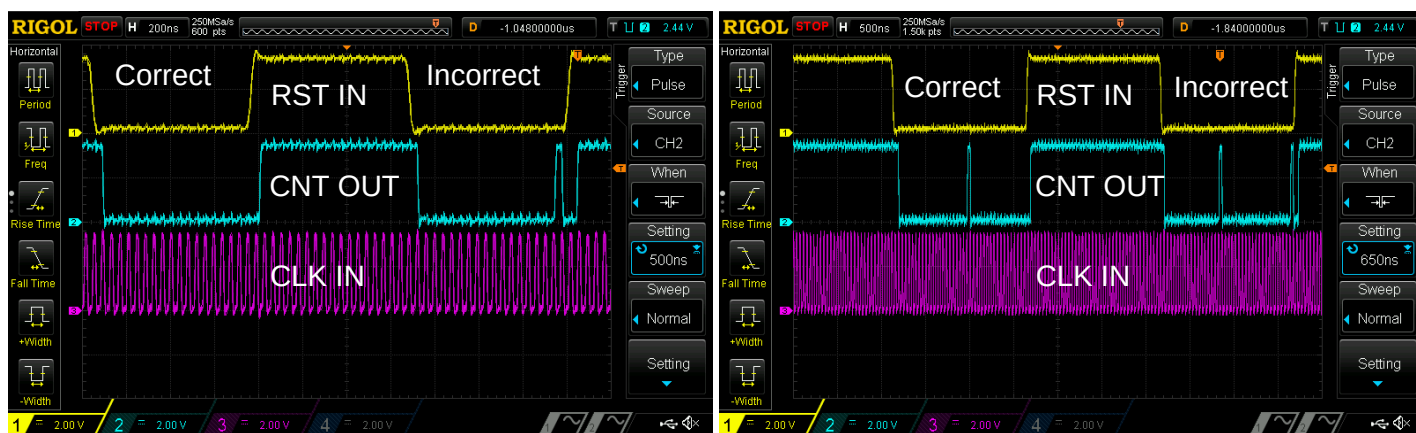
If the Counter Reset is asserted at the same time as a rising clock edge, it is possible that the Counter Data will be reset incorrectly and the counter output may appear faster than expected. This phenomenon appears more often as the clock frequency increases.

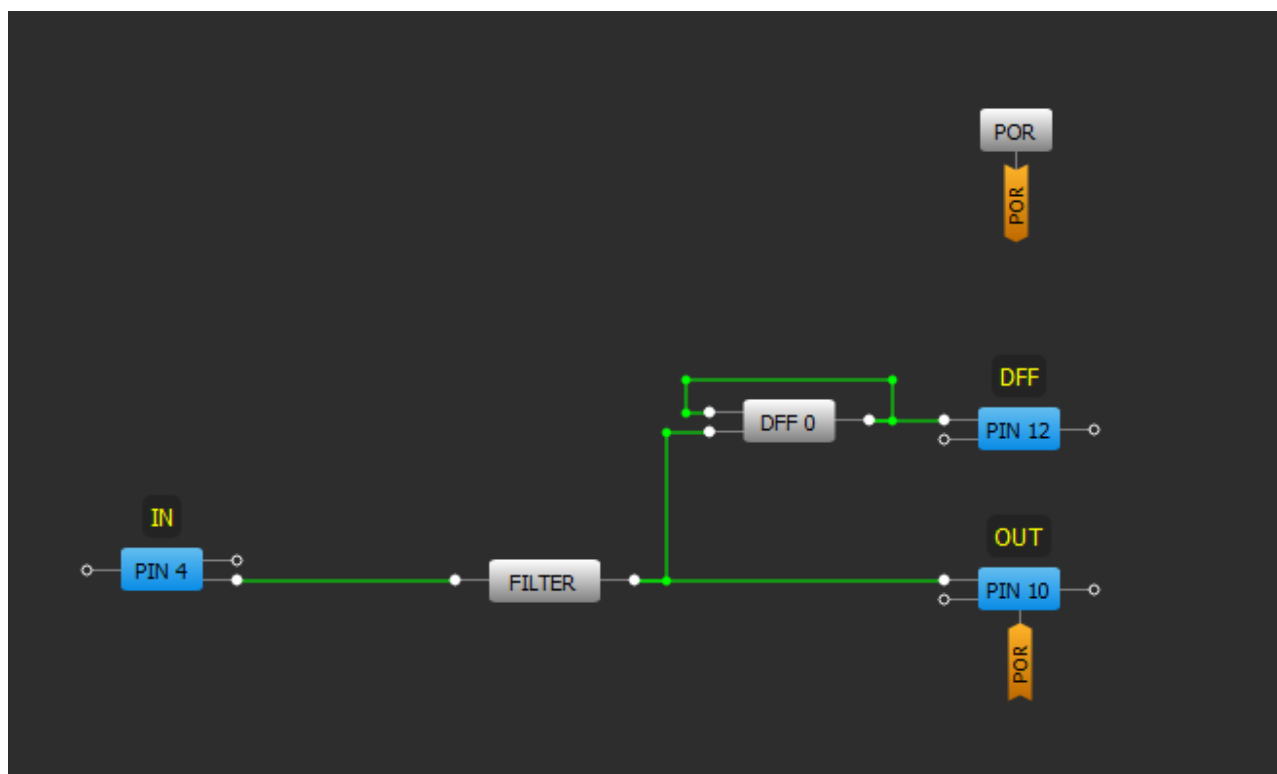
If clock type high frequency input comes in, the FILTER cell may not filter out it. There are several factors like input frequency, duty cycle and LOW duration in such signal that may lead to its passing through FILTER block.

Channel 1 (yellow/top line) – PIN#4 (IN)  
 Channel 2 (light blue/2nd line) – PIN#10 (OUT)  
 Channel 3 (magenta /3rd line) – PIN#12 (DFF)

Currently there is no workaround for this issue. Filter block is good at filtering short spontaneous glitches. It is intended to be used in series connection before the delay cell to avoid its latching (see issue #2).

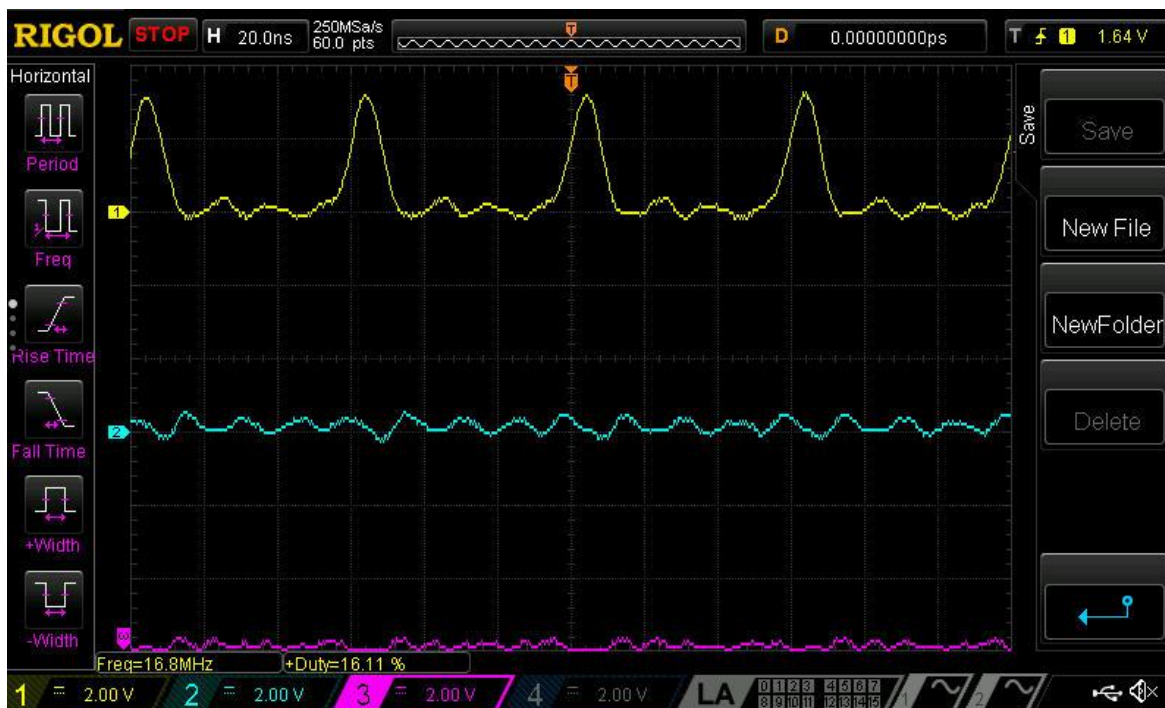
1. Period is 60ns. Pulse width is 10ns DC=16.7% (Correct functionality)

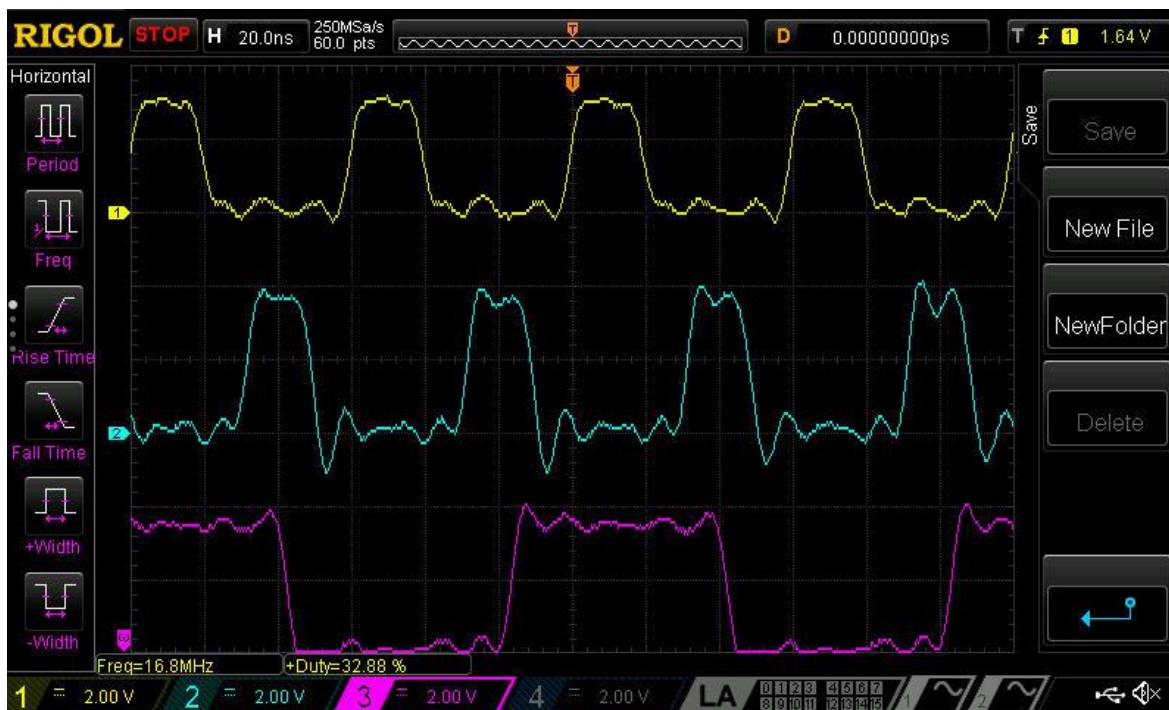
2. Period is 60ns. Pulse width is 20ns DC = 33.3% (Incorrect functionality)

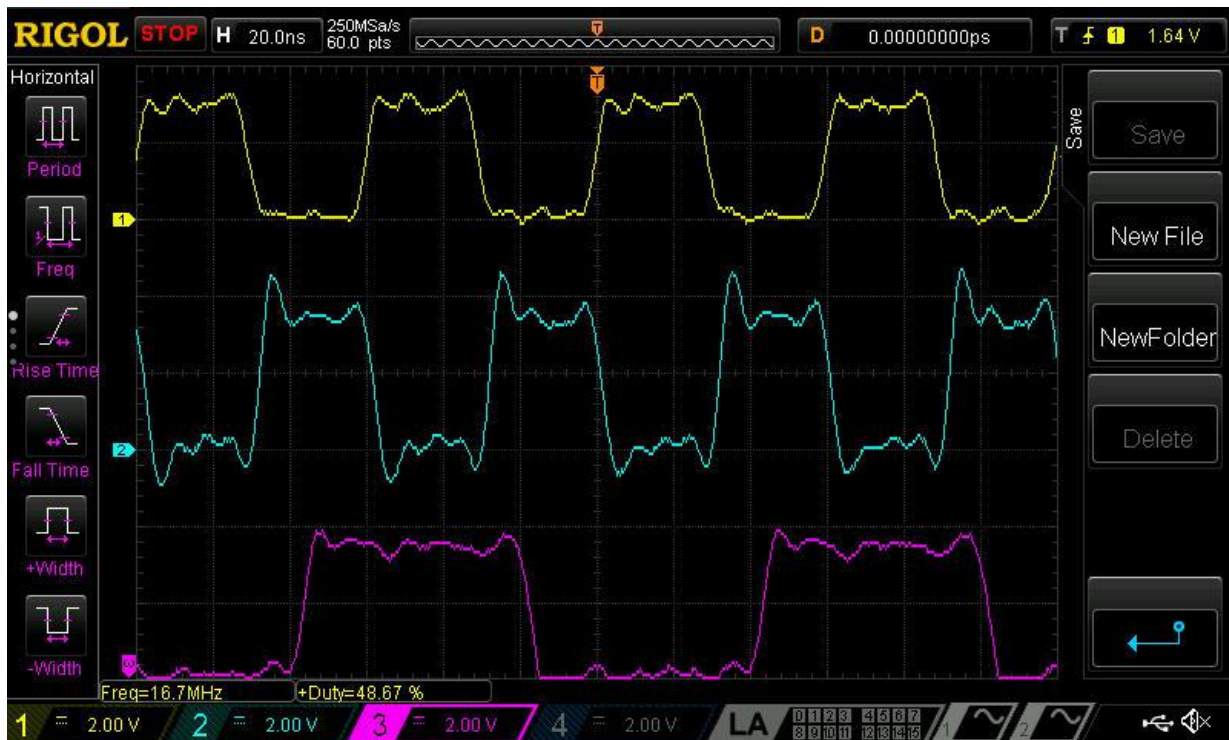
3. Period is 60ns. Pulse width is 30ns DC=50% (Incorrect functionality)

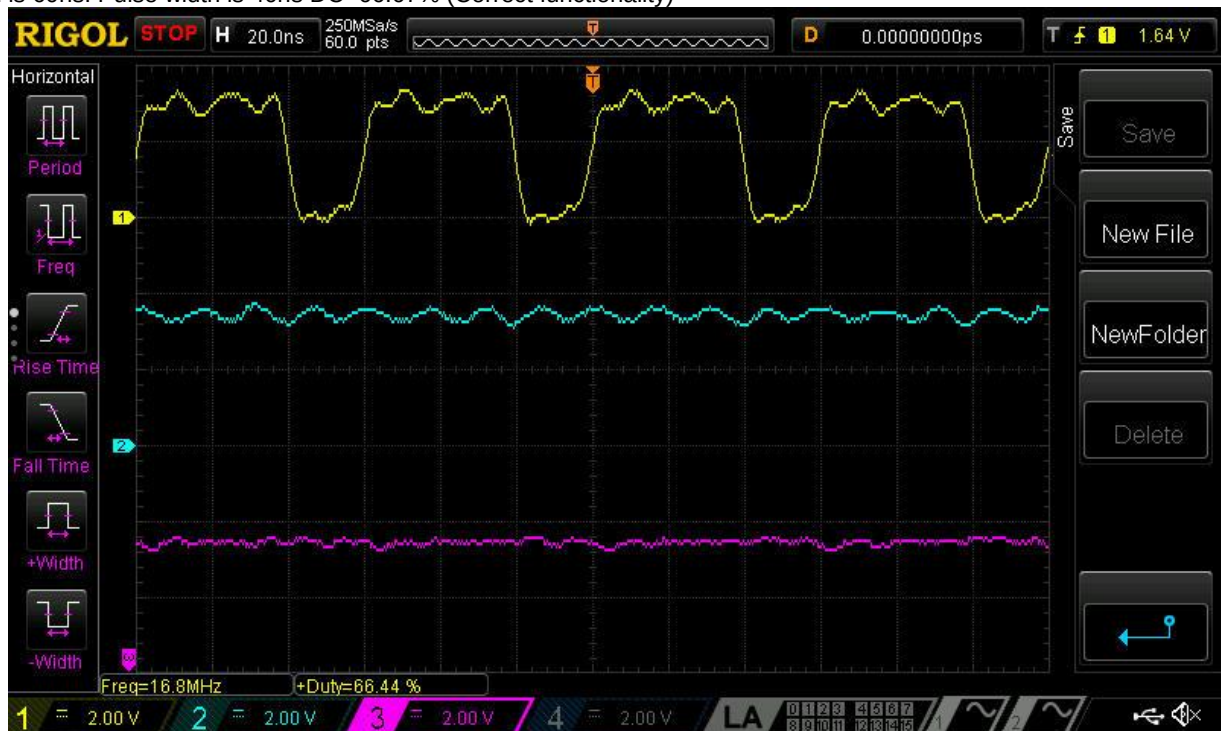
4. Period is 60ns. Pulse width is 40ns DC=66.67% (Correct functionality)

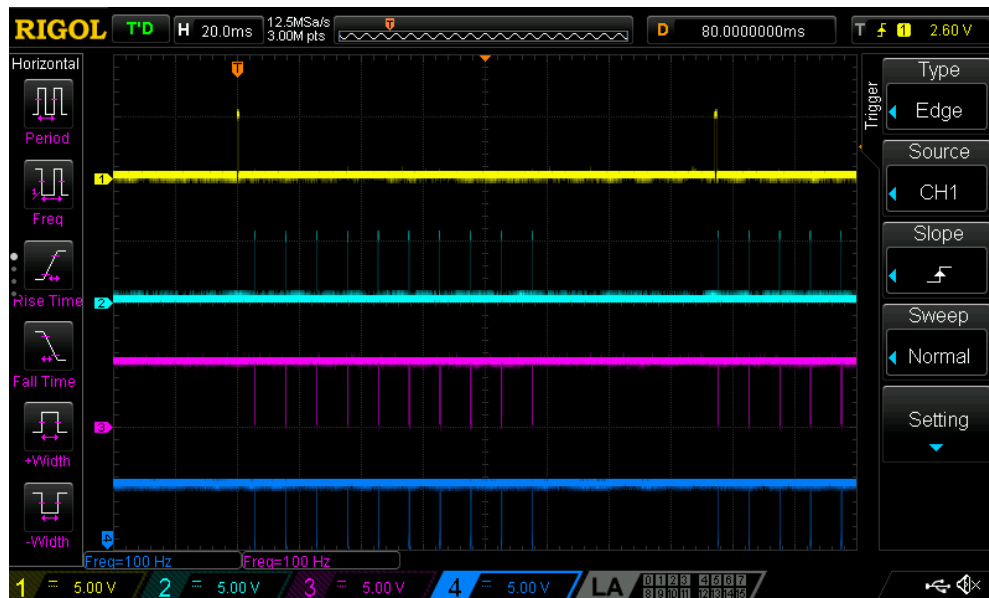
Asynchronous interaction between the CNT/DLY clock input and the I<sup>2</sup>C latch signal (generated by an I<sup>2</sup>C read command of the CNT/DLY block's count value) can result in an incorrect I<sup>2</sup>C data read. The CNT/DLY block will count accurately, but the count value transferred into the block's I<sup>2</sup>C read register might be loaded incompletely if the I<sup>2</sup>C latch signal and the clock input occur at about the same time.

The example data capture below shows ten periodic I<sup>2</sup>C reads of CNT2/DLY2 configured to count down at about 16 clocks per read. The sixth read sample erroneously shows a value greater than that of the fifth. The seventh sample reads as if the previous I<sup>2</sup>C error never occurred - the difference from the fifth sample (176) to the seventh (143) is 33 clocks or 16 clocks + 17 clocks as expected.

Channel 1 (yellow/top line) – PIN#2 (CNT2/DLY2 Out)  
 Channel 2 (light blue/2nd line) – PIN#1 (I<sup>2</sup>C Read Triggers)  
 Channel 3 (magenta /3rd line) – PIN#8 (I<sup>2</sup>C SCL)  
 Channel 3 (dark blue /4th line) – PIN#9 (I<sup>2</sup>C SDA)

If the possibility of incorrect I<sup>2</sup>C data reads can't be accommodated for by external software checks, one can guarantee proper operation by stopping the CNT/DLY block's clock during I<sup>2</sup>C reads through one of the following methods: by disabling the oscillator block, by reconfiguring the CNT/DLY block's clock source, or by gating an external clock using a LUT (Look-up Table) in the signal matrix. After disabling the CNT/DLY block's clock, the count registers can be read without error. Please note that this workaround will add the I<sup>2</sup>C read and processing time to the counter's overall clock period.

The best workaround depends on the resource constraints of the application. If the oscillator block doesn't clock other logic elements within the design, a matrix output can be used to manually power down the oscillators for the I<sup>2</sup>C read. When the CNT/DLY block's clock source is routed internally from the oscillator block, I<sup>2</sup>C commands can temporarily reconfigure the CNT/DLY block's clock source registers to select "Ext. CLK. (From Matrix)." This action will disable the clock by connecting it to ground. If the CNT/DLY block is clocked from the signal matrix, a LUT can be used to gate the clock during an I<sup>2</sup>C read.
