SLG46580

ISSUE 1: Long 2 MHz OSC Settling Time Functional Blocks Affected: OSC, Counter, Delay

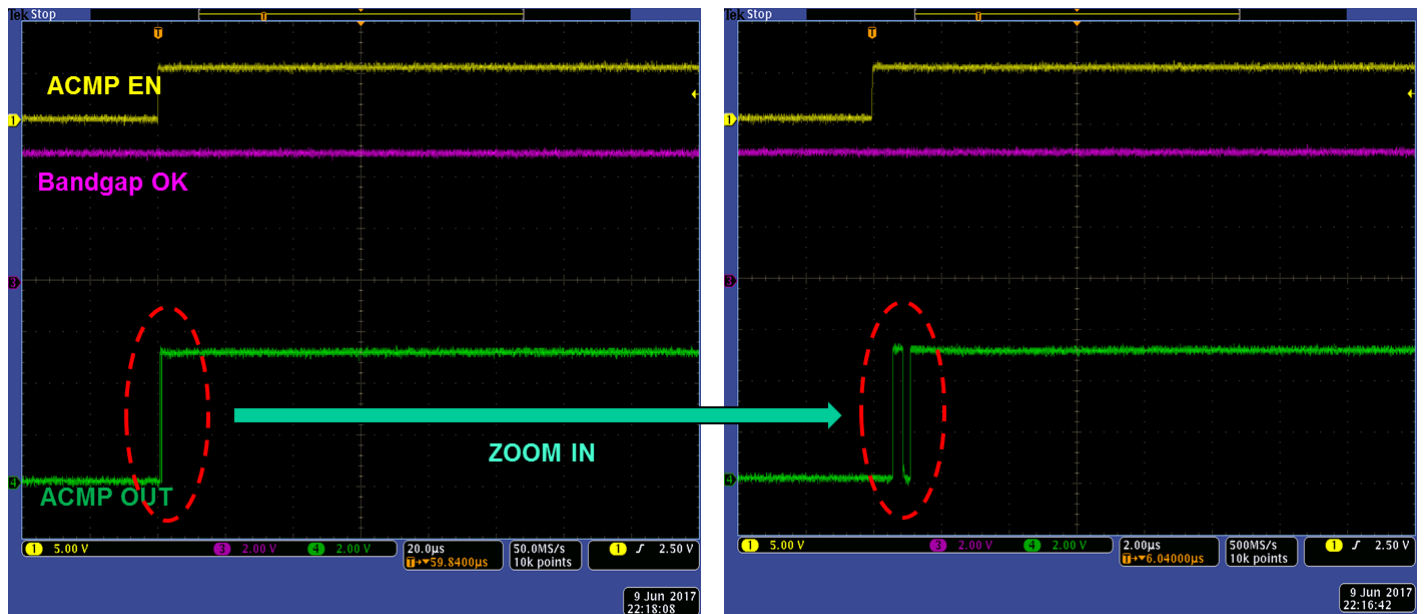
After power-up, if LDO is enabled earlier than ACMP, its output may generate a glitch.

VDD = 5.0 V, ACMP IN+ > IN-, one of LDOs enabled.

Because BG_OK is already released by LDO, there is no gating signal. Depending on the ACMP VREF condition & the positive input value, it is possible for the ACMP to have a glitch. Subsequently, the other ACMP will not have an issue unless the customer repeats LDO enable first and ACMP later during power stable.

- Use both edge delay on the output to filter out the glitch.

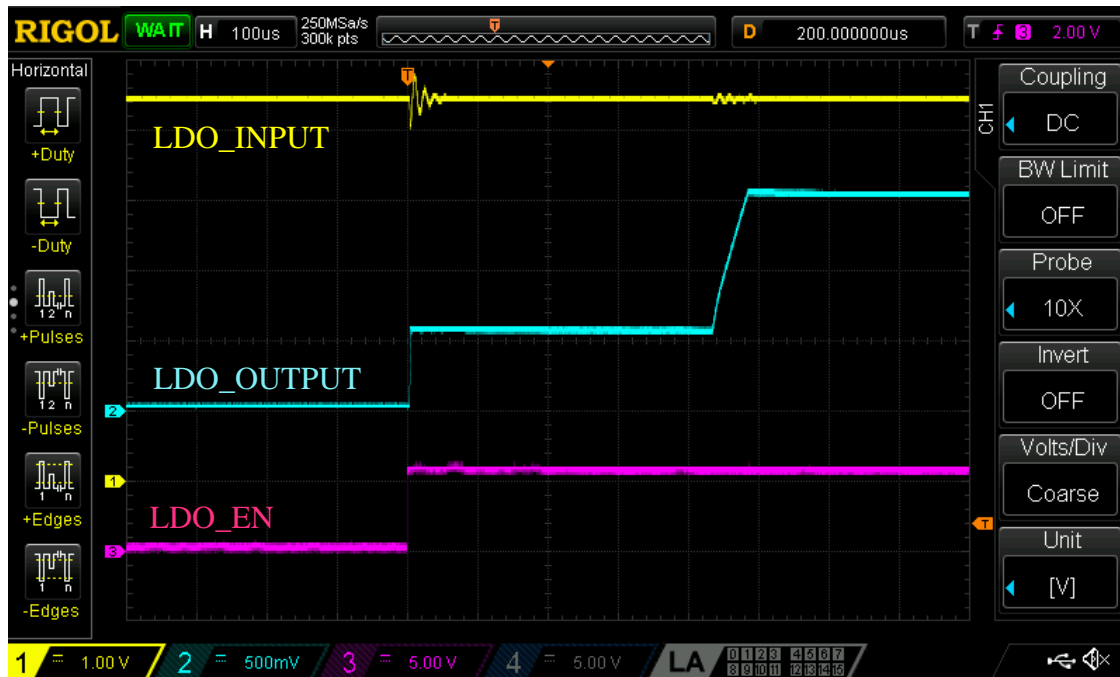
When a GreenPAK's first LDO is enabled, the LDO's VOUT will step to a non-zero voltage during its 500 μ s wait time. The magnitude of this step is directly proportional to the LDO's VIN and the GreenPAK's VDD. With a large LDO input voltage and VDD, this step can exceed 500 mV.

VDD = 5.5 V, LDO_INPUT = 5.5 V, all other LDOs disabled.

- If your GreenPAK design has an unused LDO, you can reduce the magnitude of this voltage step by keeping an unused LDO enabled in high power mode.
