SLG46580 Errata

CE-GP-002

This document contains the known errata for SLG46580 and the recommended workarounds.

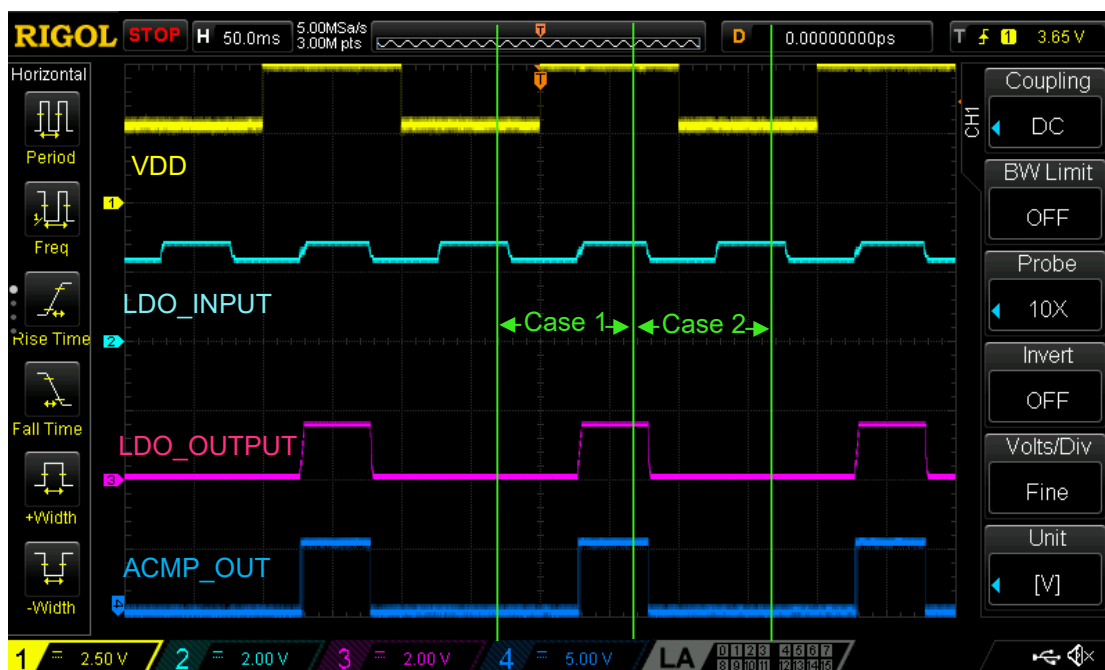
If an LDO's VIN pin (LDO_INPUT) has an internal connection (depicted with an orange wire) to the ACMP's IN+ port, the ACMP's output may give an erroneous result with respect to the LDO's input voltage. The switch between the LDO's VIN pin and the ACMP's IN+ port is implemented using an NMOS-only based transmission gate with its gate controlled by logic supplied from V_{DD}. As a result, this switch is unable to pass LDO input voltages that are close to V_{DD}. This can result in the ACMP's IN+ port seeing a lower voltage than the actual voltage present at LDO_INPUT. This lower input voltage may cause the output of the ACMP to behave unexpectedly.

Case 1: proper behavior at $V_{DD} = 5\text{ V}$.

With a 5 V V_{DD} , the NMOS transmission gate passes the 2.25 and 2.75 V LDO_INPUT pin voltages to the ACMP's IN+ port. When the input voltage exceeds the 2.4 V IN- threshold of the ACMP, the LDO is enabled.

Case 2: erroneous behavior at $V_{DD} = 2.75\text{ V}$.

When the V_{DD} is reduced to 2.75 V, the NMOS transmission gate is unable to pass LDO_INPUT's full magnitude to the ACMP's IN+ port. Since the IN+ port of the ACMP doesn't exceed the 2.4 V IN- threshold, the ACMP's output stays low and keeps the LDO disabled.

If the GreenPAK's V_{DD} is always powered up before the LDO's VIN input, you can externally short the LDO's VIN to another dedicated analog input pin for the desired ACMP.

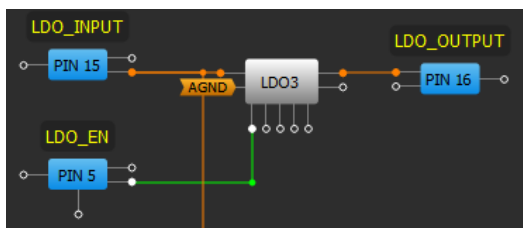
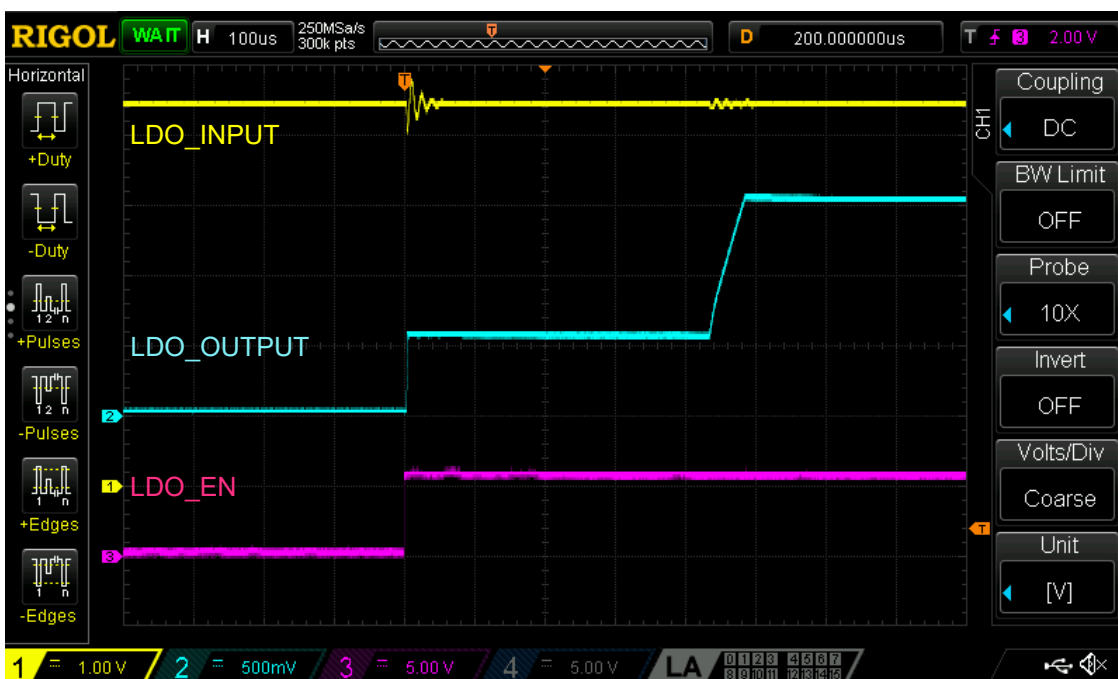
When a GreenPAK's first LDO is enabled, the LDO's VOUT will step to a non-zero voltage during its 500 μs wait time. The magnitude of this step is directly proportional to the LDO's VIN and the GreenPAK's V_{DD} . With a large LDO input voltage and V_{DD} , this step can exceed 500 mV.

V_{DD} = 5.5 V, LDO_INPUT = 5.5 V, all other LDOs disabled.

If your GreenPAK design has an unused LDO, you can reduce the magnitude of this voltage step by keeping an unused LDO enabled in high power mode.

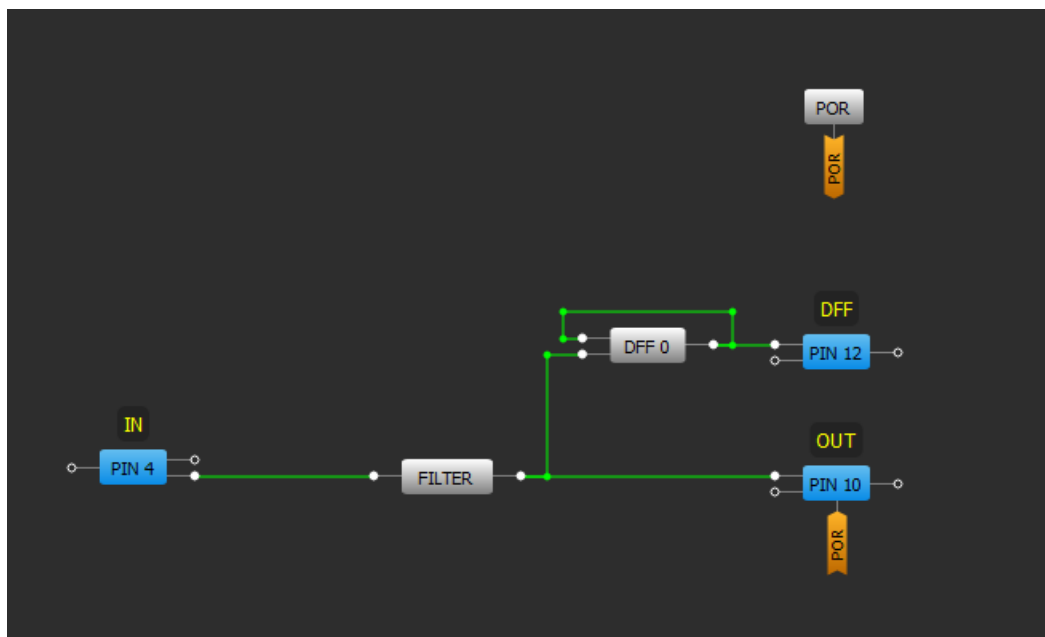
If the FILTER cell's input signal contains multiple consecutive pulses within short time intervals, the FILTER cell may not filter the input pulses as expected. The errant behavior applies only to repeated input pulses and depends on both their frequency and duty cycle.

Channel 1 (yellow/top line) – PIN#4 (IN).
 Channel 2 (light blue/2nd line) – PIN#10 (OUT).
 Channel 3 (magenta /3rd line) – PIN#12 (DFF).

Currently, there is no workaround for this issue. The FILTER block correctly filters isolated glitches, but it shouldn't be used to filter repetitive, high frequency input signals.

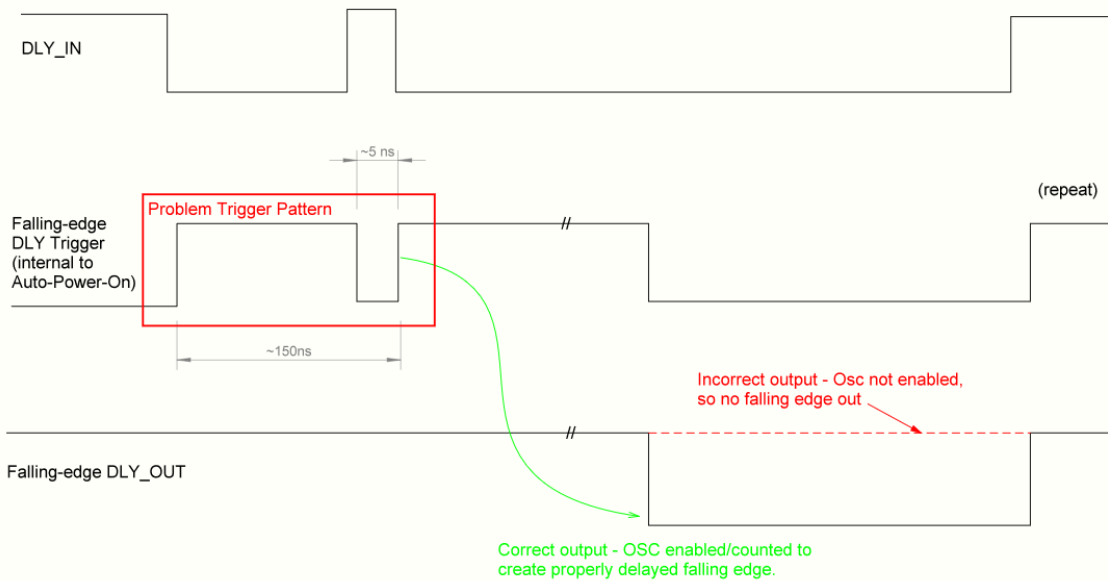
Figure 1: Problem Trigger Pattern

For this chip, the Auto Power On circuitry of the 25 kHz/2 MHz generators contains a circuit errata, which can potentially fail to power on the OSC for a specific pattern and timing of the OR of all related DLY trigger signals. The pattern is shown in Figure 1 (boxed in red) and consists of a relatively longer pulse (~145 ns) followed by a shorter (~5 ns) glitch of opposite polarity.

1. Use signal conditioning circuits to prevent glitch on DLY inputs < 200 ns. Examples:
 - a. ACMP with Hysteresis
 - b. External RC in front of Digital Input with Schmitt Trigger
 - c. Filter cell.
2. Set OSC power mode to Force Power On mode instead of Auto Power On.
3. Use different oscillator, such as 25 MHz Ring OSC, which does not have Auto Power On issue.

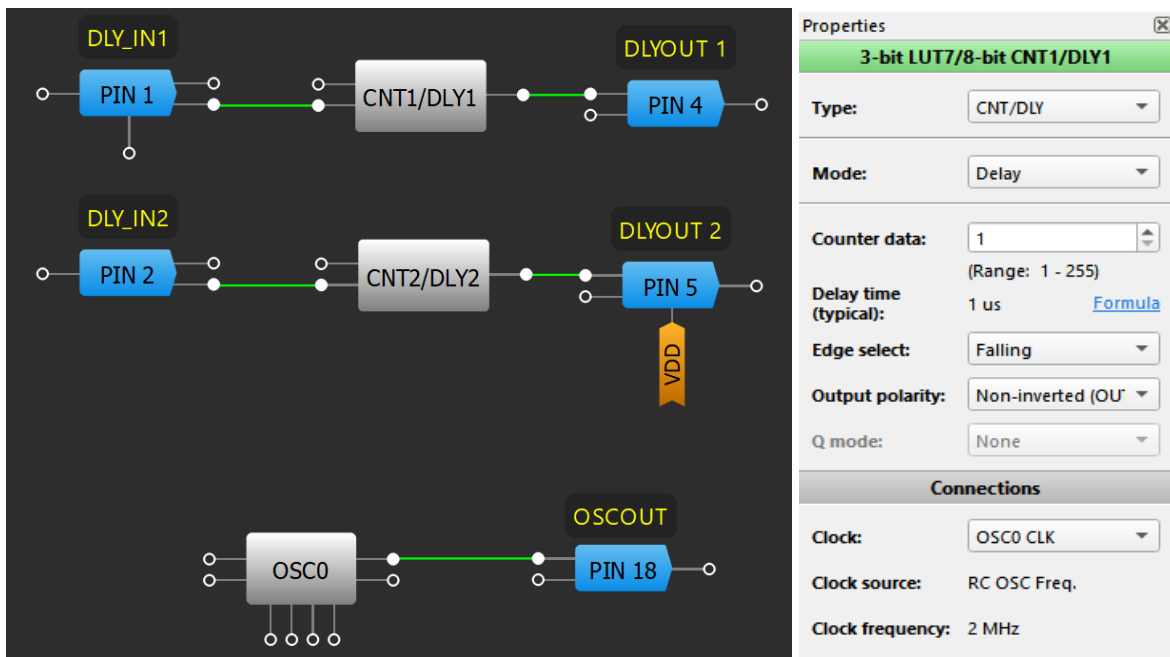
Figure 2: Test Circuit

The error is difficult to capture as the timing must be exact within ns, and short (ns) pulses are difficult to generate glitch precise enough to induce the problem. GPIO naturally filter out ns pulses, so for purposes of errata capture, two simultaneous falling-edge DLY circuits (as shown in Figure 2) were used. By lining up two delays precisely at a particular timing relationship, we can use the internal Auto Power On (OR logic) to generate the glitch pattern necessary to cause the error.
