SLG46582

ISSUE 1: Long 2 MHz OSC Settling Time Functional Blocks Affected: OSC, Counter, Delay

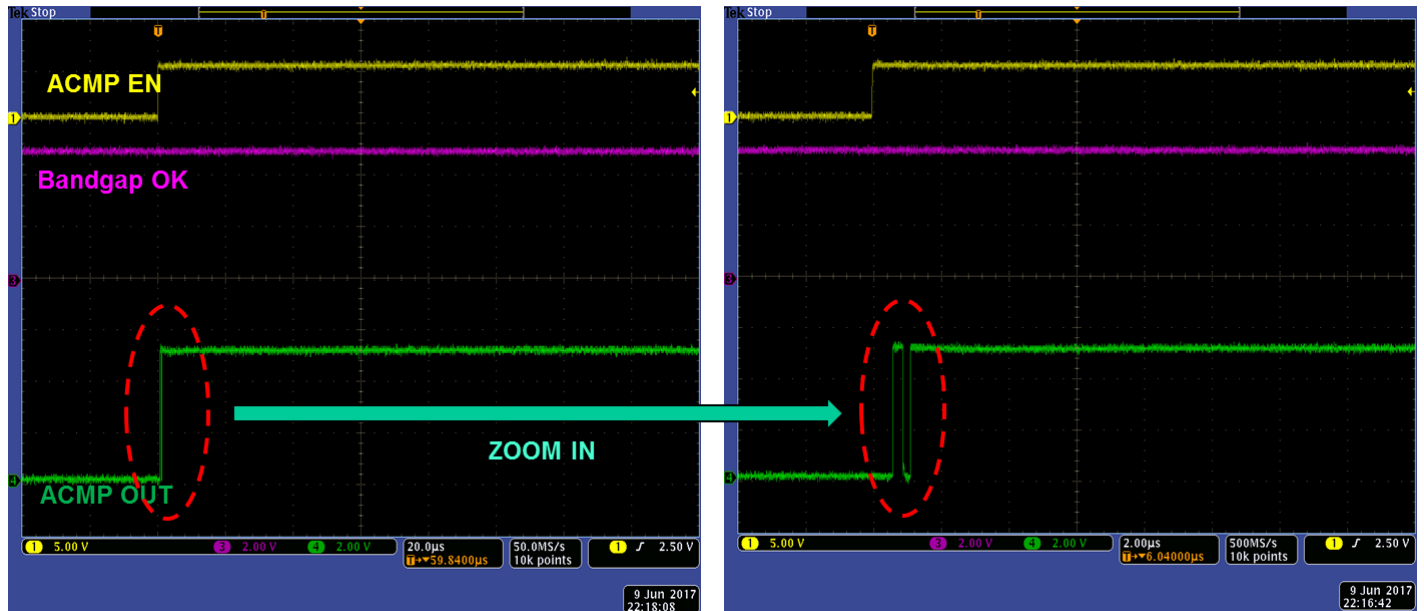
After power-up, if LDO is enabled earlier than ACMP, its output may generate a glitch.

VDD = 5.0 V, ACMP IN+ > IN-, one of LDOs enabled.

Because BG_OK is already released by LDO, there is no gating signal. Depending on the ACMP VREF condition & the positive input value, it is possible for the ACMP to have a glitch. Subsequently, the other ACMP will not have an issue unless the customer repeats LDO enable first and ACMP later during power stable.

- Use both edge delay on the output to filter out the glitch.

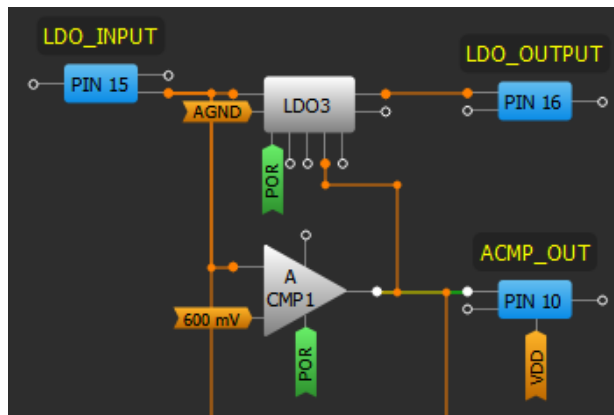
If an LDO's VIN pin (LDO_INPUT) has an internal connection (depicted with an orange wire) to the ACMP's IN+ port, the ACMP's output may give an erroneous result with respect to the LDO's input voltage. The switch between the LDO's VIN pin and the ACMP's IN+ port is implemented using an NMOS-only based transmission gate with its gate controlled by logic supplied from VDD. As a result, this switch is unable to pass LDO input voltages that are close to VDD. This can result in the ACMP's IN+ port seeing a lower voltage than the actual voltage present at LDO_INPUT. This lower input voltage may cause the output of the ACMP to behave unexpectedly.

If the LDO's UVLO feature is enabled, the ACMP's output will cause unexpected LDO behavior that results from the previously described transmission gate voltage drop.

With a 5 V VDD, the NMOS transmission gate passes the 2.25 and 2.75 V LDO_INPUT pin voltages to the ACMP's IN+ port. When the input voltage exceeds the 2.4 V IN- threshold of the ACMP, the LDO is enabled.

When the VDD is reduced to 2.75 V, the NMOS transmission gate is unable to pass LDO_INPUT's full magnitude to the ACMP's IN+ port. Since the IN+ port of the ACMP doesn't exceed the 2.4 V IN- threshold, the ACMP's output stays low and keeps the LDO disabled.

- If the GreenPAK's VDD is always powered up before the LDO's VIN input, you can externally short the LDO's VIN to another dedicated analog input pin for the desired ACMP.

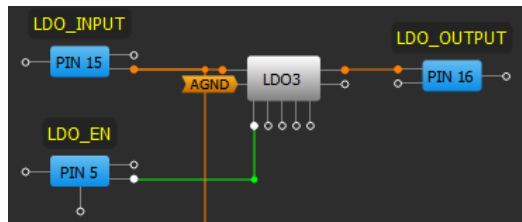
When a GreenPAK's first LDO is enabled, the LDO's VOUT will step to a non-zero voltage during its 500 μs wait time. The magnitude of this step is directly proportional to the LDO's VIN and the GreenPAK's VDD. With a large LDO input voltage and VDD, this step can exceed 500 mV.

VDD = 5.5 V, LDO_INPUT = 5.5 V, all other LDOs disabled.

- If your GreenPAK design has an unused LDO, you can reduce the magnitude of this voltage step by keeping an unused LDO enabled in high power mode.

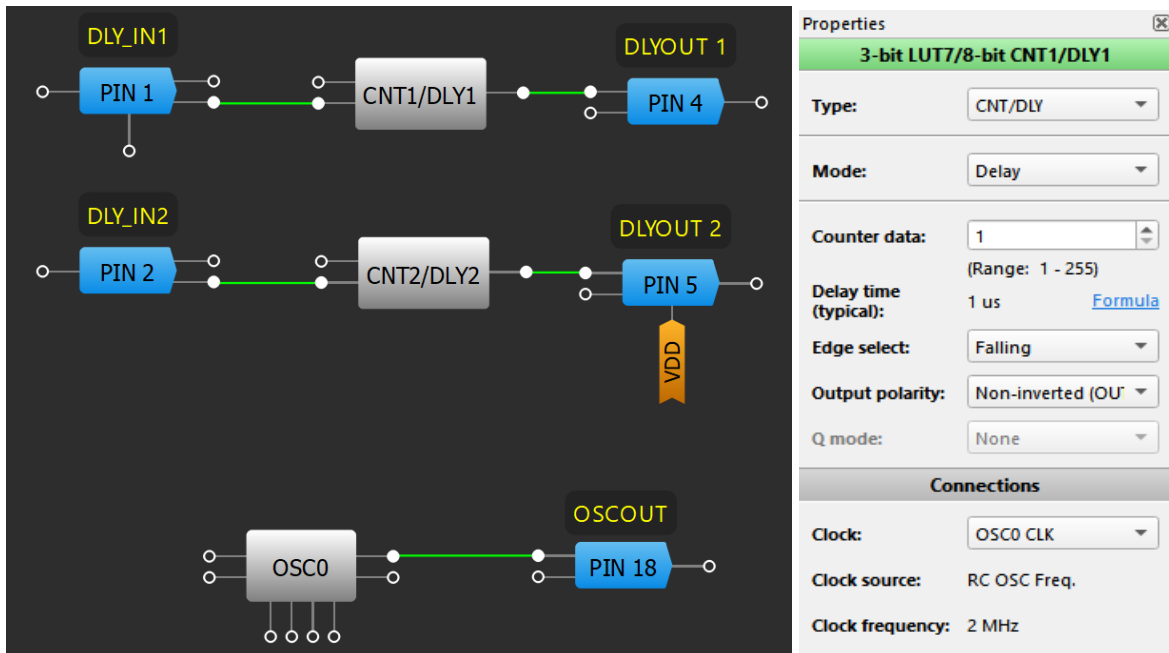
Figure 2: Test Circuit

The error is difficult to capture as the timing must be exact within ns, and short (ns) pulses are difficult to generate glitch precise enough to induce the problem. GPIO naturally filter out ns pulses, so for purposes of errata capture, two simultaneous falling-edge DLY circuits (as shown in [Figure 2](#)) were used. By lining up two delays precisely at a particular timing relationship, we can use the internal Auto Power On (OR logic) to generate the glitch pattern necessary to cause the error.
