Errata Sheet

SLG46620

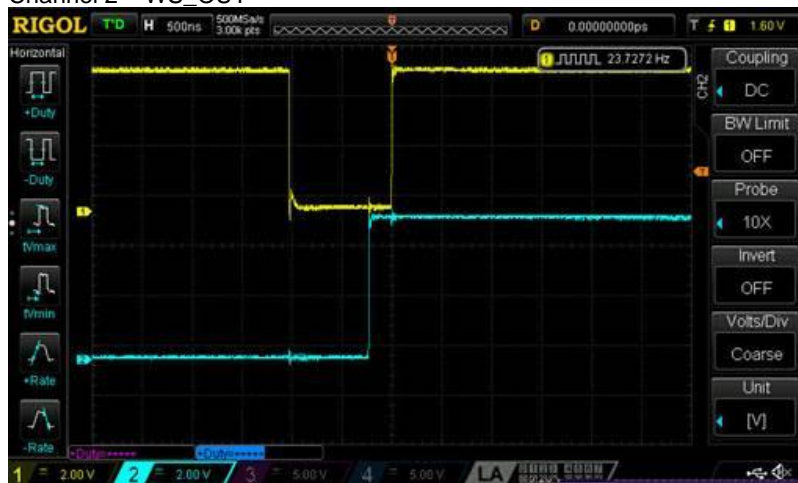
ISSUE 3: ACMP Output Glitch due to Ring OSC Operation

The output of the ACMP incorrectly goes low even when IN+ is greater than IN- if the RING OSC is active when the WS signal rises

Channel 1 – ACMP out

Channel 2 – WS_OUT

- Avoid using the RING OSC with the WS Controller, or add a filtering block on the ACMP output to filter out the glitch.

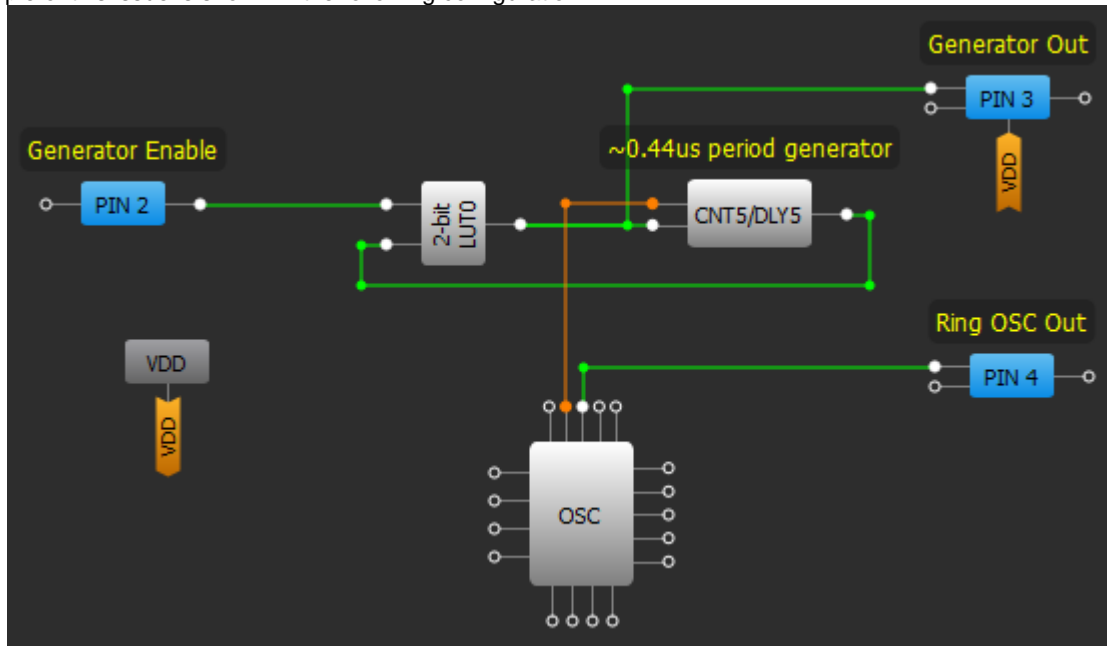
ISSUE 4: Long Ring OSC Settling Time

The Ring OSC has a longer settling time when configured as Auto Power On in the designs that have very short Ring OSC disable time. An example of this issue is shown in the following configuration:

The configuration shown above generates a periodical signal with a frequency defined by the Delay cell and started by a high signal on PIN2. The issue becomes apparent in a longer settling time when the scheme generates short pulses (Delay is configured as a rising edge delay only). See waveform below.

- Set Ring OSC power mode to “Force Power On”
- or, Set Turn on by register option in BG (Band Gap) block as “Enable”

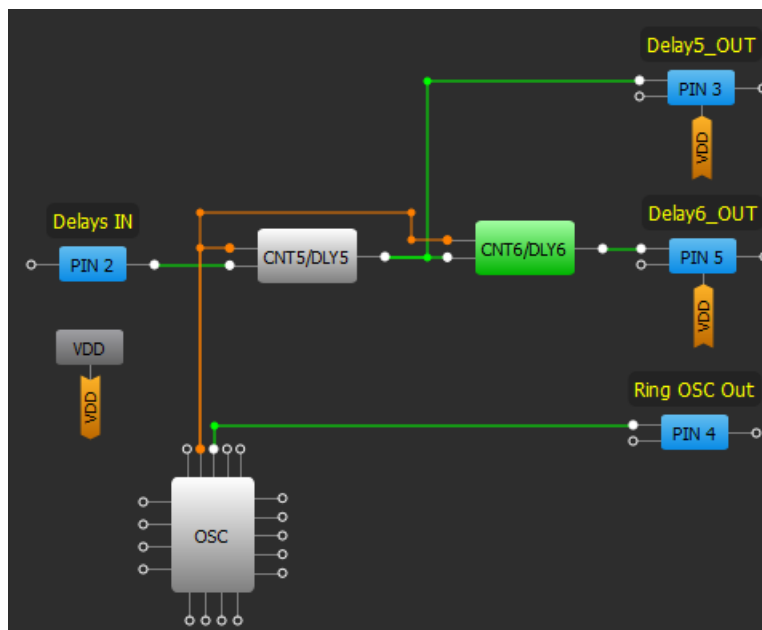
A similar situation can occur while using two connected delays (all edge detect types except for a pair “Rising edge DLY – Falling edge DLY”).

In the following example, Delay5 and Delay6 are configured in the same way. However, Delay5 time is 11.4us instead of expected 0.4us (Delay5 time).

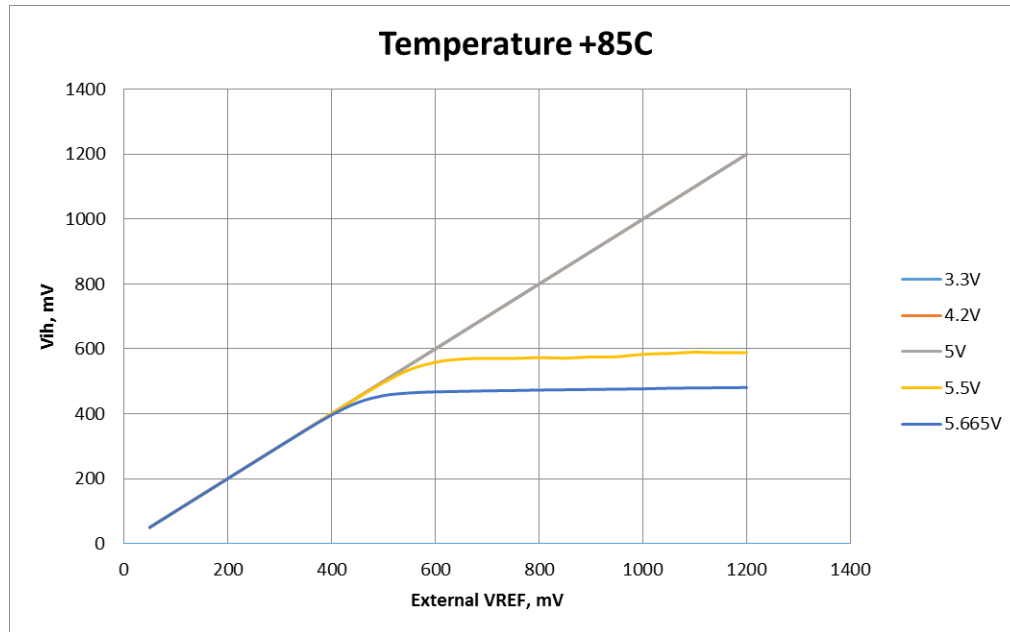
ISSUE 6: ACMP Output is Inaccurate when using External Vref at High VDD and Temperature Functional Block Affected: ACMP

When using external Vref source, the ACMP comparison may happen at wrong threshold if the external Vref voltage is higher than a particular value (please see figure below) at high VDD values (> 5V) and high temperature.

- Avoid using ACMPs in such conditions.

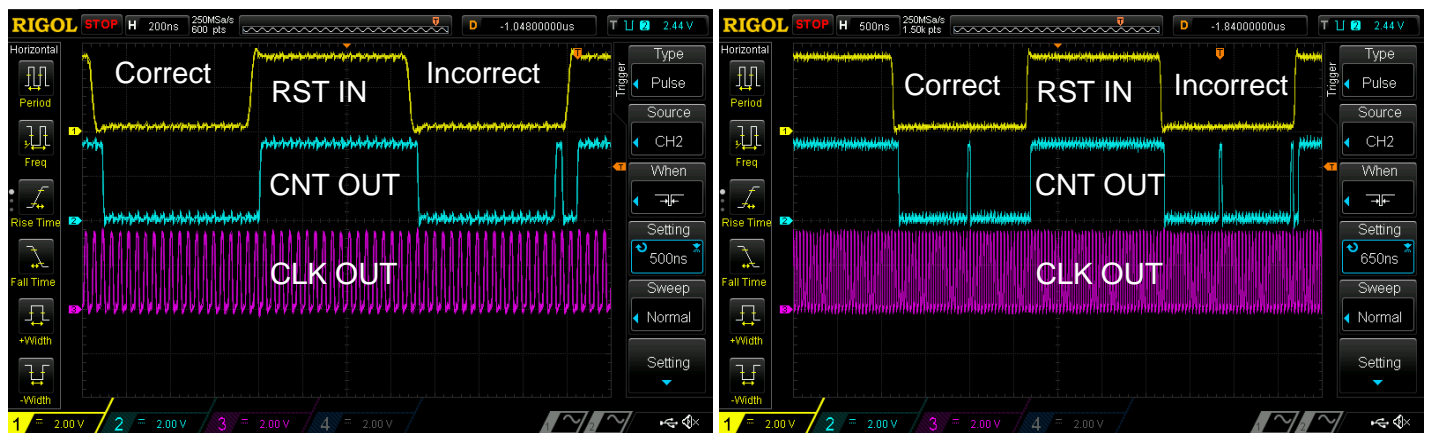
ISSUE 7: Incorrect Counter Operation after the Reset Functional Block Affected: Counter

If the Counter Reset occurs at a time very close to a rising edge of the clock signal during clock signal generation (for example OSC operation), there is a possibility that the Counter Data of the Counter is reset incorrectly and the counter end signal (HIGH pulse) may appear faster than expected. This phenomena appears more frequently the higher the clock frequency is.

- Synchronize RESET input of the Counter with its CLK using 2 DFF cells as shown in the image below.

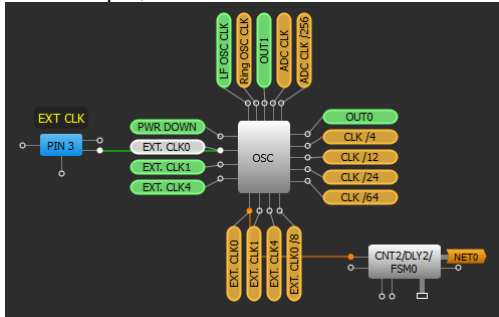
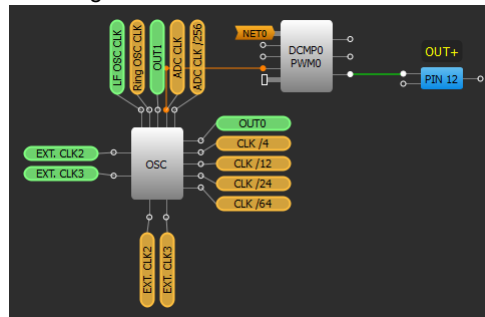
ISSUE 8: DCMPO OUT+ Output Glitch

DCMPO's OUT+ output may have a glitch when the input data is changed. This issue appears more frequently the higher DCMPO clock is.

For example, DCMPO IN+ sources from FSM0 and IN- from Register0. DCMPO is clocked from the Ring OSC.

- Synchronize the data source clock with the DCMPO clock source using 2 DFF cells as shown in the images below.

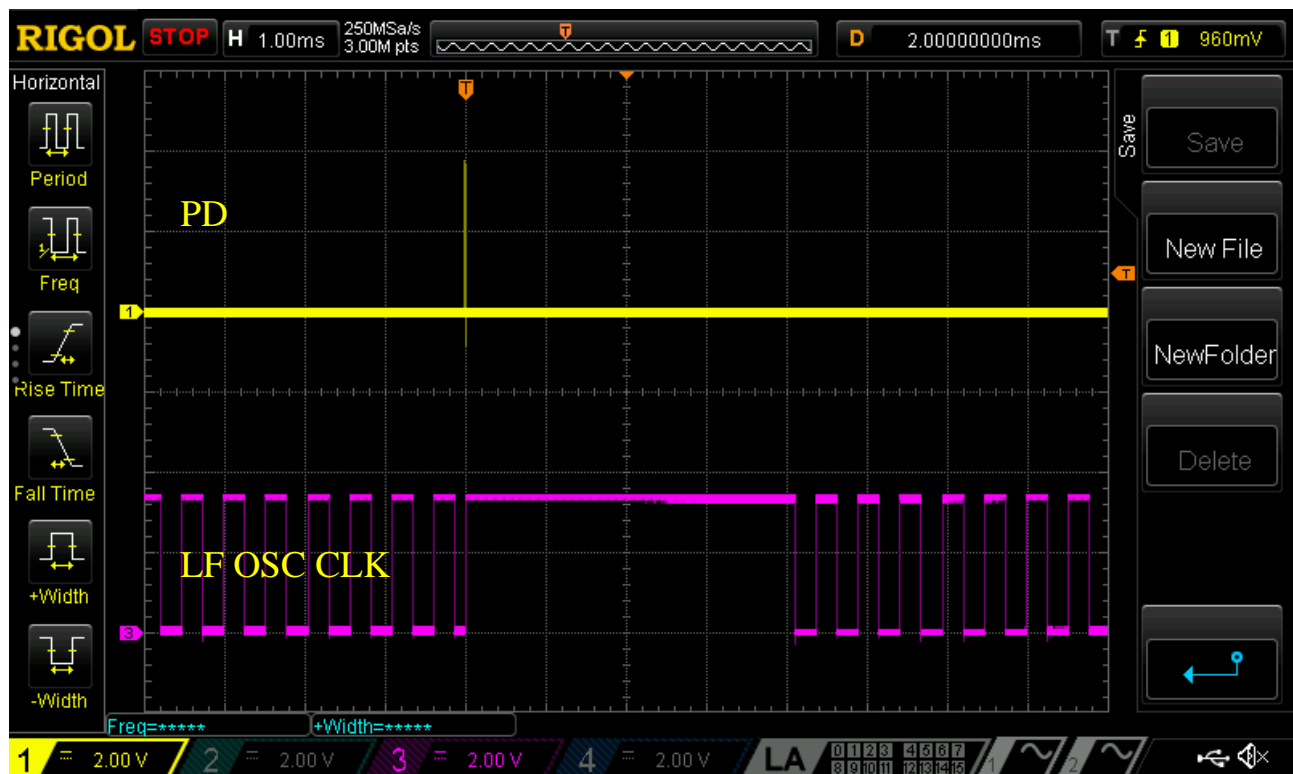
1.9 kHz OSC long start-up:

If a pulse with a duration of less than ~40 ns is applied to the PWR DOWN input of an oscillator, the oscillator outputs remain stuck for milliseconds.

The issue is observed for all available oscillators.

Avoid applying glitches to the PWR DOWN input of an OSC.
