## SLG46620-A

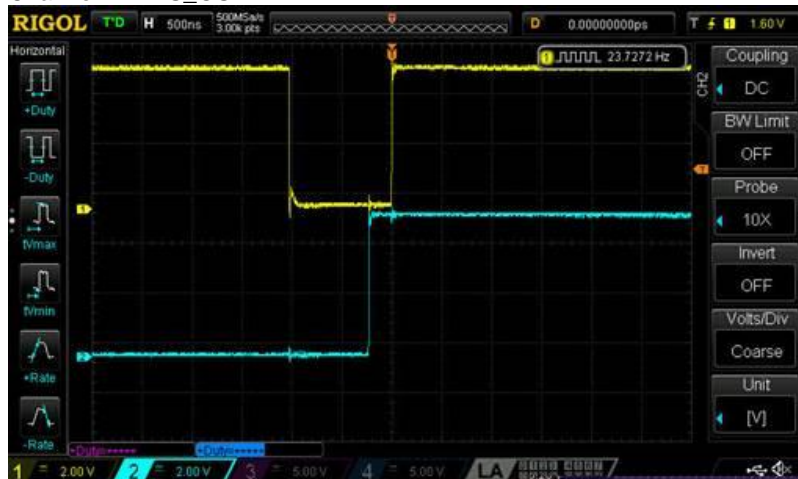
The output of the ACMP incorrectly goes low even when IN+ is greater than IN- if the RING OSC is active when the WS signal rises

Channel 1 – ACMP out

Channel 2 – WS\_OUT

- Avoid using the RING OSC with the WS Controller, or add a filtering block on the ACMP output to filter out the glitch.

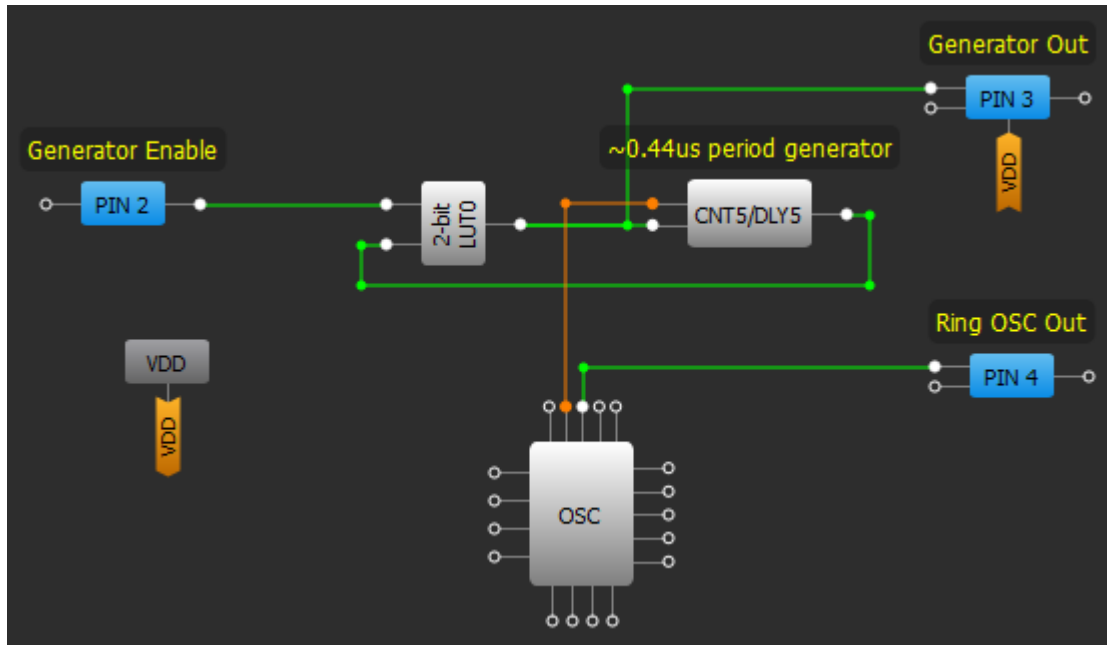
The Ring OSC has a longer settling time when configured as Auto Power On in the designs that have very short Ring OSC disable time. An example of this issue is shown in the following configuration:

- Set Ring OSC power mode to “Force Power On”
- or, Set Turn on by register option in BG (Band Gap) block as “Enable”

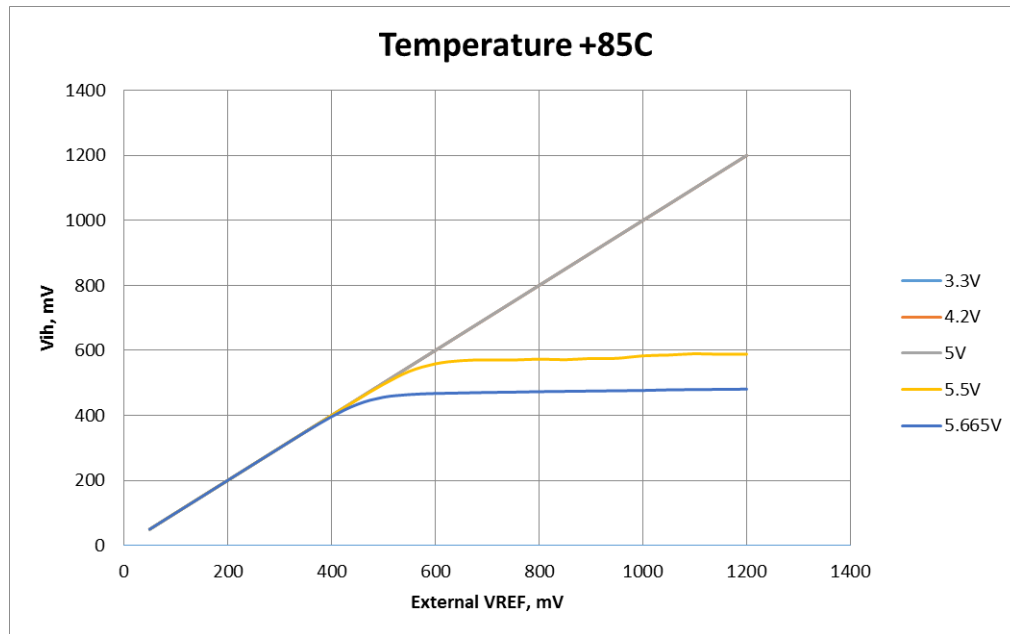
When using external Vref source, the ACMP comparison may happen at wrong threshold if the external Vref voltage is higher than a particular value (please see figure below) at high VDD values (> 5V) and high temperature.

- Avoid using ACMPs in such conditions.

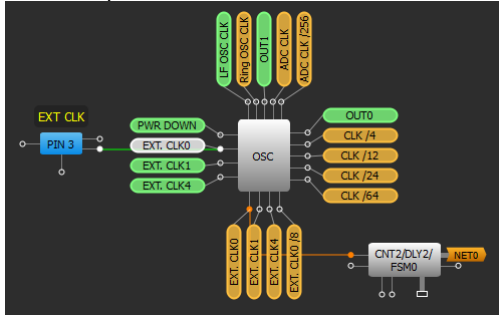
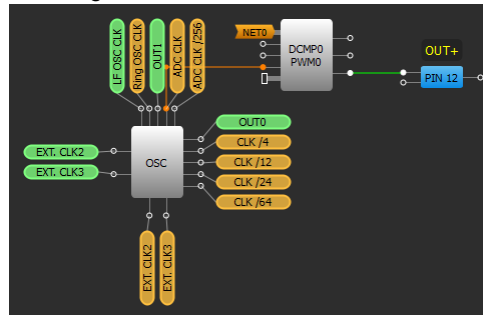
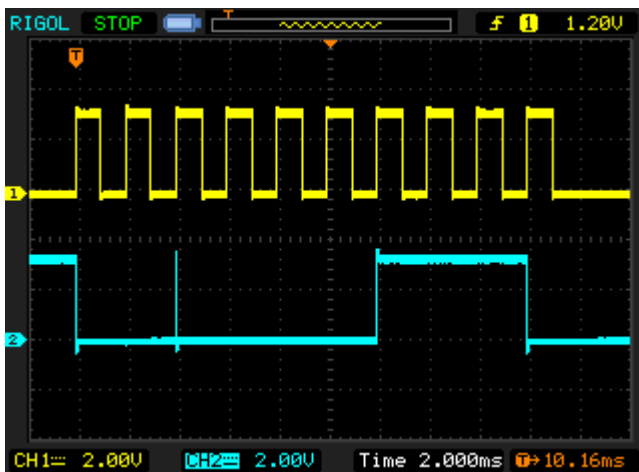
DCMP's OUT+ output may have a glitch when the input data is changed. This issue appears more frequently the higher DCMP clock is.

For example, DCMP IN+ sources from FSM0 and IN- from Register0. DCMP is clocked from the Ring OSC.

- Synchronize the data source clock with the DCMP clock source using 2 DFF cells as shown in the images below.
