## SLG46620-A

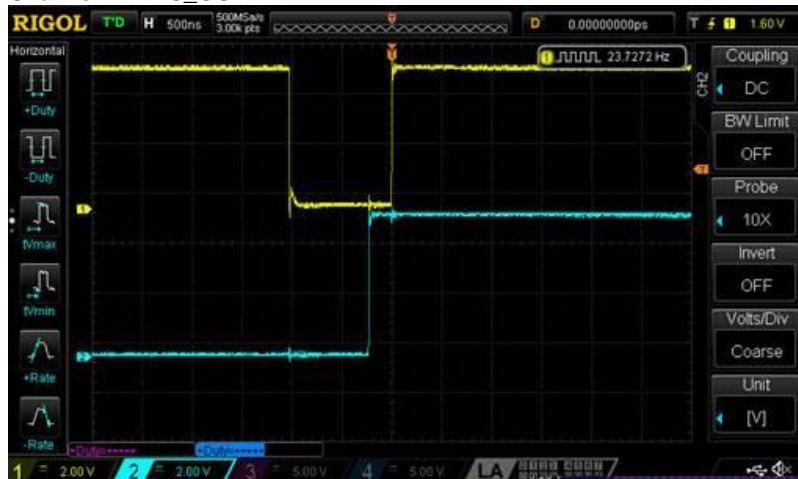
The output of the ACMP incorrectly goes low even when IN+ is greater than IN- if the RING OSC is active when the WS signal rises

Channel 1 – ACMP out

Channel 2 – WS\_OUT

- Avoid using the RING OSC with the WS Controller, or add a filtering block on the ACMP output to filter out the glitch.

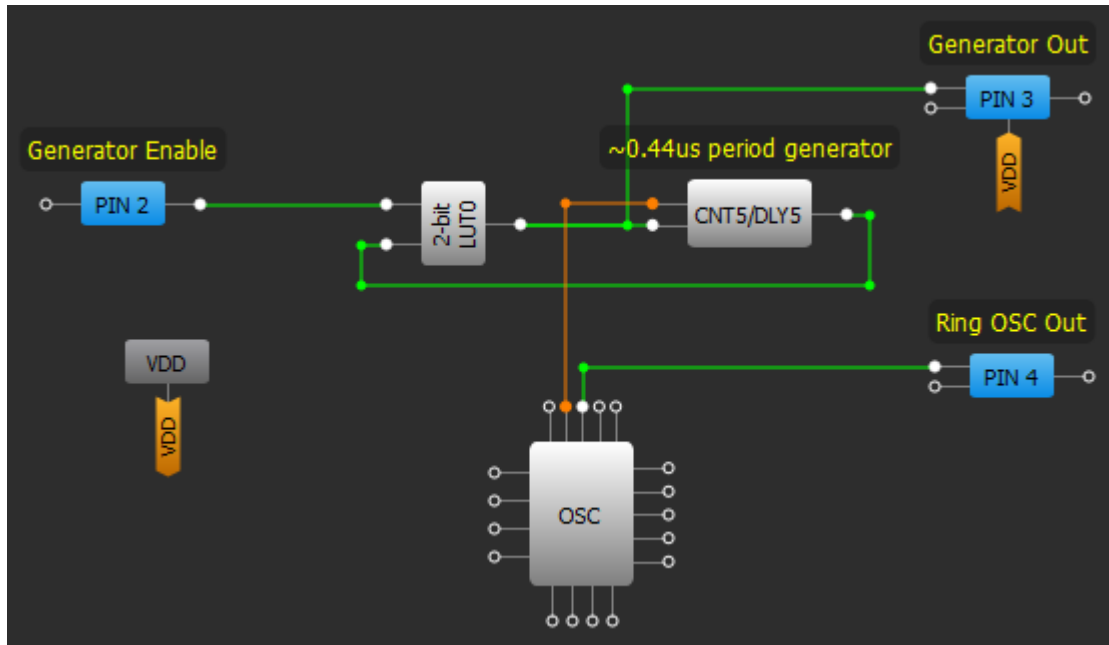
The Ring OSC has a longer settling time when configured as Auto Power On in the designs that have very short Ring OSC disable time. An example of this issue is shown in the following configuration:

The configuration shown above generates a periodical signal with a frequency defined by the Delay cell and started by a high signal on PIN2. The issue becomes apparent in a longer settling time when the scheme generates short pulses (Delay is configured as a rising edge delay only). See waveform below.

- Set Ring OSC power mode to “Force Power On”
- or, Set Turn on by register option in BG (Band Gap) block as “Enable”

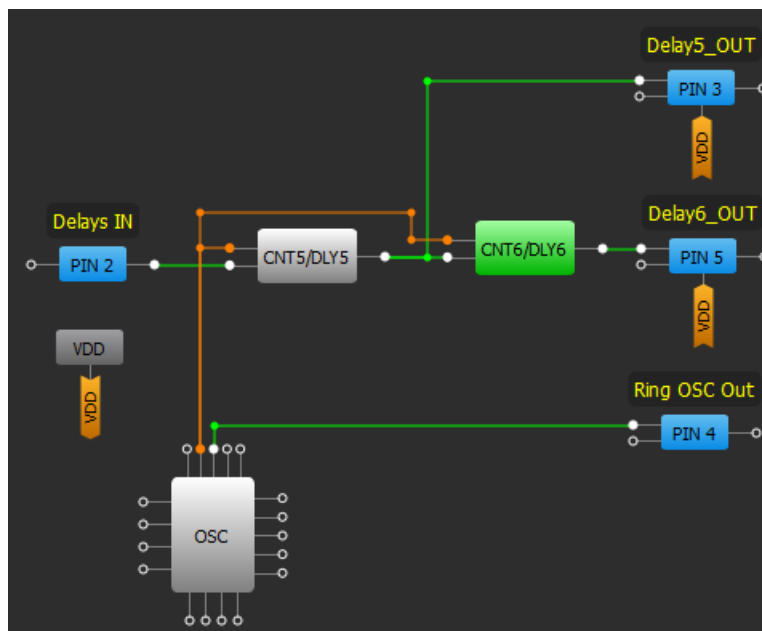
A similar situation can occur while using two connected delays (all edge detect types except for a pair “Rising edge DLY – Falling edge DLY”).

In the following example, Delay5 and Delay6 are configured in the same way. However, Delay5 time is 11.4us instead of expected 0.4us (Delay5 time).

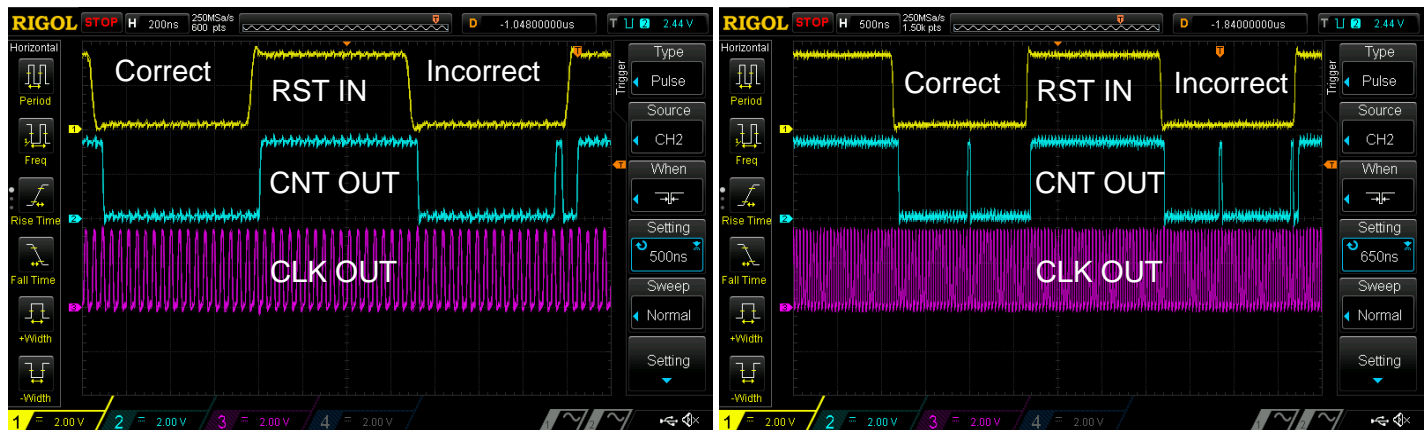
If the Counter Reset occurs at a time very close to a rising edge of the clock signal during clock signal generation (for example OSC operation), there is a possibility that the Counter Data of the Counter is reset incorrectly and the counter end signal (HIGH pulse) may appear faster than expected. This phenomena appears more frequently the higher the clock frequency is.

- Synchronize RESET input of the Counter with its CLK using 2 DFF cells as shown in the image below.
