### ISSUE 1: Long Settling Time for Ring OSC

## SLG46621

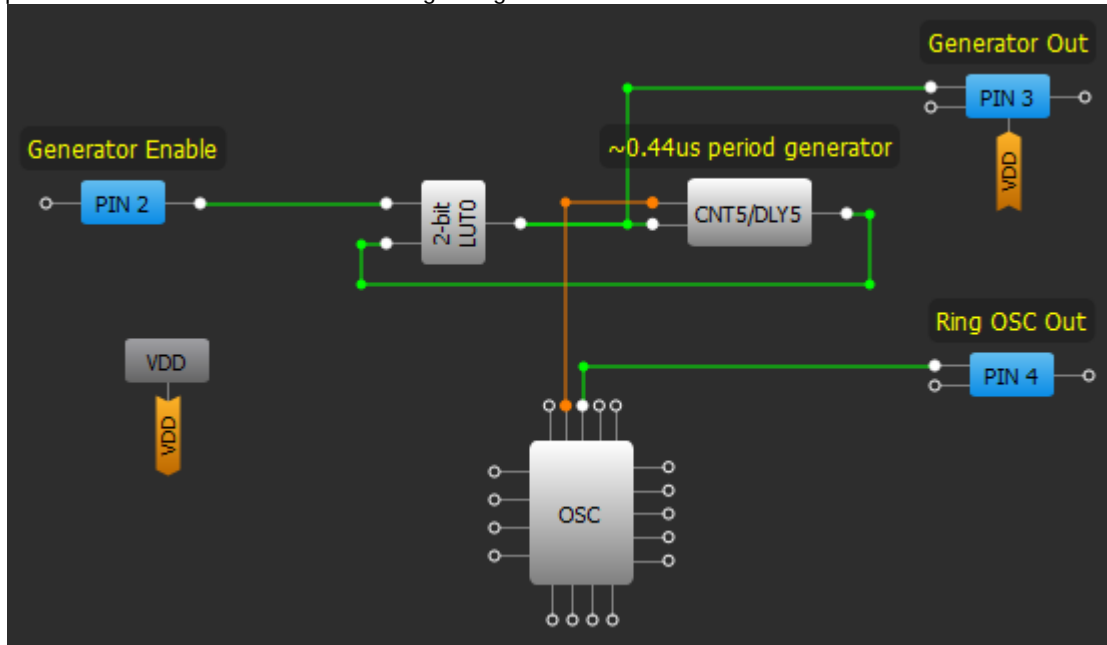
The Ring OSC has a longer settling time when configured as Auto Power On in the designs that have a very short Ring OSC disable time. An example of this issue is shown in the following configuration:

- Set Ring OSC power mode to “Force Power On”
- or, Set Turn on by register option in BG (Band Gap) block as “Enable”

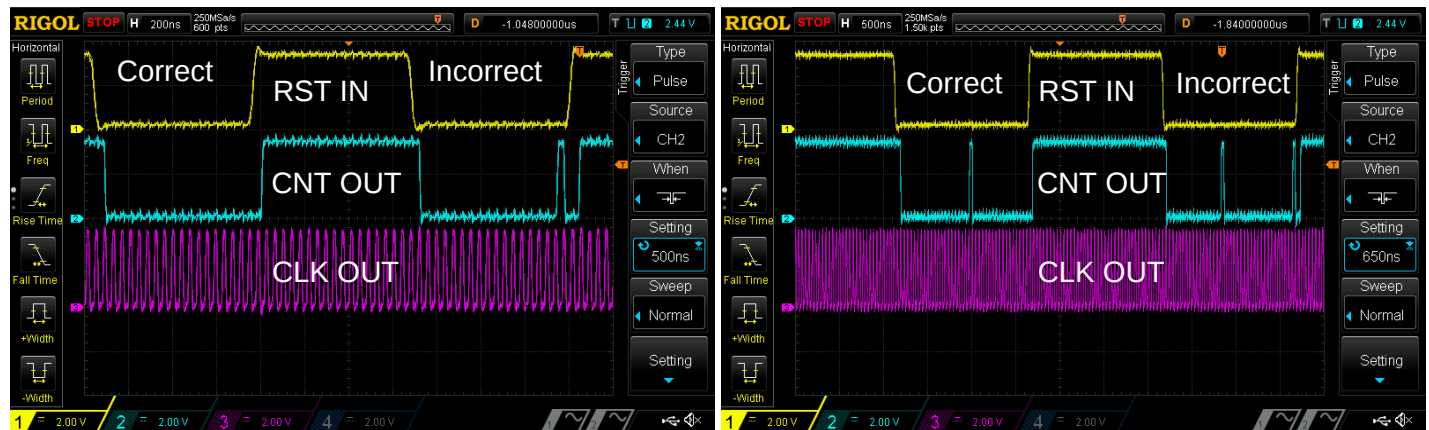
If the Counter Reset occurs at a time very close to a rising edge of the clock signal during clock signal generation (for example OSC operation), there is a possibility that the Counter Data of the Counter is reset incorrectly and the counter end signal (HIGH pulse) may appear faster than expected. This phenomena appears more frequently the higher the clock frequency is.

- Synchronize the RESET input of the Counter with its CLK using 2 DFF cells as shown in the image below.

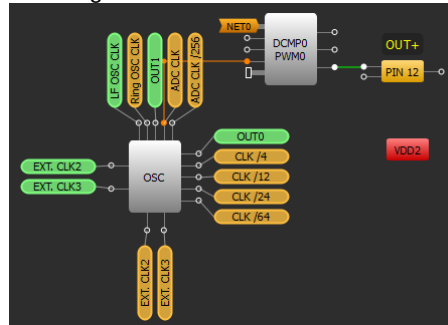
DCMP's OUT+ output may have a glitch when the input data is changed. This issue appears more frequently the higher DCMP clock is.

For example, DCMP IN+ sources from FSM0 and IN- from Register0. DCMP is clocked from the Ring OSC.

- Synchronize the data source clock with the DCMP clock source using 2 DFF cells as shown in the images below.

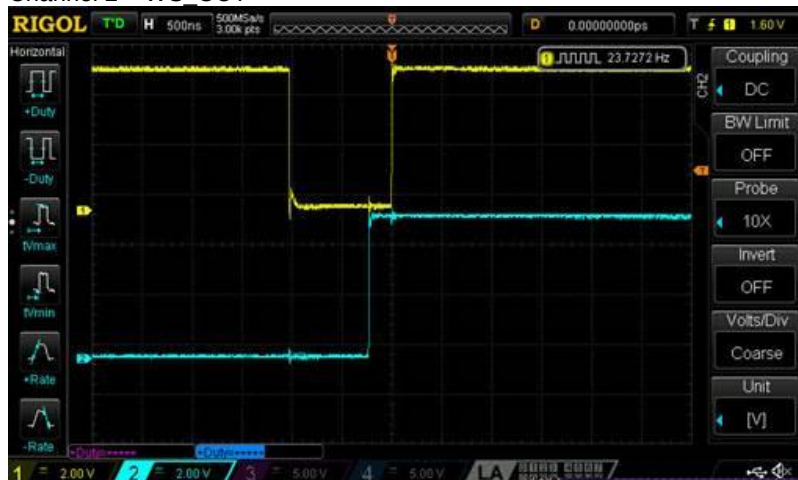
The output of the ACMP incorrectly goes low even when IN+ is greater than IN- if the RING OSC is active when the WS signal rises

Channel 1 – ACMP out

Channel 2 – WS OUT

Avoid using the RING OSC with the WS Controller, or add a filtering block on the ACMP output to filter out the glitch.
