ISSUE 1: Long Settling Time for Ring OSC

SLG46621

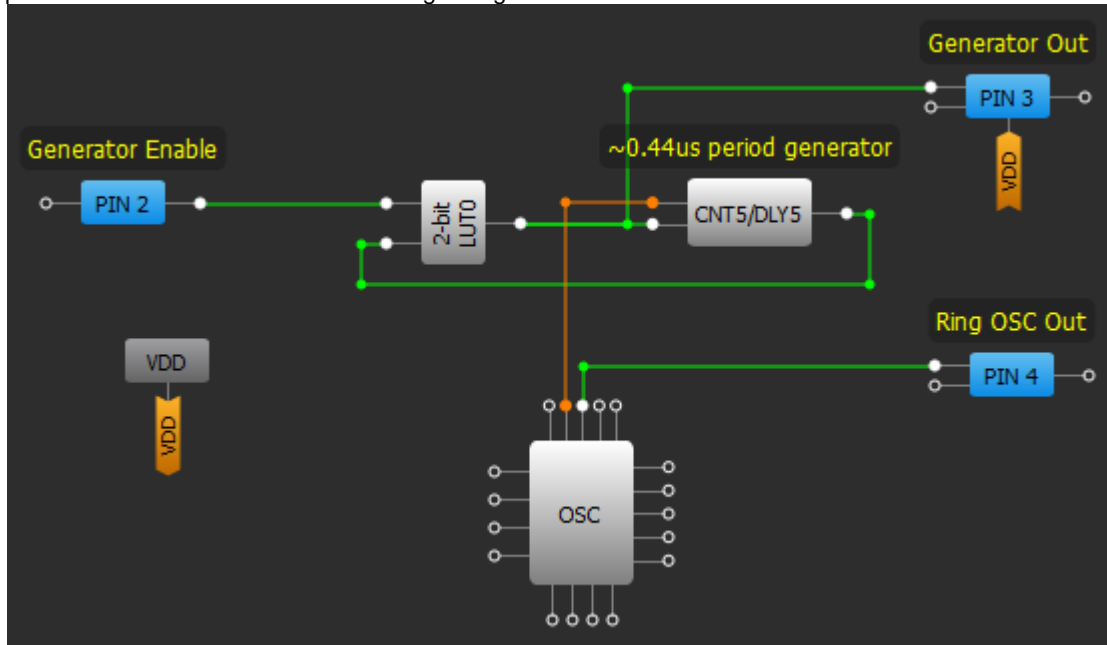
The Ring OSC has a longer settling time when configured as Auto Power On in the designs that have a very short Ring OSC disable time. An example of this issue is shown in the following configuration:

- Set Ring OSC power mode to “Force Power On”
- or, Set Turn on by register option in BG (Band Gap) block as “Enable”

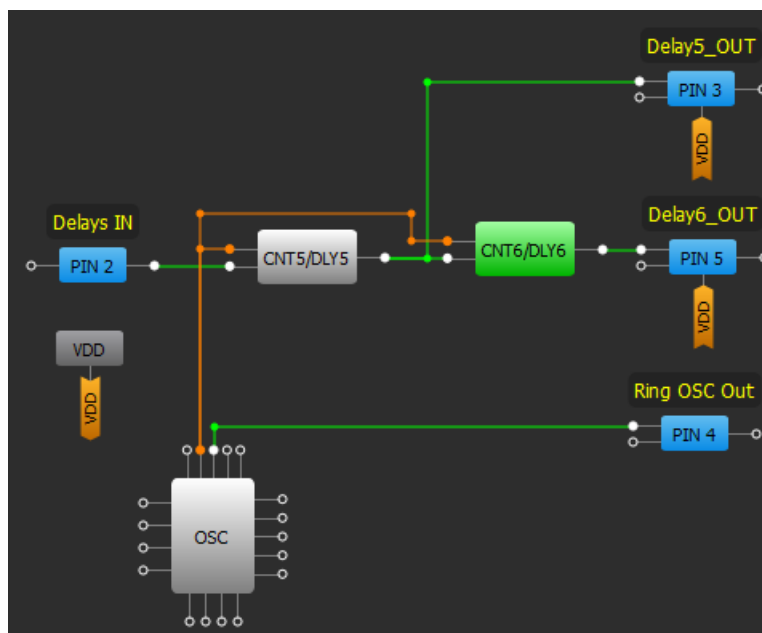
A similar situation can occur when using two connected delays (all edge detect types except when pairing “Rising edge DLY – Falling edge DLY”).

In the following example, Delay5 and Delay6 are configured in the same way. However, Delay5 time is 11.4us instead of expected 0.4us (Delay5 time).

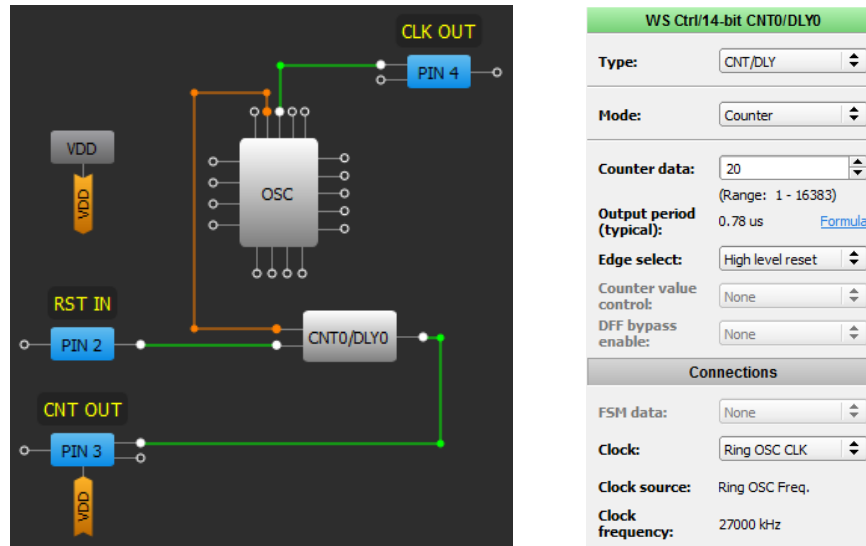
If the Counter Reset occurs at a time very close to a rising edge of the clock signal during clock signal generation (for example OSC operation), there is a possibility that the Counter Data of the Counter is reset incorrectly and the counter end signal (HIGH pulse) may appear faster than expected. This phenomena appears more frequently the higher the clock frequency is.

- Synchronize the RESET input of the Counter with its CLK using 2 DFF cells as shown in the image below.

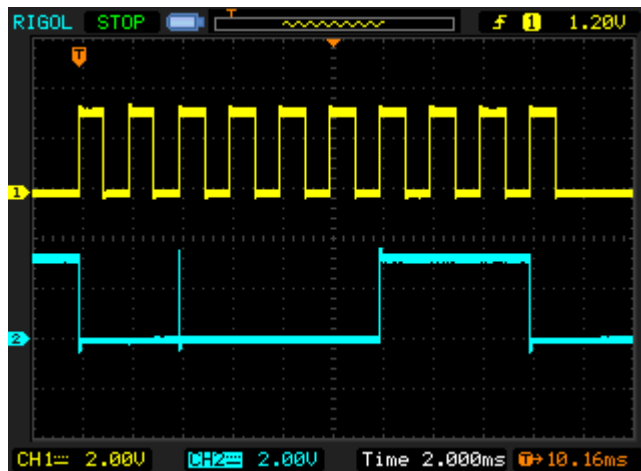
DCMP's OUT+ output may have a glitch when the input data is changed. This issue appears more frequently the higher DCMP clock is.

For example, DCMP IN+ sources from FSM0 and IN- from Register0. DCMP is clocked from the Ring OSC.

- Synchronize the data source clock with the DCMP clock source using 2 DFF cells as shown in the images below.

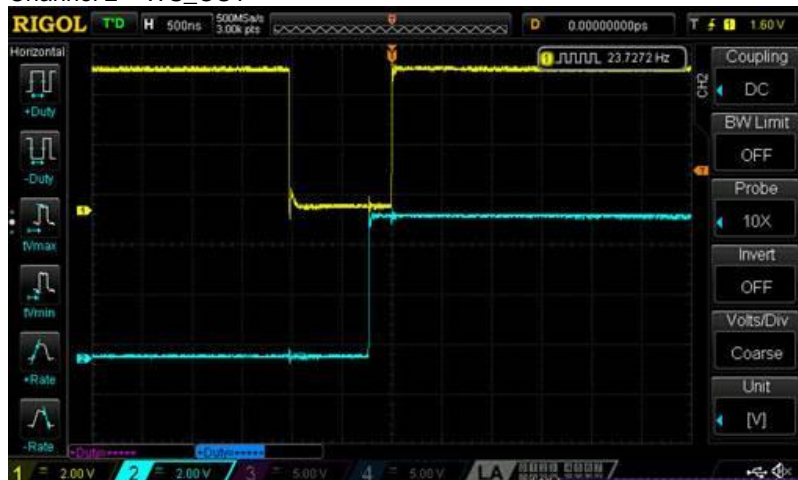
The output of the ACMP incorrectly goes low even when IN+ is greater than IN- if the RING OSC is active when the WS signal rises

Channel 1 – ACMP out

Channel 2 – WS_OUT

Avoid using the RING OSC with the WS Controller, or add a filtering block on the ACMP output to filter out the glitch.
