Errata

SLG46811

CE-GP-008

3.1 Incorrect 64 mV Hysteresis Operation while Using MS ACMP in Regular ACMP Mode

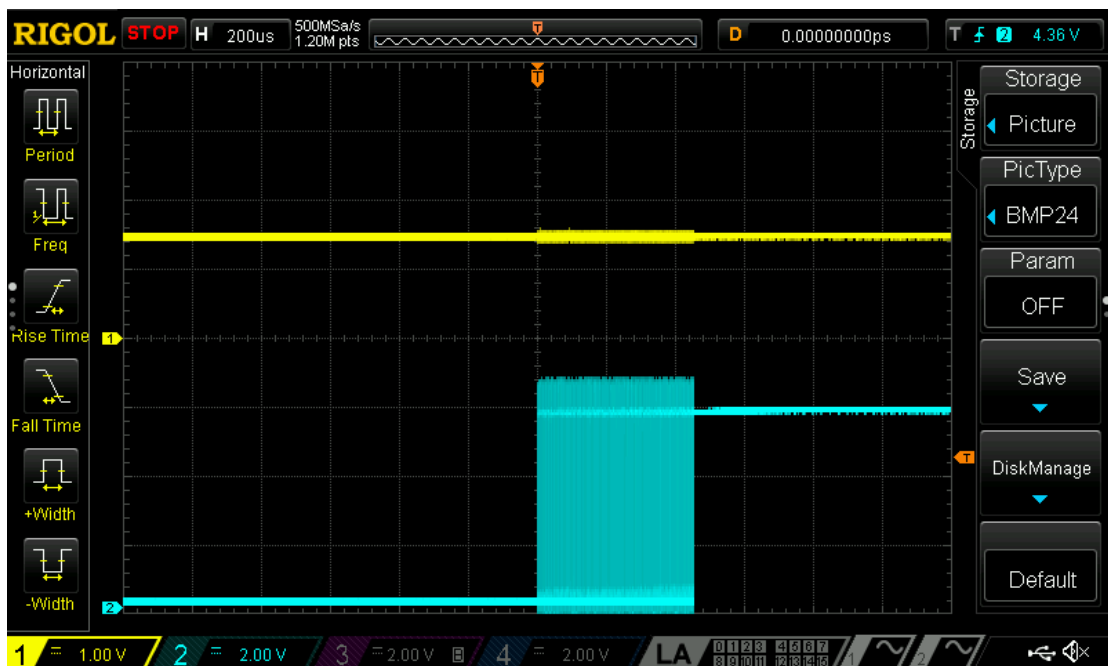
Figure 3: Zoomed ACMP Output during Glitching

2. Waveform at $V_{ref} = 1536 \text{ mV}$, hysteresis is equal to 64 mV (zoomed rising edge).

1. Use the deglitch filter connected to the MS ACMP output.
2. Decrease the reference (below 1344 mV) at $IN-$ and add the $IN+$ gain to keep the needed threshold.
3. Use MS ACMP in multichannel mode.
