# Errata

## SLG46811

### CE-GP-008

*This document contains the known errata for SLG46811 and the recommended workarounds.*

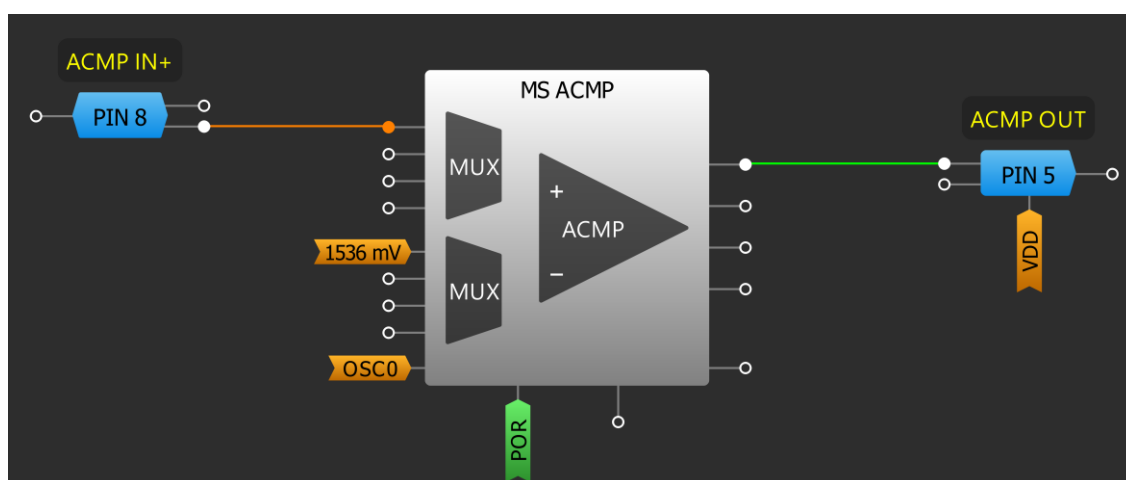
Figure 1: Testing Design

If using MS ACMP in Regular ACMP mode with 64 mV hysteresis, MS ACMP output could be glitching when MS ACMP positive input (IN+) close to the negative input (IN-). It can happen when  $V_{DD} = 4.0$  V or higher and  $V_{ref} = 1344$  mV or higher.

1. Use the deglitch filter connected to the MS ACMP output.
2. Decrease the reference (below  $1344 \text{ mV}$ ) at  $IN^-$  and add the  $IN^+$  gain to keep the needed threshold.
3. Use MS ACMP in multichannel mode.

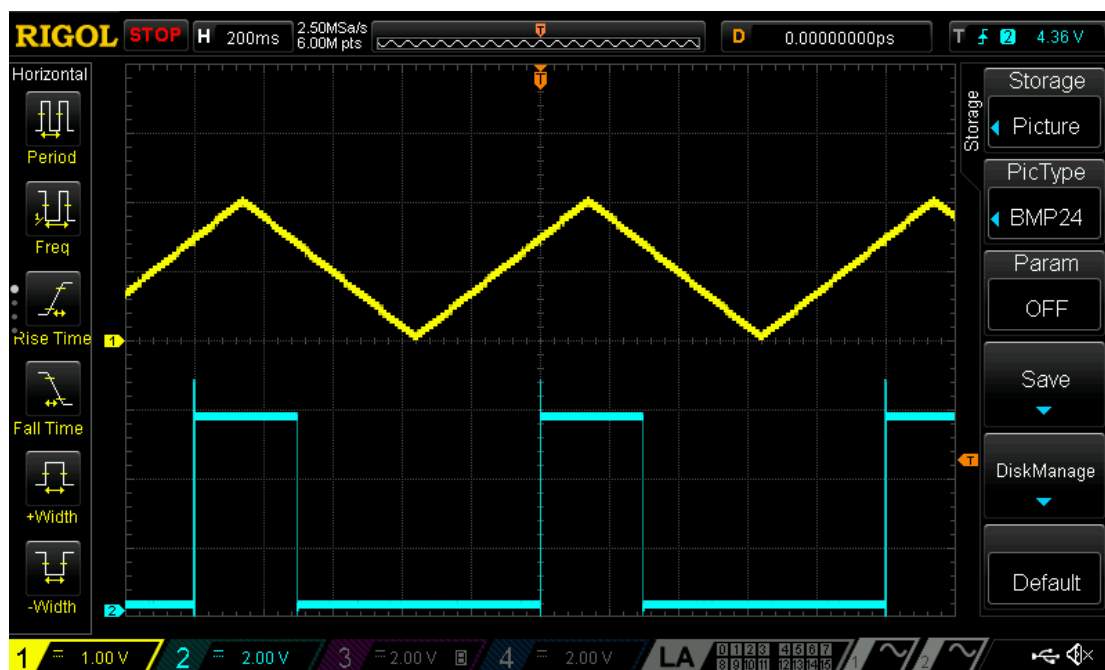
Figure 2: ACMP Output during Glitching

1. Waveform at  $V_{ref} = 1536$  mV, hysteresis is equal to 64 mV.

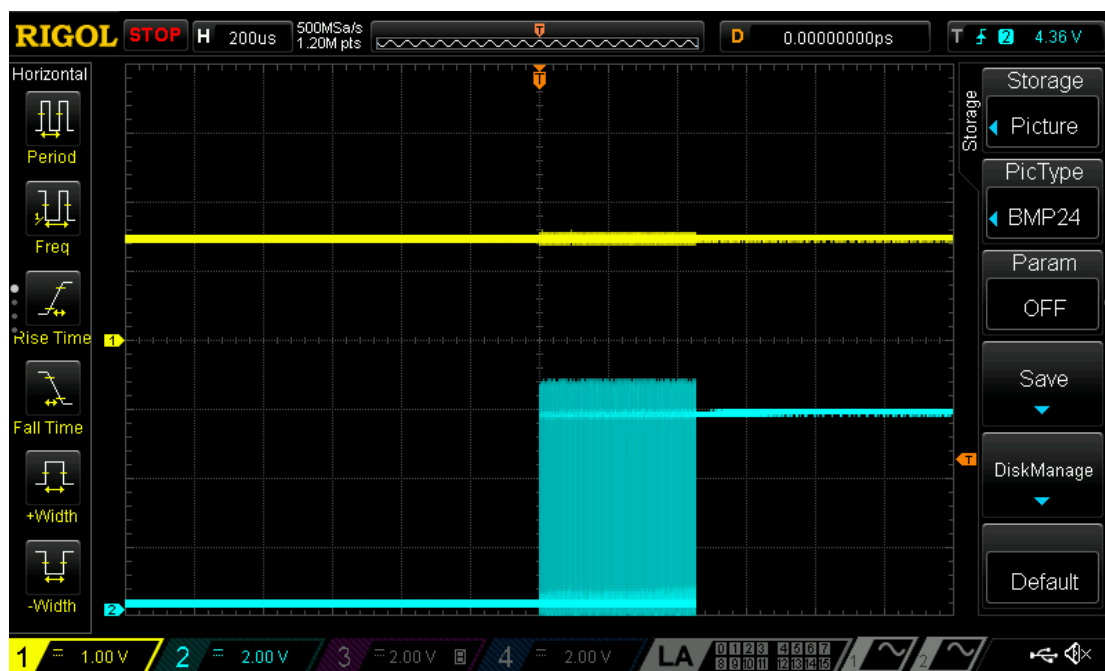
Figure 3: Zoomed ACMP Output during Glitching

2. Waveform at  $V_{ref} = 1536 \text{ mV}$ , hysteresis is equal to  $64 \text{ mV}$  (zoomed rising edge).
