PowerSpan II™ Device Errata and Design Notes

80A1010_ER001_13

November 4, 2009

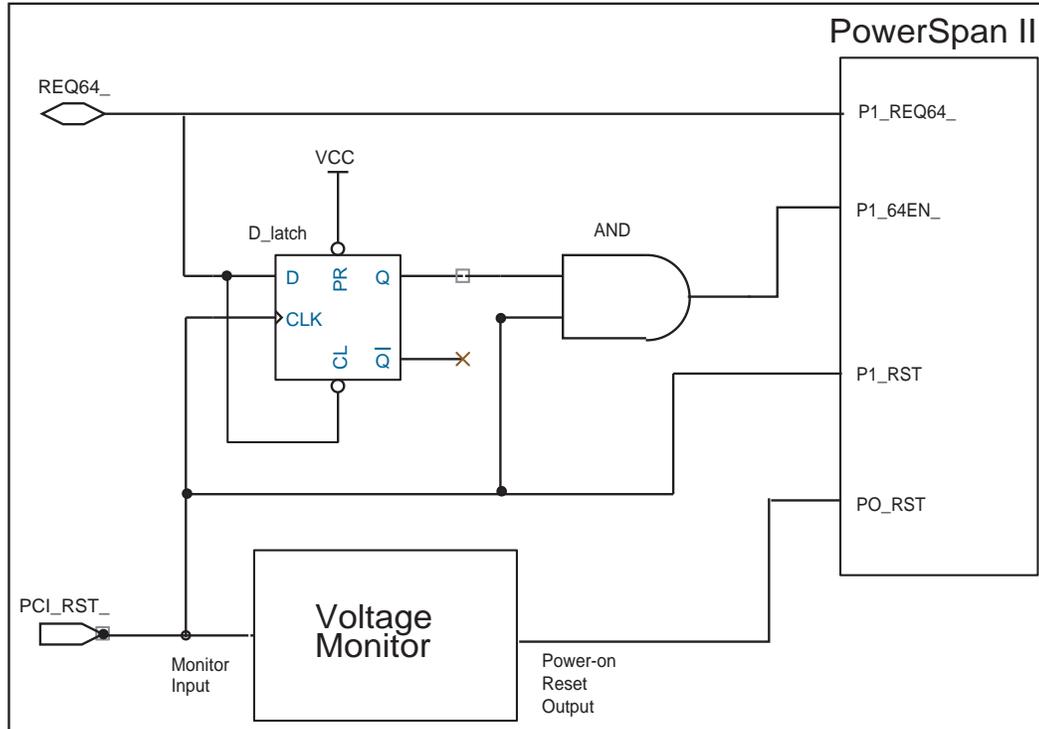
Figure 1: Logic Required to Delay Deasserting PO_RST_ to PowerSpan II

A customer used PowerSpan II in a PCI adapter card application. In this particular application, PO_RST_ was generated by a local voltage monitor device, while P1_CLK was provided by the system controller board through the backplane. Under certain power-up events, P1_CLK only became stable after the local PO_RST_ was deasserted because of different power ramping between the adapter card (containing PowerSpan II) and the system controller card. As a result of the application violating the clock and reset timing restrictions, the PowerSpan II PCI interface does not claim any transactions after reset.

By generating PO_RST_ off of PCI_RST_, there is a chance that the PowerSpan II will be unable to latch the state of the REQ64_ signal on deassertion of PCI_RST_. Therefore, an external D-Latch is used to capture the state of REQ64_ to determine the width of the bus (see [Figure 1](#)). The purpose of the asynchronous clear on D-latch is to prevent potential bus contention on the REQ64_ signal which is driven by PowerSpan II on the deassertion of P1_RST_ in a 32-bit system. The P1_64EN_ signal, which is originally used for CompactPCI Hot Swap applications, is used here to tell the PowerSpan II if this is a 32 or 64-bit application. The AND gate is AND-ing the output of D-latch with PCI_RST_ to ensure the P1_64EN_ is low when the D-latch power-up with uncertain output.

The proposed work-around to this situation is to delay deasserting PO_RST_ to PowerSpan II until the host deasserts the PCI_RST_ signal. Since the PCI_CLK is an output from the system controller along with PCI_RST_, the negation of PCI_RST_ implies the PCI_CLK is stable. The local voltage monitor uses PCI_RST_ to make sure that the PCI_CLK is stable before the deassertion of PO_RST_. A possible implementation of this circuit is shown in [Figure 1](#).

Figure 1 shows the logic required to delay deasserting PO_RST_ to PowerSpan II until the host deasserts the PCI_RST_ signal.

If the external glue logic shown in Figure 1 is implemented by a CPLD, make sure the CPLD output and Flip-flop state are not affected by any reset.

This work-around only applies to designs where PowerSpan II is in a PCI adapter card and is configured for a non-Hot Swap environment. Normally in this scenario, the PCI bus width is indicated by P1_REQ64_ signal (P1_64EN_ is pulled high). For designs where PowerSpan II is in a PCI host card or it is configured for a Hot Swap environment, the circuit shown in Figure 1 must not be used.
