Product Change Notice (PCN)

Subject: RA2E2 group I3C function revision

PCN#[MCP-AC-22-0010]

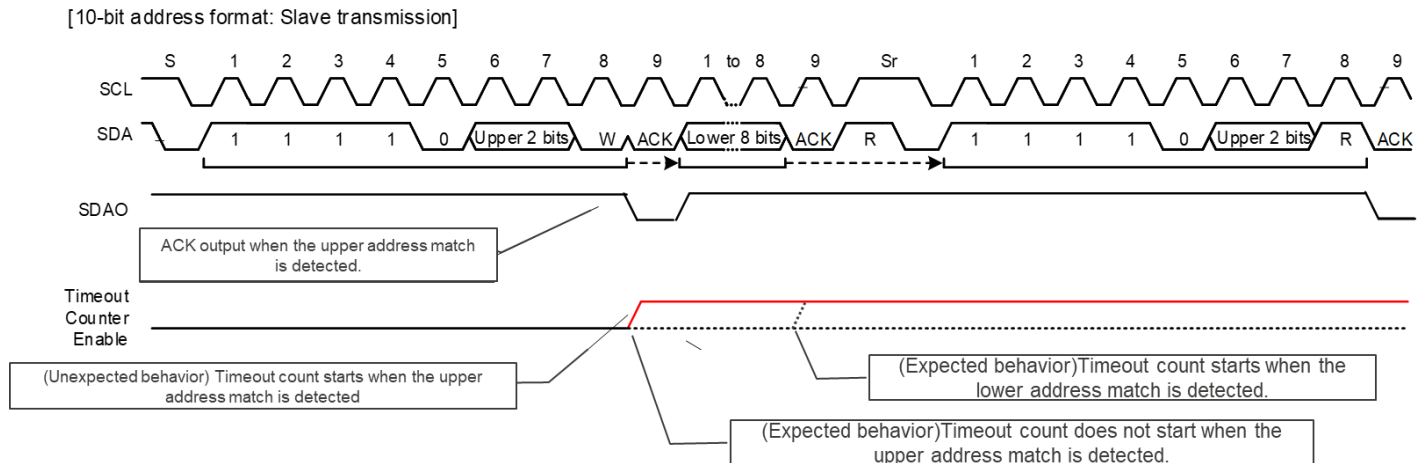
In MCU Ver.1, the timeout count starts when 10-bit address communication and the upper address match is detected.

MCU Ver.2 is revised the circuit so that the timeout count does not start until the lower address match is detected after the upper address match is detected.

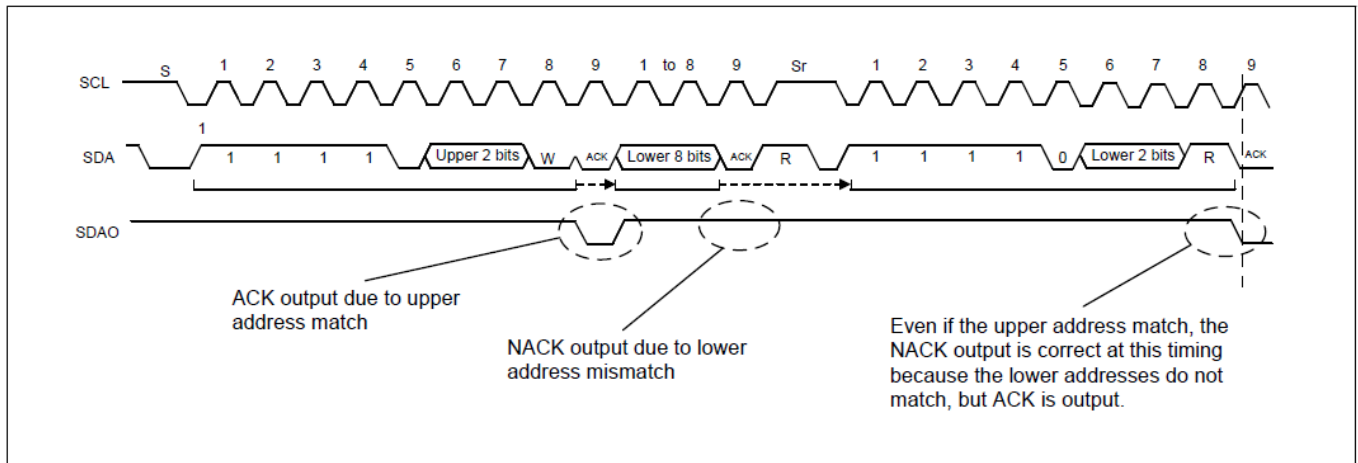
When multiple I²C slaves are connected to the I²C bus and there is a possibility that an I²C Slave other than this module will NACK for the upper address / R after Repeated START, there are the following restrictions and workarounds.

- Work around : Set the upper 2 bits of the 10-bit address assigned to this module to a value different from other Slave. If the address is exhausted and cannot be set to a different value, use restriction (1).
- Restriction (1) : 10-bit address not available.
- Restriction (2) : After the ACK response in the red circle in the above figure, none of the slaves respond to data, so the SDA keeps the high level and the I²C Master receives the 0xFF data. In the case of a system that can handle 0xFF as abnormal data, 0xFF is read and discarded on the I²C Master side. If 0xFF is valid data, use restriction (1).

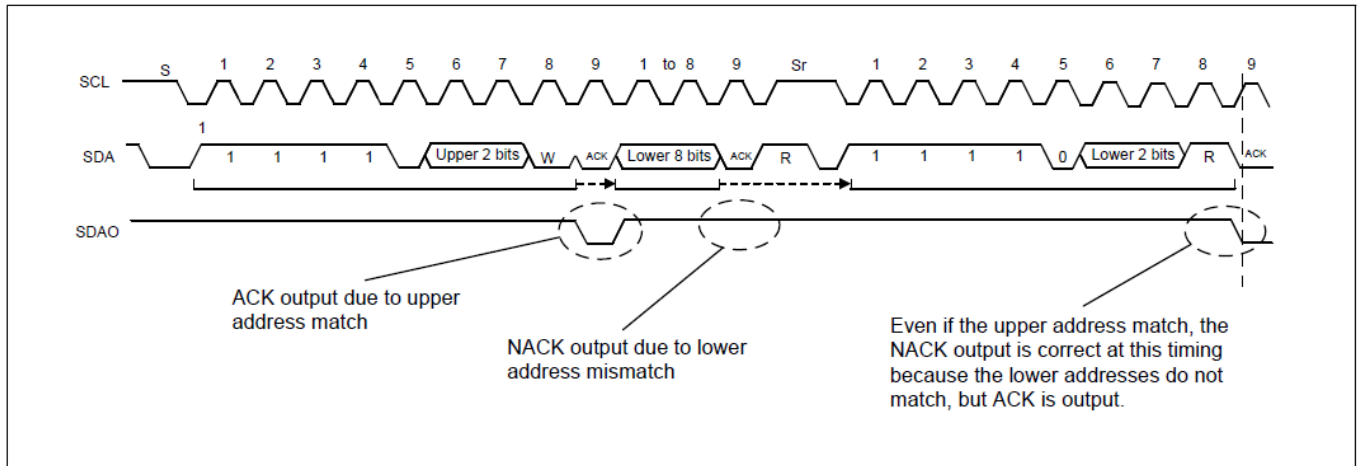
When multiple I²C slaves are connected to the I²C bus and there is a possibility that an I²C Slave other than this module will NACK for the upper address / R after Repeated START, there are the following restrictions and workarounds.

- Work around : Set the upper 2 bits of the 10-bit address assigned to this module to a value different from other Slave. If the address is exhausted and cannot be set to a different value, use restriction (1).
- Restriction (1) : 10-bit address not available.
- Restriction (2) : After the ACK response in the red circle in the above figure, none of the slaves respond to data, so the SDA keeps the high level and the I²C Master receives the 0xFF data. In the case of a system that can handle 0xFF as abnormal data, 0xFF is read and discarded on the I²C Master side. If 0xFF is valid data, use restriction (1).

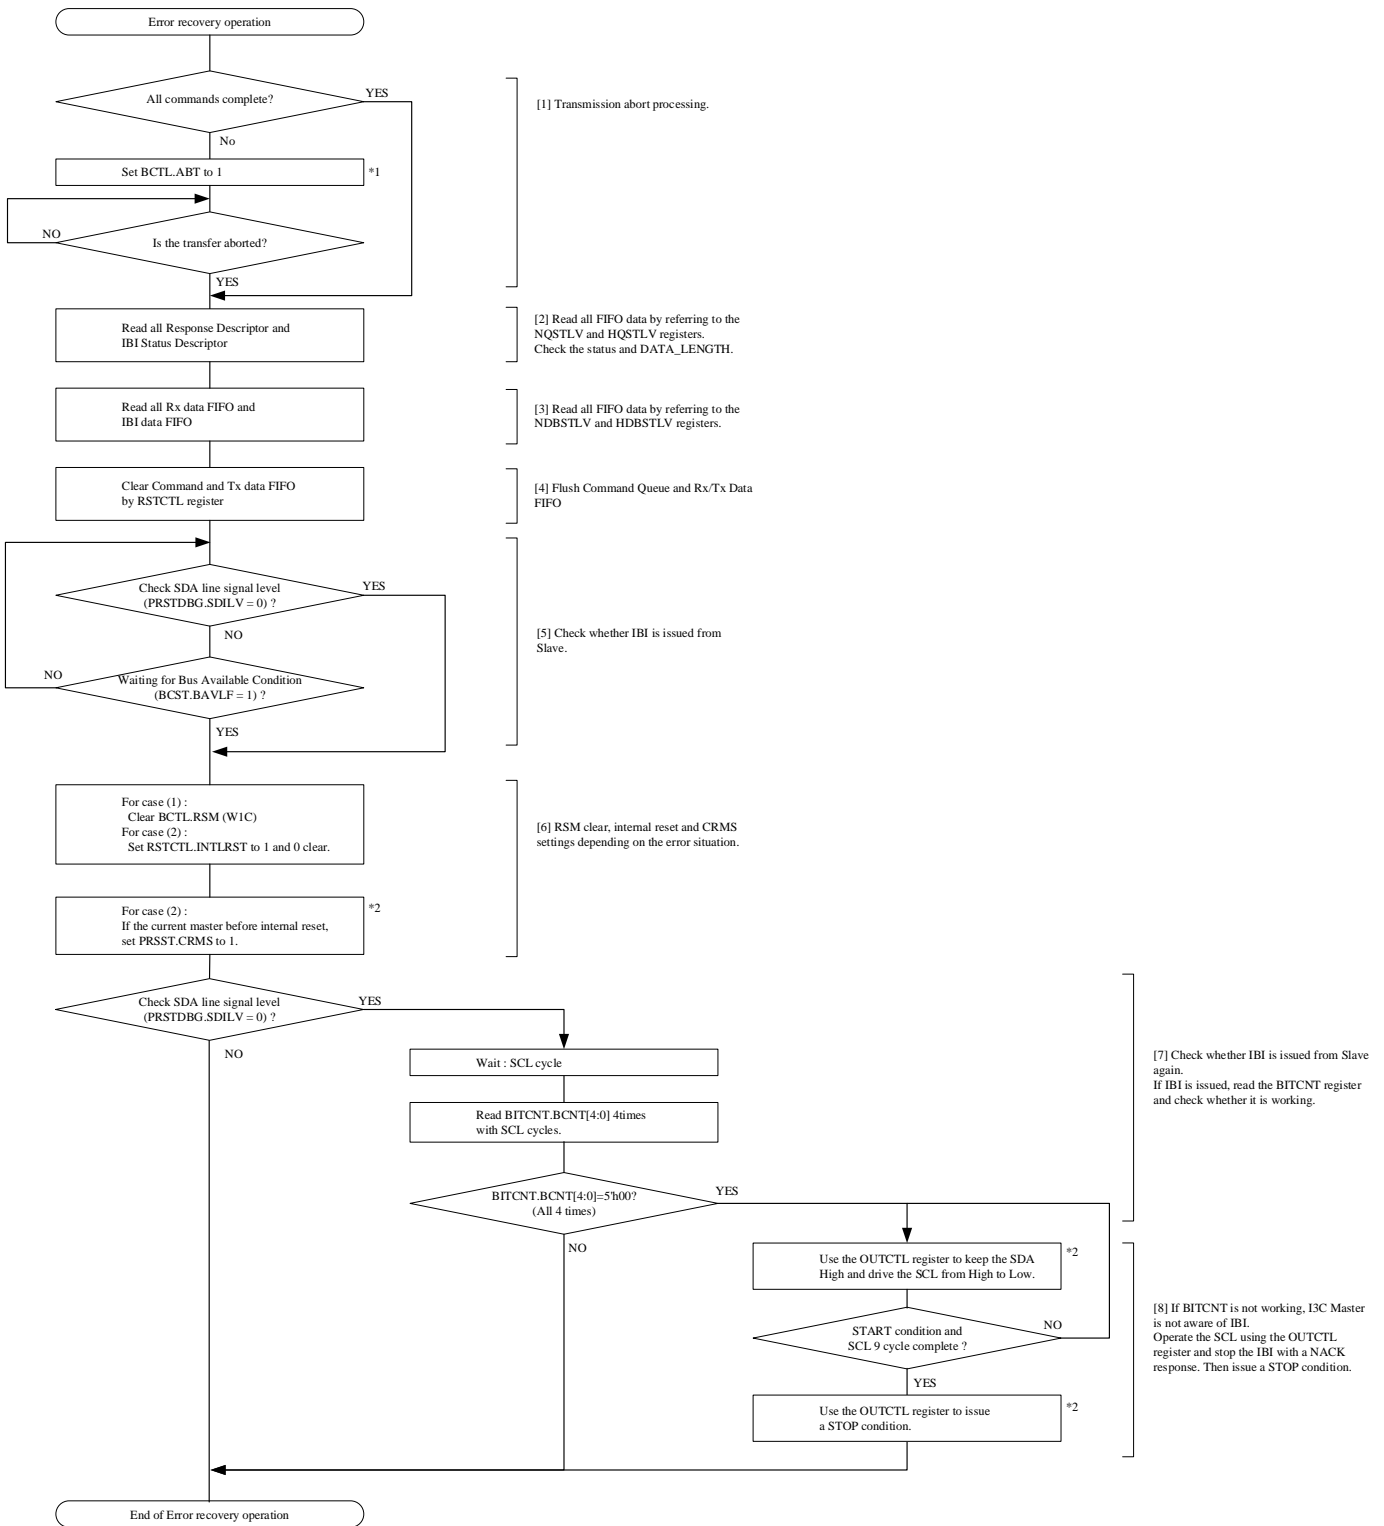
Figure 25.96 Example of error recovery operation flowchart for I3C Master

When an error occurs, the INST.INEF, NTST.TEF, NTST.TABTF, HTST.TEF and HTST.TABTF flags are set to 1 according to the cause of the error, or the interrupts associated with each flag are asserted (when detection and interrupts are enabled.)

There is a possibility of communication error or internal module error.

The I3C master must perform an error recovery flow according to the following case:

- When TEF is detected.

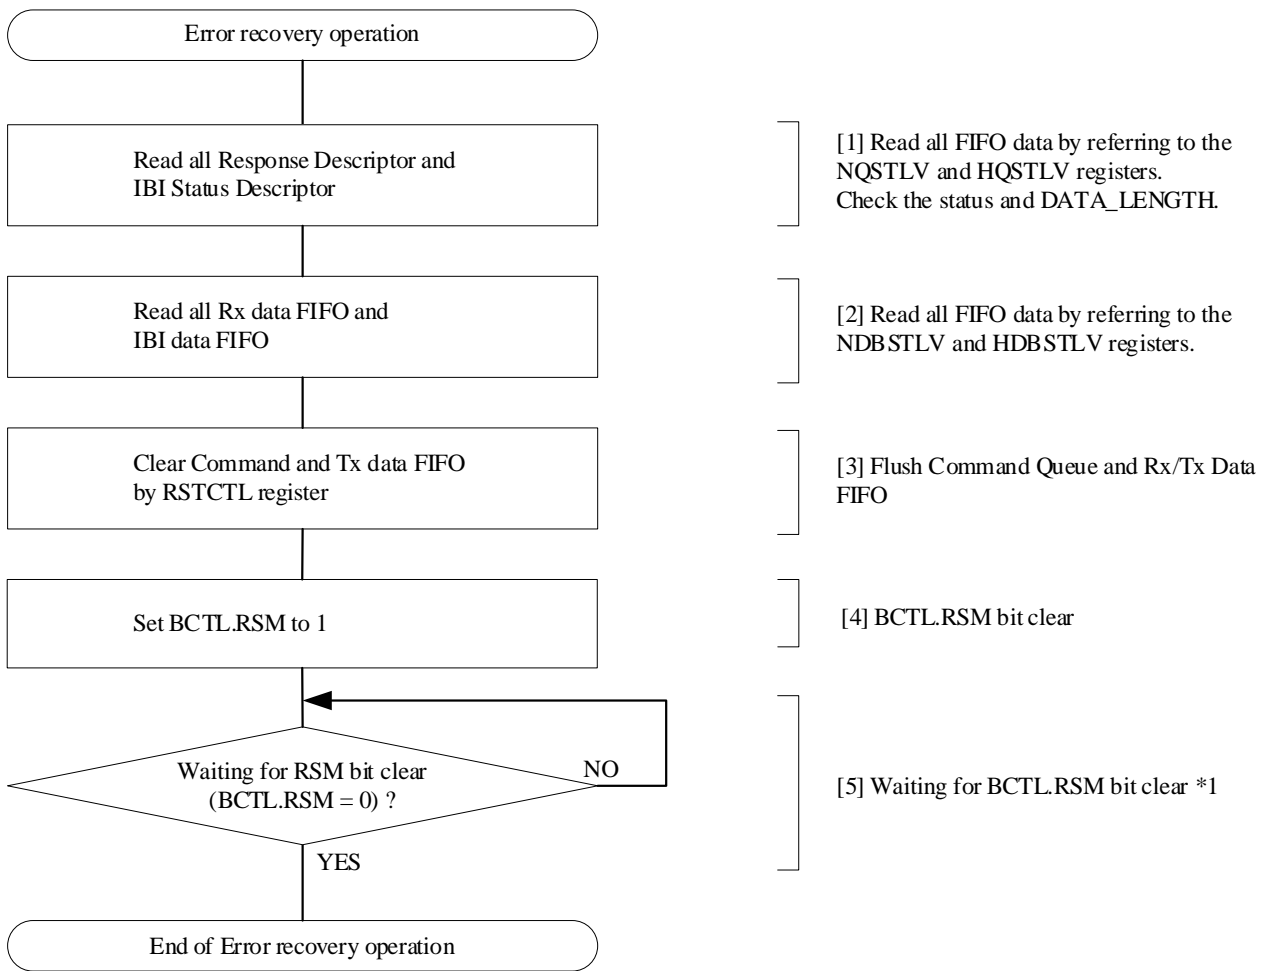
Figure 25.96-2 Example of error recovery operation flowchart for I3C Master

In order to improve the complexity of the error recovery flow, MCU Ver.2 is revised the circuit so that I3C will be suspended (BCTL.RSM becomes 1) when an error occurs. After I3C is suspended, the application must write the value 1 to the BCTL.RSM bit to resume I3C operation and recover form suspended state.

If an error occurs, I3C will be suspended. (BCTL.RSM becomes 1.) After I3C is suspended, the application must write the value 1 to the BCTL.RSM bit to resume I3C operation and recover from the suspended state.

Note 1. It is possible to set the Command Descriptor while waiting for the RSM bit to be cleared.
