32-Bit Microcontroller V850/SV1 Usage Restrictions		Document No.	SBG-T-2477-1-E	1/2
		Date issued	September 11, 2001	
		Issued by	Microcomputer Engineering Dept. Solution Engineering Div. NEC Electron Devices NEC Corporation	
Related documents	User's manual -Hardware: U14462EJ	Notification classification	√	Usage restriction
	User's manual -Architecture: U10243EJ			Upgrade
	Data sheet (Flash memory): U14622EJ			Document modification
	Data sheet (Mask ROM): U13953EJ			Other notification

1. Affected products

V850/SV1 flash memory version

V850/SV1 mask ROM version

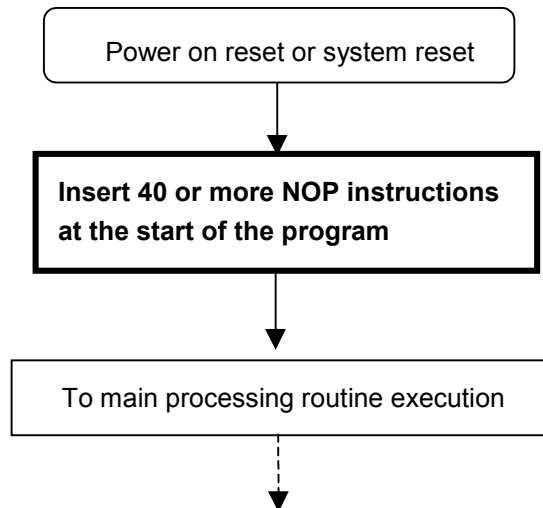
Figure) NOP Insertion Program Flowchart

The microcontroller may become inoperable after the power is turned on or the system is reset.

It is necessary to secure time for the voltage to rise sufficiently before the first fetch of the program. To do this, please insert **40 or more** NOP instructions at the start of the program.
