Microcontroller Technical Information

ID78K0S-QB 78K0S Integrated Debugger Usage Restrictions	Document No.	ZBG-CD-07-0057	1/1
	Date issued	August 30, 2007	
	Issued by	Development Tool Solution Group Multipurpose Microcomputer Systems Division Microcomputer Operations Unit NEC Electronics Corporation	
Related documents ID78K0S-QB Ver. 2.90 Operation User's Manual: U18247EJ1 78K0S Integrated Debugger ID78K0S-QB V2.90 Operating Precautions: ZUD-CD-06-0166	Notification classification	√	Usage restriction
			Upgrade
			Document modification
			Other notification

78K0S Integrated Debugger ID78K0S-QB Usage Restrictions

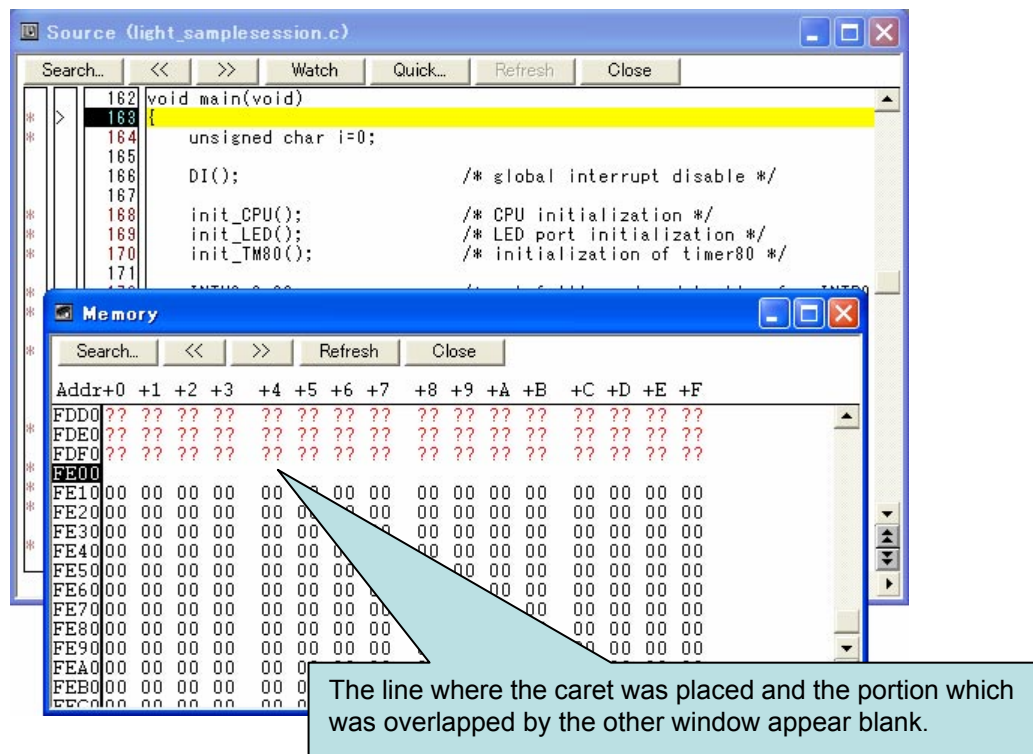
No. 6 Bug in redraw <Common>

When the Memory window is displayed in front of another window, if the window behind the Memory window is clicked to the front and then the Memory window is clicked to the front again, the line where the caret was placed and the portion which was overlapped by the other window appear blank in the Memory window.

Click the [Refresh] button or click on the blanked line to restore the original display.

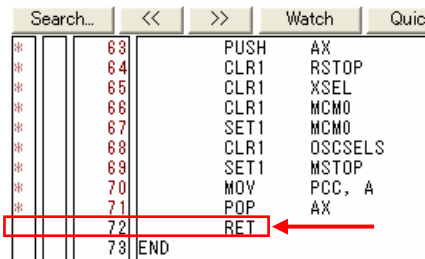
If the instruction placed at the end of a source file is a 1-byte instruction such as RET, as shown below, an asterisk (program code) is not displayed in the instruction line. Consequently, events such as a breakpoint cannot be set to the line, or stepwise execution cannot be performed.

Set events such as a breakpoint in the Assemble window and perform stepwise execution.

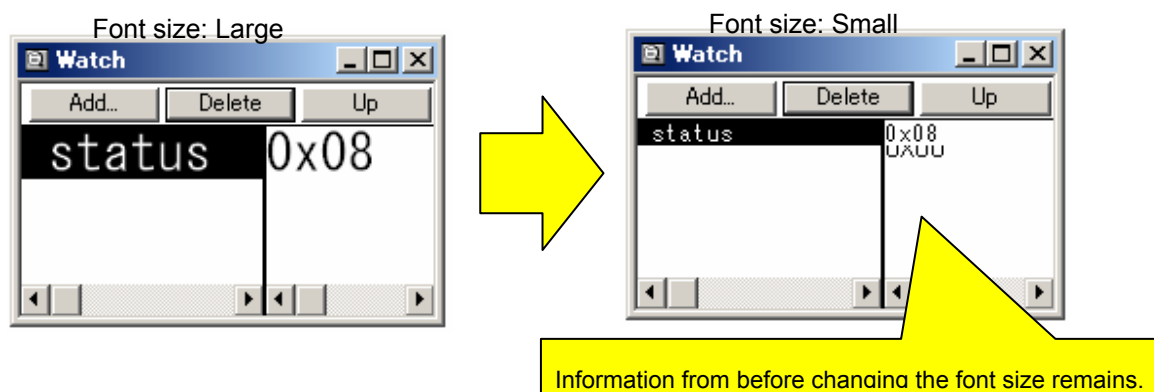
The font size in the Watch window and Local Variable window can be specified in the [Font] area in the Debugger Option dialog box, which is opened by selecting the [Option] menu → [Debugger Option...], but if the font size is reduced, information from before changing the font size remains in the window.

When such a case occurs, minimize the window once and then restore the window size, or close the window once and then open it again.
