RENESAS TECHNICAL UPDATE

Product Category	System LSI		Document No.	TN-RZ*-A0073A/E	Rev.	1.00
Title	Advanced 5port Switch (A5PSW) function issues and usage notice		Information Category	Technical Notification		
Applicable Product	See below	Lot No.	Reference Document	RZ/N1D Group RZ/N1S Group RZ/N1L Group User's Manual (See below for details)		
		See below

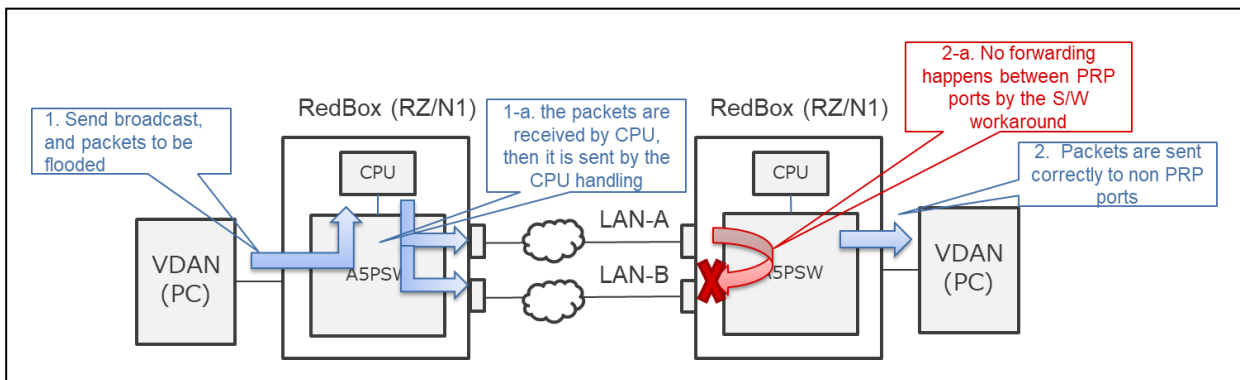
A5PSW (Advanced 5port Switch) forwards specific packets received at one PRP port to the other PRP port. According to the PRP specification, packet forwarding does not happen between PRP ports.

Figure 1: Example of sending packets which corresponds to the bug conditions

- Set 0 to the PRP group ports in the default mask registers (*) in order not to forward broadcast packet and unknown unicast and multicast packet.

- Send packets which cause the bug, broadcast packet and packet to be flooded, by CPU handling.
i.e. Not using 5port Switch's PRP function for those packets

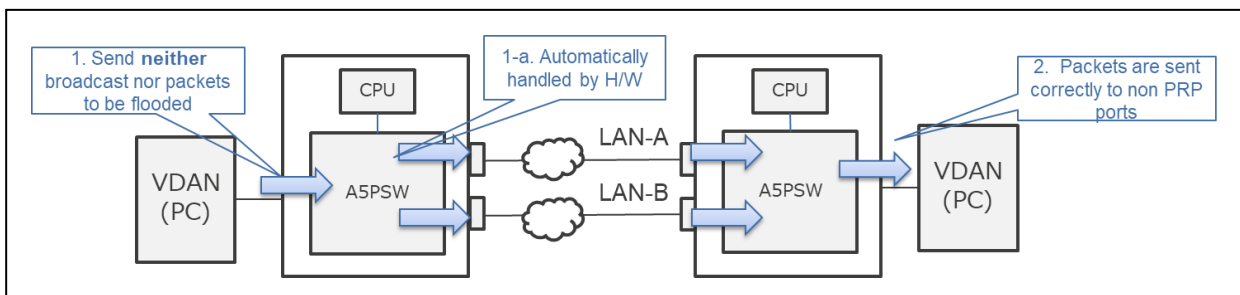
Figure 2: Example of sending packets which don't correspond to the bug conditions

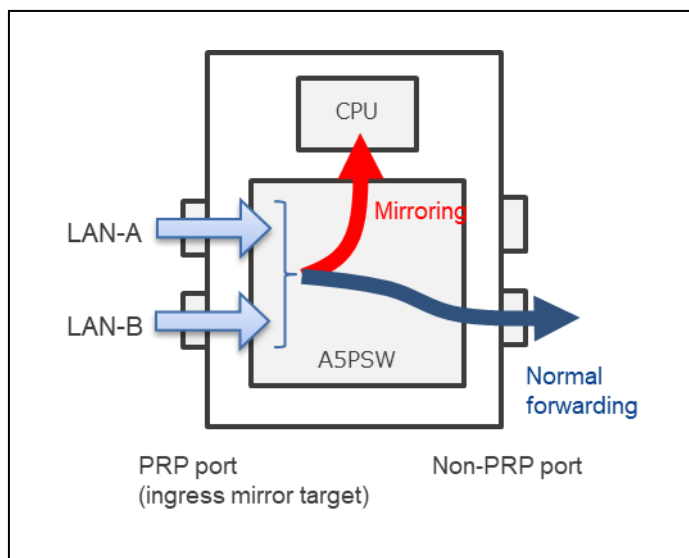
PRP Wrong ID LAN-A/-B Count Registers (CntErrWrongLanA and CntErrWrongLanB) do not work correctly. Even if LanId is attached incorrectly, it is not detected in these count registers.

Figure 3: Frame forwarding by mirroring function

1. Mirror the incoming frames on PRP ports to the management port with management tag to know which port incoming frame comes from, LAN A or LAN B.
2. Host CPU confirms all the frames from management port whether lanId is correct or not by SW, and software counter is incremented if it is incorrect.

In order to reduce CPU load, mirroring frames can be reduced by setting MIRROR_CNT register. Two options are available dependent on the situation as below, for example,

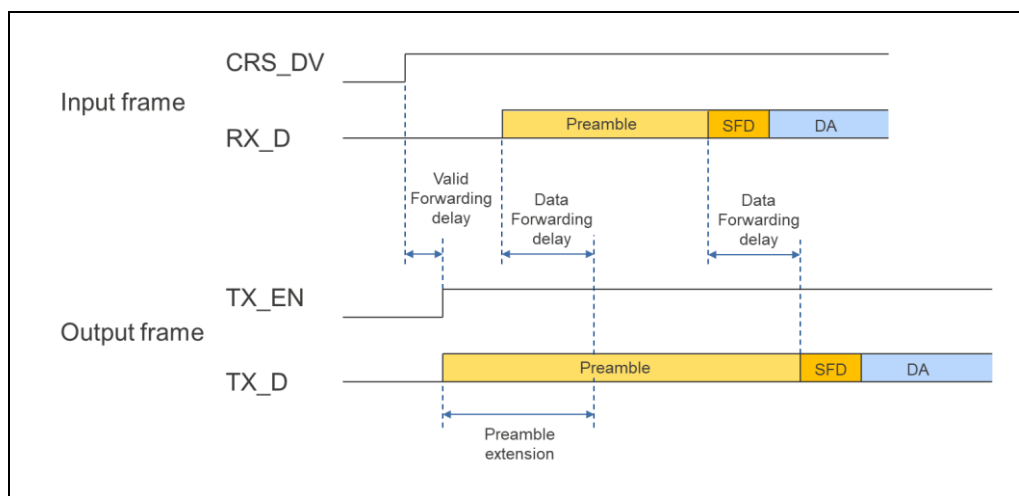
When using Hub module, preamble of the frame output from A5PSW is extended compared with input frame. This is used to indicate the frame transmission to the next devices and to avoid the collision as soon as possible.

Figure 4: Timing of input and output frames in case of using Hub module

From the Ethernet standard point of view, extension of preamble is permitted. However, it is found that some Ethernet POWERLINK support devices can't receive the frame with extended preamble. Therefore, do not use Hub module when supporting Ethernet POWERLINK.
