HITACHI MICROCOMPUTER TECHNICAL UPDATE

DATE	25 January 2001	No.	TN-SH7-272A/E
THEME	Bug of a serial data reception of the multiprocessor communication function at SCI		
CLASSIFICATION	<input type="checkbox"/> Spec change <input checked="" type="checkbox"/> Limitation on Use <input type="checkbox"/> Supplement of Documents		
PRODUCT NAME	HD6417750 ,HD6417750S ,HD6417751	Lot	Lot #All
REFERENCE DOCUMENTS	SH7750 series Hardware Manual	Rev.	Effective Date
	SH7751 Hardware Manual		Eternity

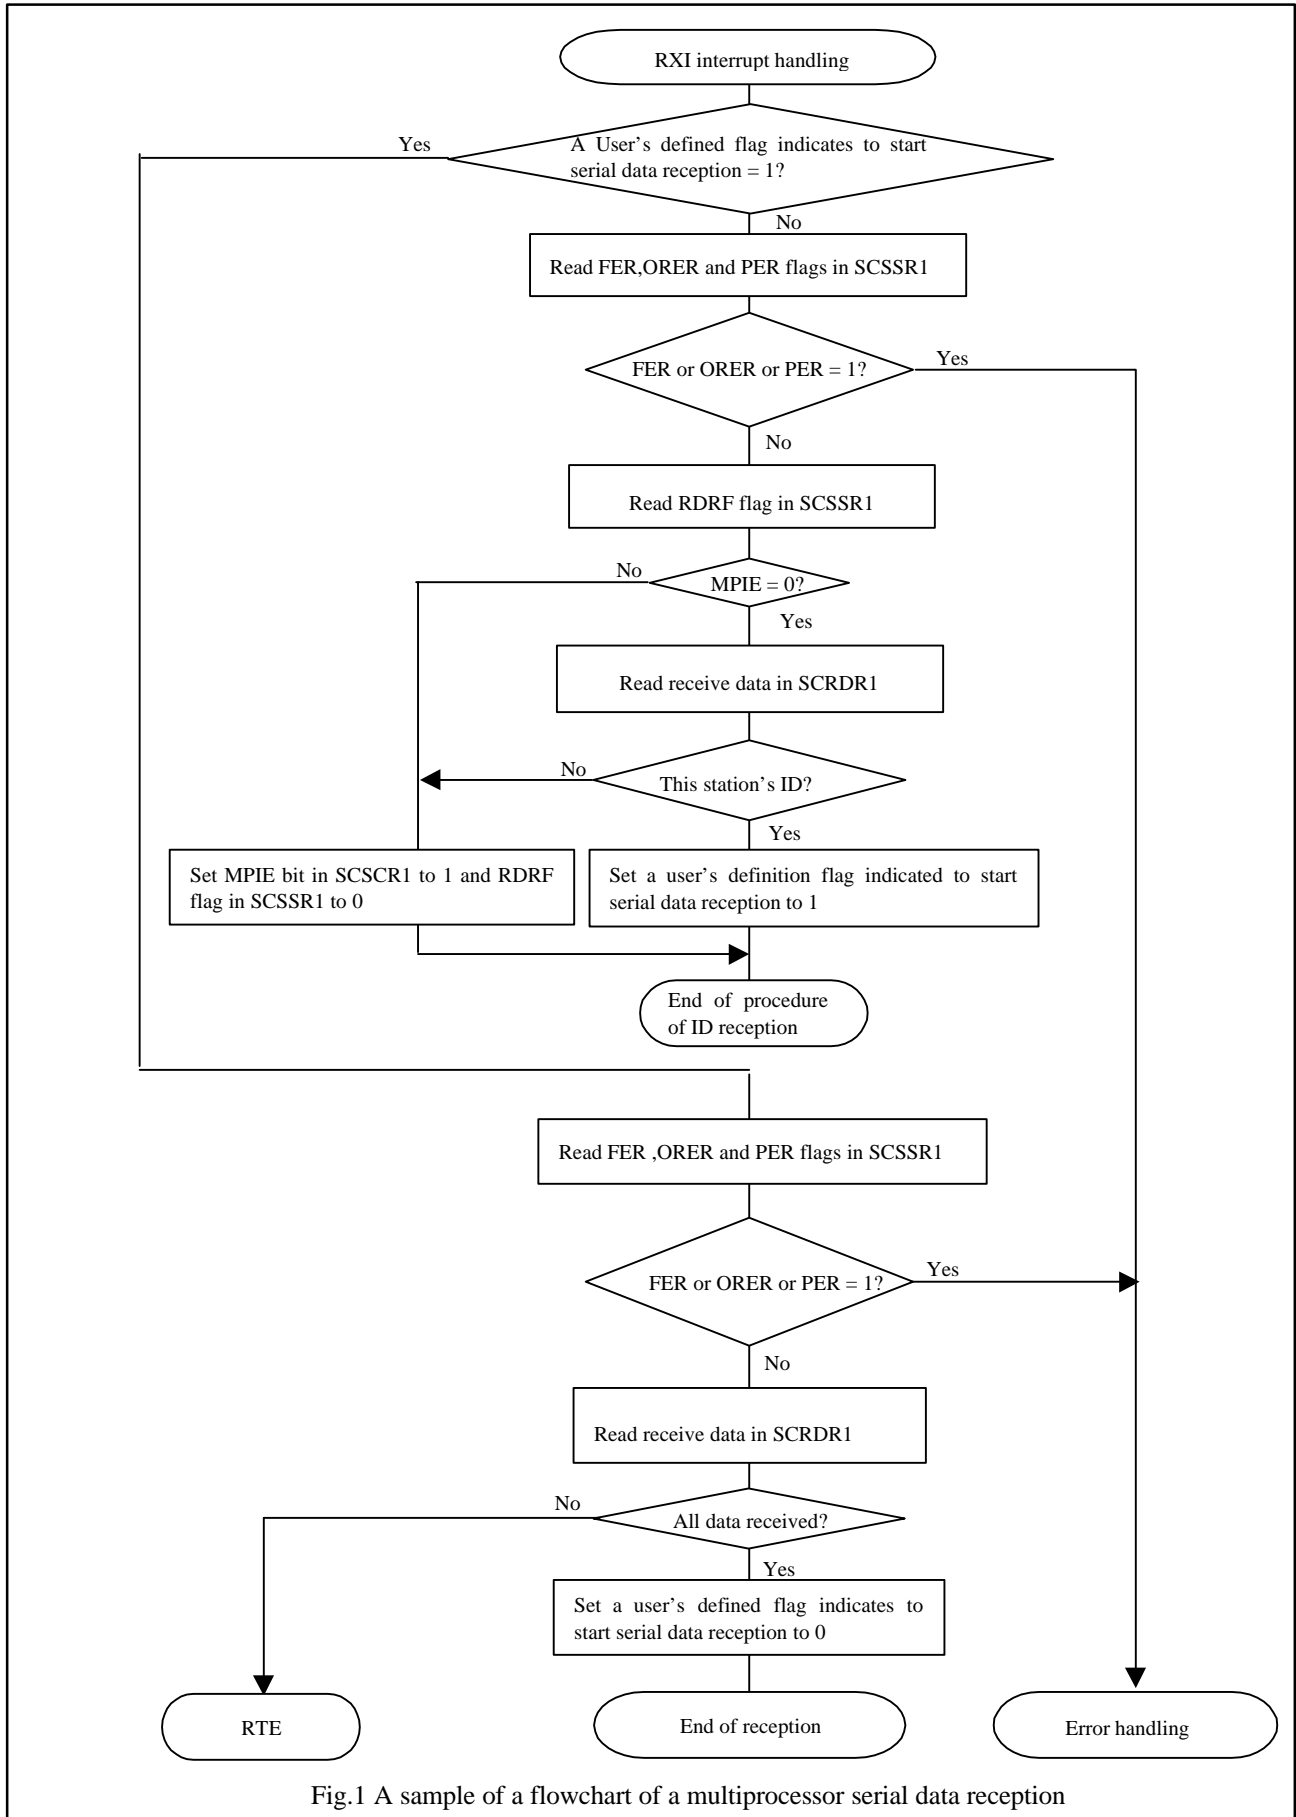
Fig.1 A sample of a flowchart of a multiprocessor serial data reception

In the processing of software to distinguish a receive data between this station's ID (MPB=1) and a valid data (MPB=0), please create a user's defined flag on a memory which indicates information about starting a serial data reception.

A sample of a flowchart of a multiprocessor serial data reception is shown in the following.
