RENESAS TECHNICAL UPDATE

Product Category	Development Environment		Document No.	TN-EML-A139A/E	Rev.	1.00
Title	H8/36109 group expansion I/O board for the E6000: Problems with the timing of the slave interface		Information Category	Technical Notification		
Applicable Product	H8/36109 group expansion I/O board (model name: HS36109EIO61H)	Lot No.	Reference Document	H8/36109 group expansion I/O board HS36109EIO61H user's manual (REJ10J1320-0100)		
		0001 to 0031, 0BA0001B

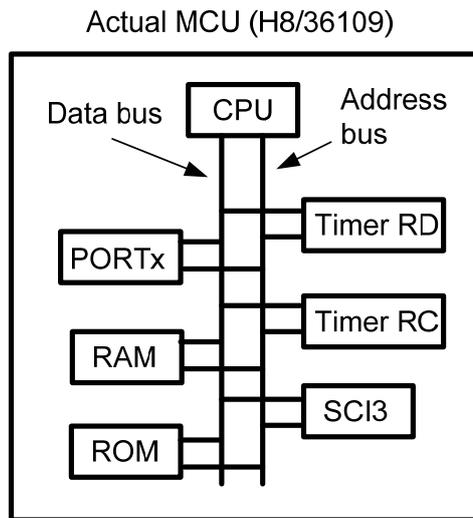
Figure 1 H8/36109's Block Diagram

The actual H8/36109 is a single-chip MCU. Thus the address-bus, data-bus, and strobe signals are connected within the MCU (see figure 1).

When the H8/36109 is used alone, however, this problem does not occur because of the difference in configuration as shown in the figures.

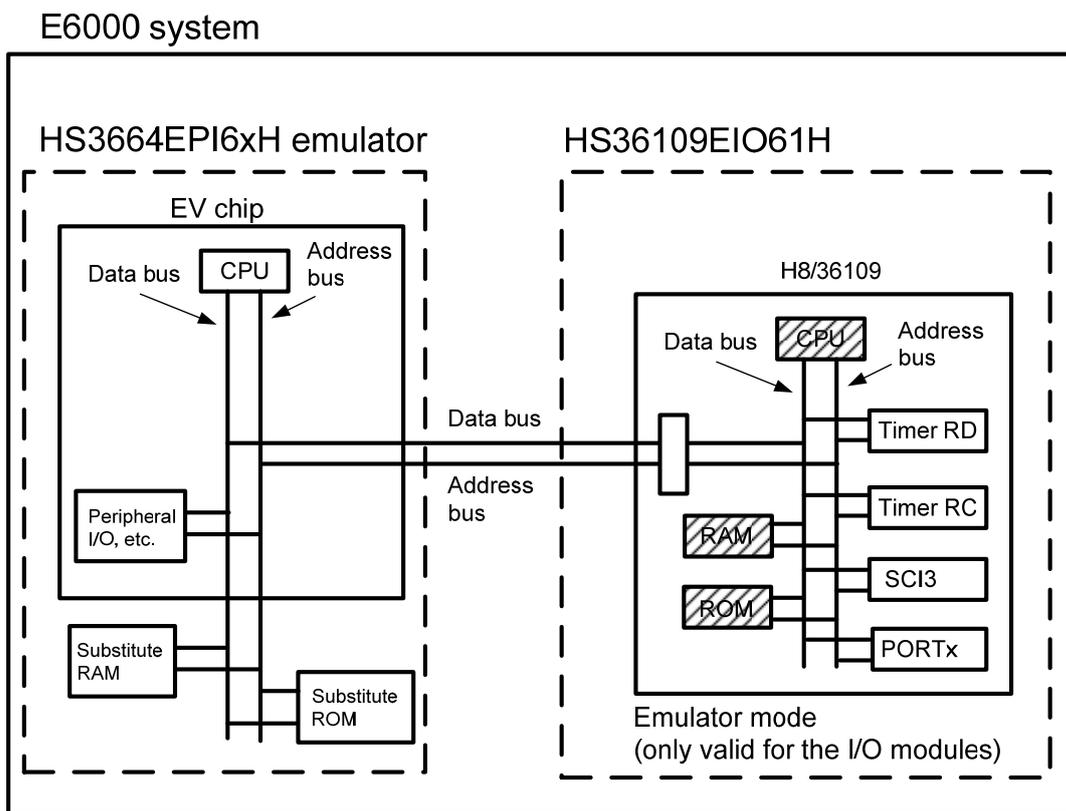
Figure 2 Block Diagram of the E6000 System

The E6000 emulator, on the other hand, uses the H8/36109 in emulator mode*. For emulation, an EV chip is used in conjunction with the H8/36109 in emulator mode (hereafter referred to as the slave chip) (see figure 2). For this reason, address-bus, data-bus, and strobe signals are supplied from the EV chip to the slave chip.

1. This problem occurs only when the H8/36109 is used in emulator mode. The address-bus timing within the slave chip was earlier than the timing of other signals (data-bus and select signals) and this led to insufficient holding time between the slave address and select signals.

2. This problem occurs only when the H8/36109 is used in emulator mode. The timing of negating the slave-chip read signal (which is input from the EV chip to the slave chip) was earlier than the internal clock timing. So the data-bus signal output from the slave chip was negated a half clock cycle earlier and the EV chip could not read the correct value.

1. We will delay the timing of an input to the pins of the slave chip by approximately a half cycle (e.g. 25 ns in operation at 20 MHz), considering the delay time within the slave chip.

2. We will adjust the timing, considering the delay time within the slave chip, so that the ASESLRDN signal input to the slave chip will be negated following the falling edge of the T4 cycle with a delay in accord with the AC characteristics of the slave chip.
