RENESAS TECHNICAL UPDATE

Product Category	System LSI		Document No.	TN-RIN-A005A/E	Rev.	1.00
Title	Hardware Real Time OS library issue (Mailbox queuing, timeout and wakeup request count)		Information Category	Technical Notification		
Applicable Product	See following	Lot No.	Reference Document	R-IN32M3 Series User's Manual R-IN32M3-CL (R18UZ0007EJ0202) R-IN32M3 Series User's Manual R-IN32M3-EC (R18UZ0003EJ0301) R-IN32M3 Series User's Manual Peripheral Functions R-IN32M3-CL R-IN32M3-EC (R18UZ0005EJ0601) R-IN32M3 Series Programming Manual (OS edition) R-IN32M3-EC R-IN32M3-CL (R18UZ0011EJ0400)		
		All lots

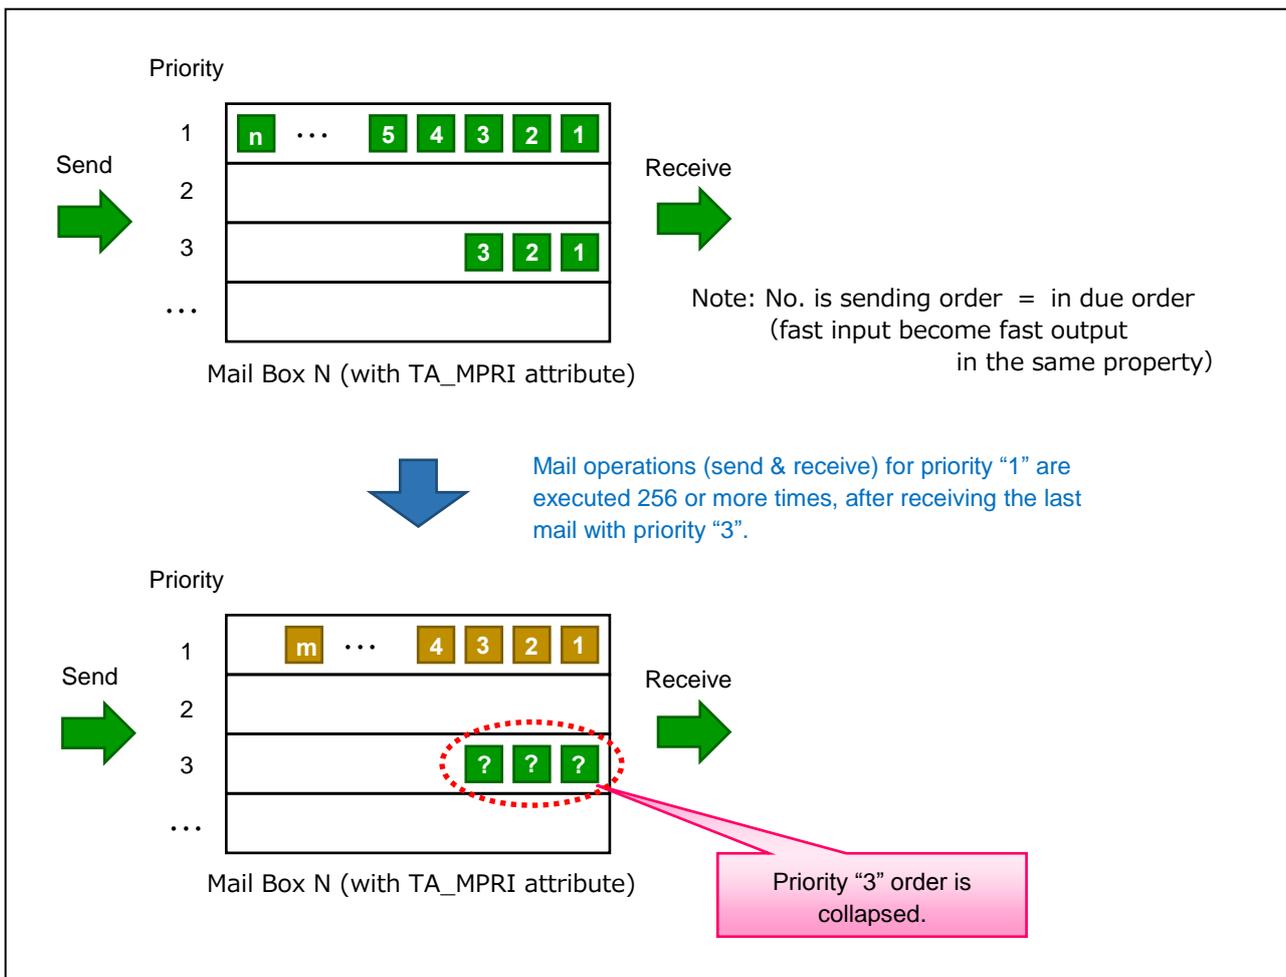
2.1. Issue 1 (Mailbox queuing)

When using synchronization and communication function (mailbox) with TA_MPRI attribute that specifies queuing of messages in priority order, message queue ordering might not be kept in the same priority queue.

- Mailbox ID with TA_MPRI attribute is used.
- After multiple low priority messages are stored into the mailbox, high priority messages are sent and received 256 and more times without receiving the low priority messages.

- 1) Mailbox queuing
Basically, forbids to use mailbox with TA_MPRI attribute. (TA_MFIFO, message queue is in FIFO order, can be used.)
- 2) Timeout
Timeout action occurs 1ms earlier than specified time.
- 3) Wakeup request count
Forbids to issue “wup_tsk” and “iwup_tsk” system call when wakeup request count is the maximum (63).

- New service call supports enable/disable setting for mailbox with TA_MPRI attribute.
- Mailbox with TA_MPRI attribute is disabled as default.
- In the case of enabling mailbox with TA_MPRI attribute, specification of sending ASP is changed to return E_QOVR when one or more messages are left in the mailbox queue and sending APIs are issued 256 or more times. Same error will be returned until mailbox is empty. Thus, user has to receive the message until mailbox is empty.

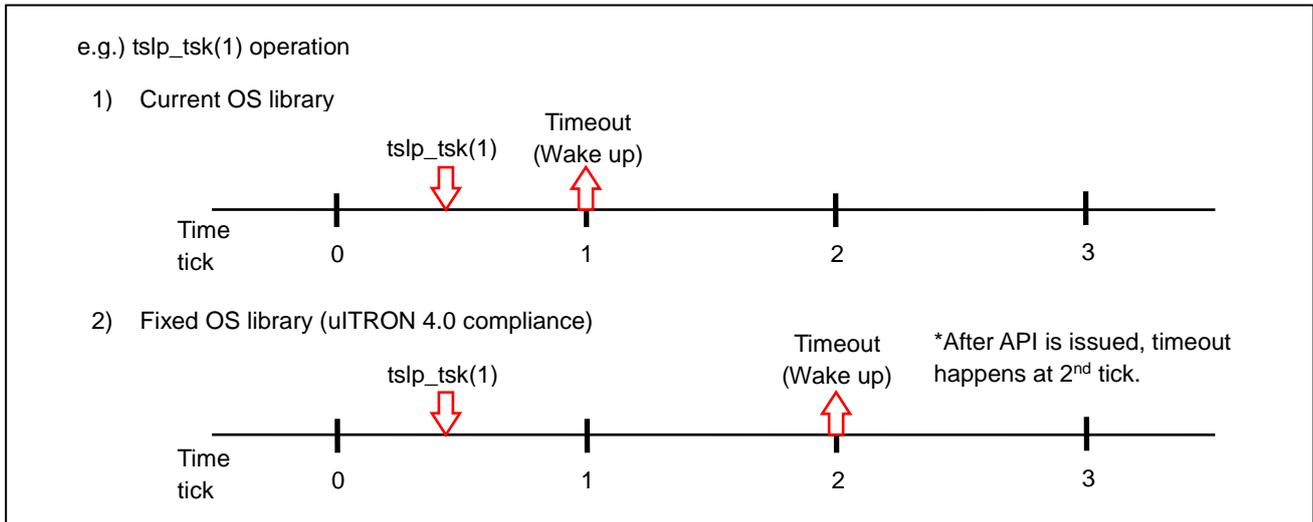
2.2. Issue 2 (Timeout)

For service calls with timeout, Timeout action occurs 1ms earlier than specified time. When the following service calls are used and specified timeout is set to 1 or more, the issue will happen.

- tslp_tsk
- twai_sem
- twai_flg
- trcv_mbx
- tloc_mtx

Note: There is no issue when TMO_POL(0) or TMO_FEVR(-1) is specified.

The updated API follows uITRON 4.0 specification for Timeout.
