# HITACHI SEMICONDUCTOR TECHNICAL UPDATE

Classification of Production	MCU			No	TN-SH7-402B/E	
THEME	Information about bug with FDIV on SH7055RF		Classification of Information	1. Spec change 2. Supplement of Documents ③ Limitation of Use	4. Change of Mask 5. Change of Production Line	
PRODUCT NAME	SH7055RF	Lot No.	Reference Documents	SH-2E Programming Manual Rev.1.0 ADE-602-178	Rev.	Effective Date
		SH7055RF :ALL lots			2.0	Unlimited

We would like to inform you that there is a bug with FDIV on SH7055RF.

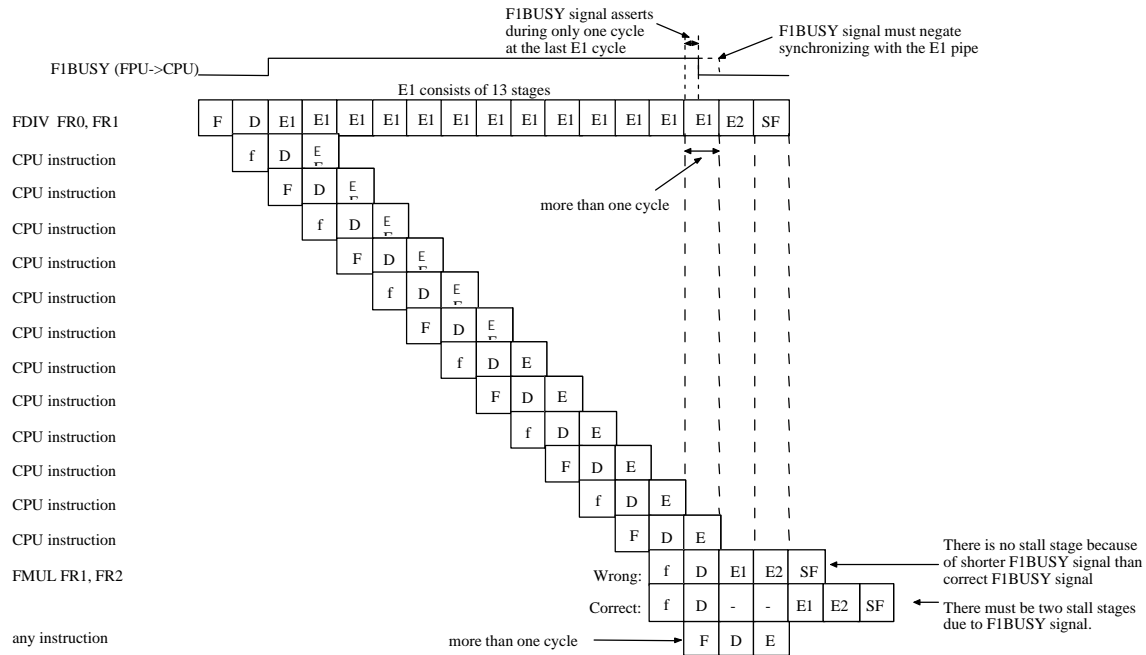
In this example, FDIV operates FR1/FR0 -> FR1, and then FMUL at the 13<sup>th</sup> instruction after FDIV operates FR1 x FR2 -> FR2. If the number of the fetch cycle of the next instruction of FMUL is more than one cycle, the number of the last E1 cycle of FDIV is extended to more than one cycle due to it. So there is no stall stage in FMUL and FMUL uses the FR1 value before FDIV operation, not the FR1 value after FDIV operation. But FDIV operates itself correctly.

Fig1. Example 1 about bug with FDIV

Example 1 of Fig 1 is an example of this. There is no this case if the program is located on the internal flash memories and rams.

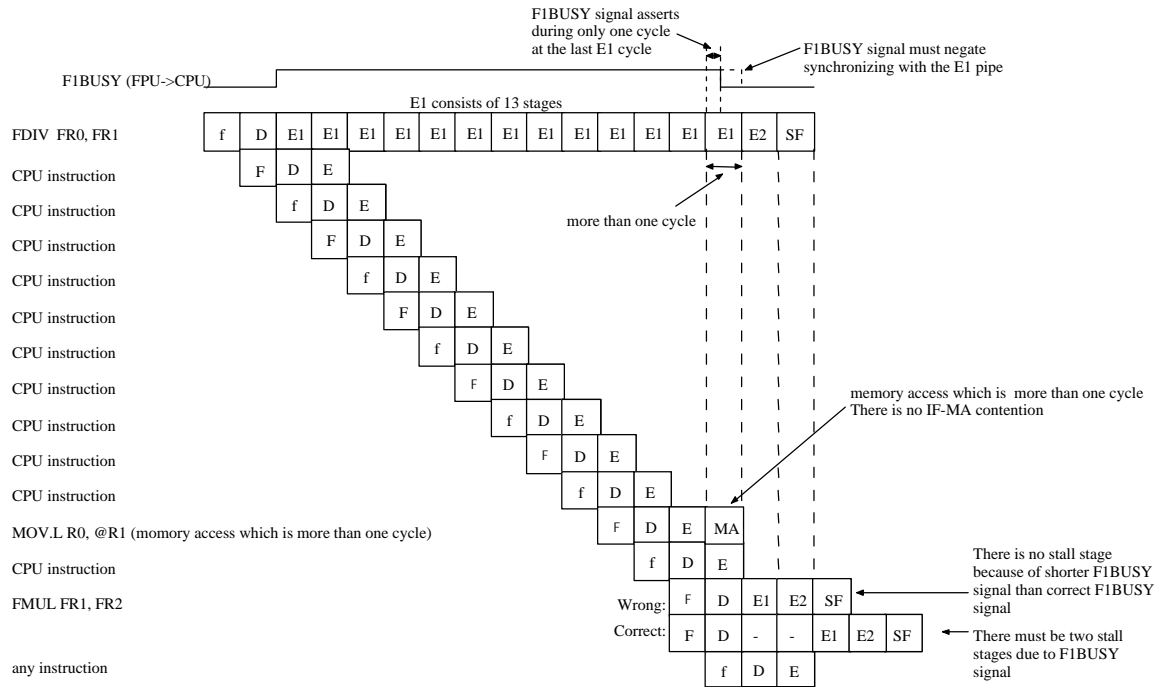
In this example, FDIV operates FR1/FR0 -> FR1, and then FMUL at the 13<sup>th</sup> instruction after FDIV operates FR1 x FR2 -> FR2. If the 2<sup>nd</sup> instruction before FMUL operates memory access which is more than one cycle and there is no IF-MA contention at the memory access, the number of the last E1 cycle of FDIV is extended to more than one cycle due to it. So there is no stall stage in FMUL and FMUL uses the FR1 value before FDIV operation, not the FR1 value after FDIV operation. But FDIV operates itself correctly.

Fig2. Example 2 about bug with FDIV

Example 2 of Fig 2 is an example of this. There is no this case if there is no instruction with MA of more than one cycle at one or two instruction before the FPU instruction.
