RENESAS TECHNICAL UPDATE

Product Category	MPU/MCU		Document No.	TN-RZ*-A0082A/E	Rev.	1.00
Title	Initialization setting issue of CRU MIPI CSI2 Link Registers		Information Category	Technical Notification		
Applicable Product	RZ/G2L Group RZ/G2LC Group RZ/V2L Group	Lot No.	Reference Document	RZ/G2L Group, RZ/G2LC Group User's Manual: Hardware Rev.1.00 (R01UH0914EJ0100) RZ/V2L Group User's Manual: Hardware Rev.1.00 (R01UH0936EJ0100)		
		All lots

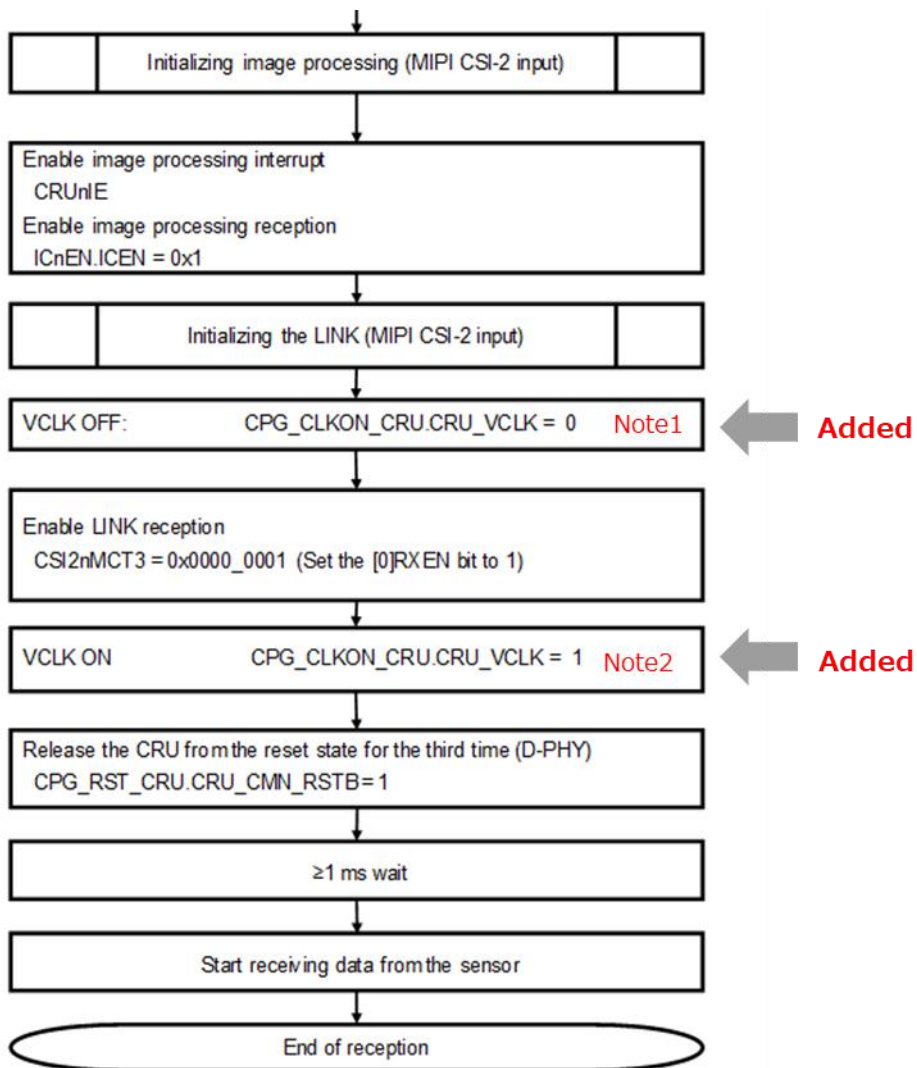
<After>

At the time of initial setting, the following MIPI-CSI2 Link register setting may not be reflected correctly.

Additional operations are added to "35.3.1, Figure 35.33 Reception Start Flow for the MIPI CSI-2 Input" to avoid this issue.

Note1: After VCLK OFF setting, confirm whether VCLK is off by reading CPG_CLKMON_CRU.CLK1_ON=0.

Note2: After VCLK ON setting, confirm whether VCLK is on by reading CPG_CLKMON_CRU.CLK1_ON=1.
