# RENEASAS TECHNICAL UPD

Product Category	MPU&MCU	Document No.	TN-MC*-009A/EA	Rev.	1.0
Title	Limitation on the HCAN RESET, SLEEP control bit		Information Category	Usage Limitation	
Applicable Product	See the reference documents in the following.	Lot No.	Reference Document	See the reference documents in the following	
		All Lots

This is a limitation discription using the HCAN.

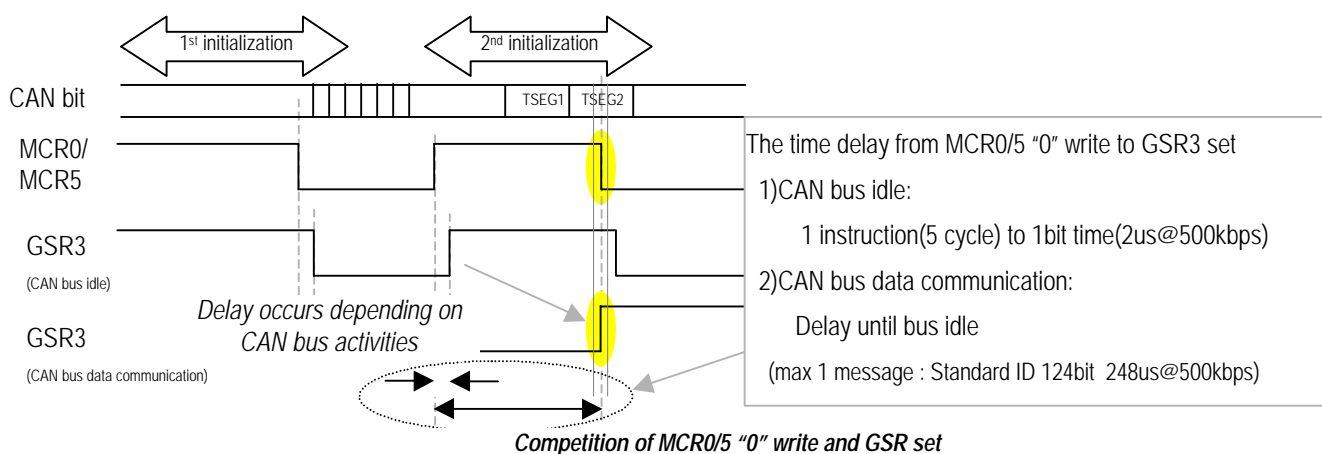
Diagram1. Timing of GSR3 stuck to 1

GSR3(bit3) of the GSR(General Status Register) will remain as "1" and the HCAN stops communication when there is a competition between "0" write of MCR0(bit0) or MCR5(bit5) of the MCR(Master Control Register) and the GSR3 set timing.

Diagram 1 shows an example of 2 consecutive initializations. During the 2<sup>nd</sup> initialization "1" and "0" is written to the MCR0/5 bit and the status bit GSR3 corresponds with a delay. GSR3's clear delay timing is always fixed(1instruction to 1 bit time) but the set timing depends on the CAN bus activities. If there are no CAN bus activities the GSR3 will be set to "1" between 1 instruction to 1bit time delay, but if there are CAN bus activity the GSR3 set timing will be delayed maximum 1 message length. In this case the competition will occur.

- 1) Confirm that GSR3 = 1 before writing a "0" to the MCR0/5.
- 2) Limit the initialization procedure to 1 time(Write 0 to MCR0/5 only once).

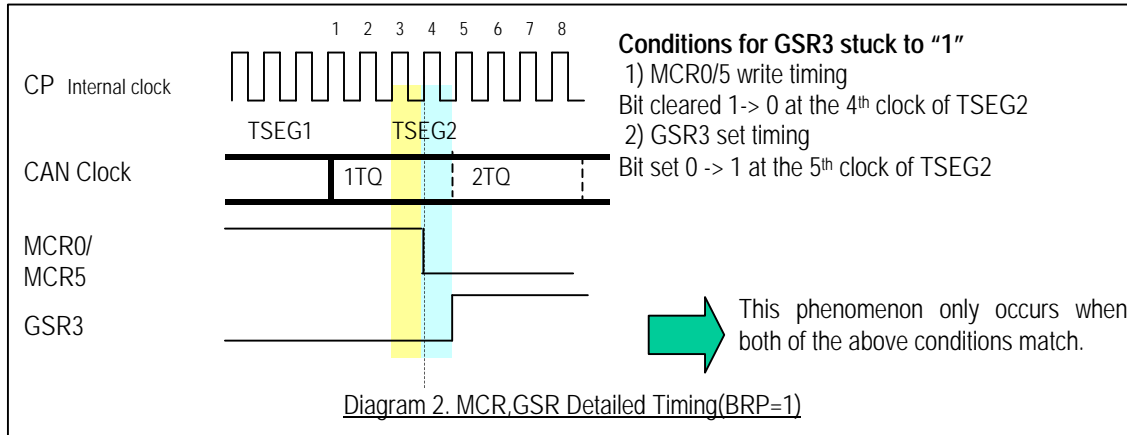
Detailed timings are shown in diagram 2. This limitation occurs only when the MCR0/5 "0" write signal matches the 4<sup>th</sup> clock, GSR3 set signal matches the 5<sup>th</sup> clock of the HCAN internal clock(CP).

Furthermore, after this condition if MCR0 is written "1" and "0" the GSR3 will be cleared again and returns to the normal operating condition.
