# RENESAS TECHNICAL UPDATE

Product Category	MPU&MCU		Document No.	TN-SH7-A543A/E	Rev.	1.0
Title	Limitation for use of SH7710 internal Ethernet DMAC.		Information Category	Technical Notification		
Applicable Product	HD6417710 HD6417712 R4J7710ABG	Lot No.	Reference Document	SH7710 Hardware manual REJ09B0079-0100Z Rev.1.0		
		ALL

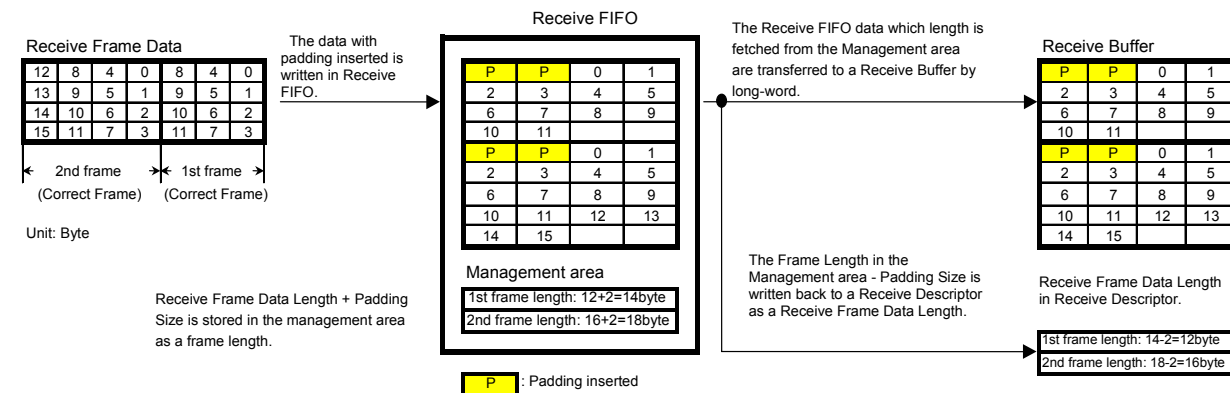
<The case that 2 bytes padding is inserted at the head of a frame and a correct frame is received : Correct Reception>

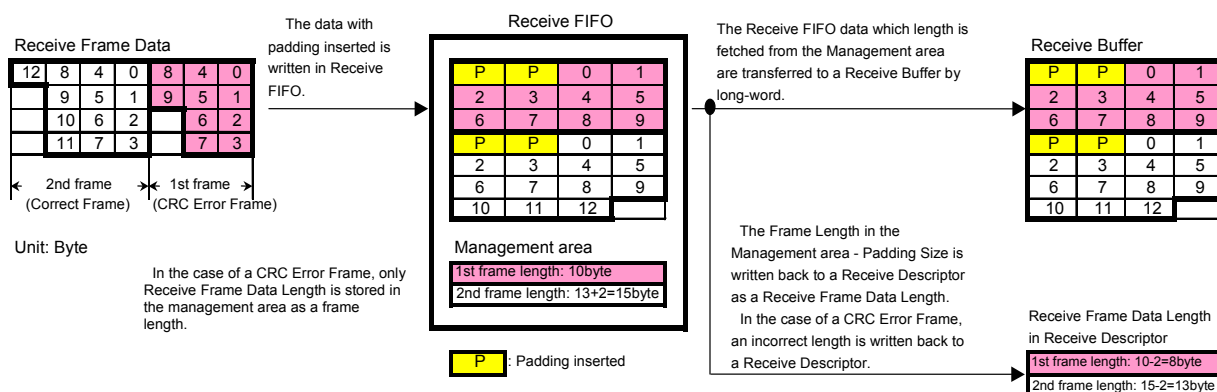
When a CRC error occurs in the case the receiving data padding insertion function is set enabled, the E-DMAC writes back an incorrect receive frame length, which is the inserted padding bytes short of the correct length, to a Receive Descriptor.

<The case that 2 bytes padding is inserted at the head of a frame and a CRC error frame is received : the error (1) only>

Please do not use the padding insertion function of E-DMAC.

When a CRC error occurs in the case the receiving data padding insertion function is set enabled, please execute a Software Reset by taking the following procedure to recover your system.

- a) Check EtherC/E-DMAC Status Register (EESR) bit 0(CERF) = 1 to confirm a Receive Frame CRC Error.
- b) Execute a Software Reset by setting E-DMAC Mode Register (EDMR) bit 0(SWR) = 1.
- c) Execute an initial set-up of EtherC, E-DMAC and receive descriptors.
- d) Activate a receive function of E-DMAC by setting EDRRR bit 0(RR) = 1.
- e) Start to receive data by setting EtherC Mode Register (ECMR) bit 6(RE) = 1.

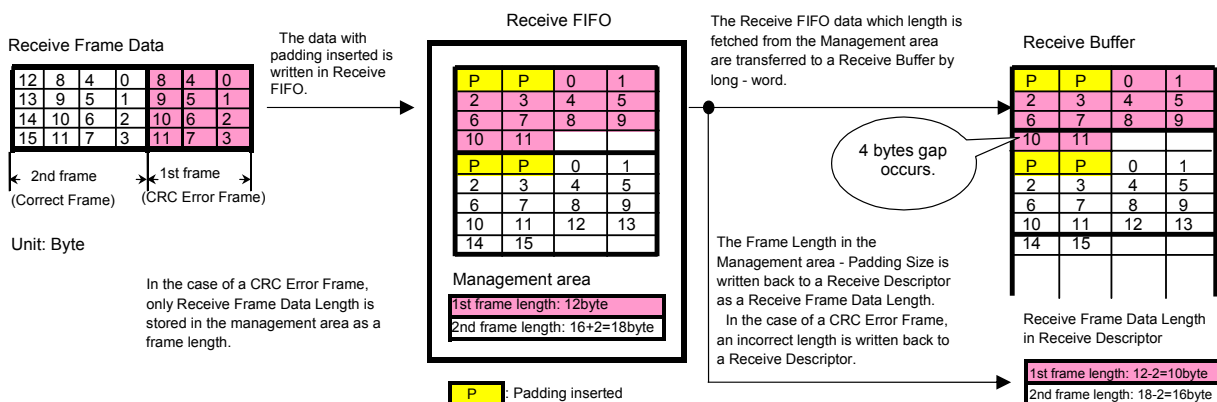
The error (1) above is also the cause that the last 4 bytes data of the CRC error frame may not be transferred from Receive FIFO to Receive Buffer after CRC error frame reception.

In this case the remained last 4 bytes data is transferred to Receive Buffer as the first 4 bytes of the following receive frame. Therefore, the receive frame data after the CRC error frame are stored in Receive Buffer with 4 bytes gap.

<The case that 2 bytes padding is inserted at the head of a frame and a CRC error frame is received : the error (1) and (2) >
