MAEC TECHNICAL NEWS

No. M16C-84-0204

M16C/62N Flash Memory Versions and M3062GF8NFP/GP Usage Precaution on Stop Mode

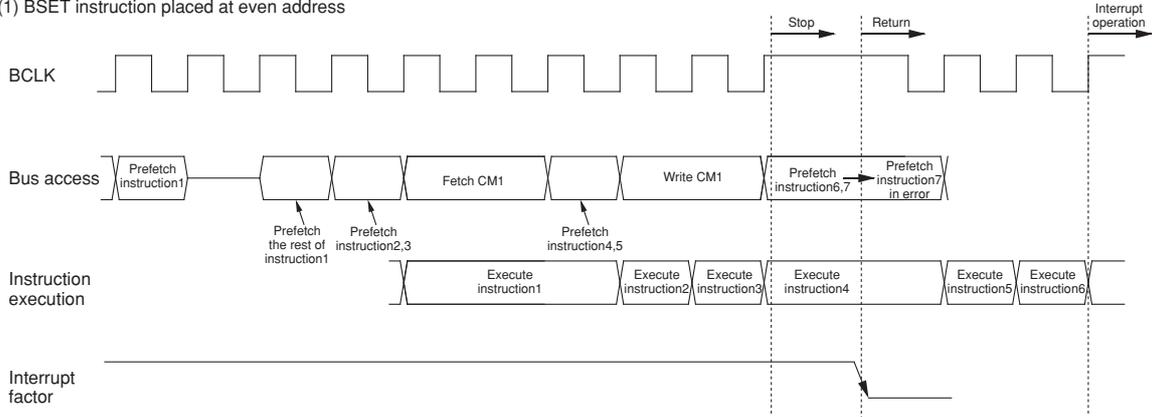
(1) BSET instruction placed at even address

An erroneous value may be read out of flash memory when a STOP mode is entered while reading data out of the flash memory. When this erroneous value is executed, an undefined operation may occur due to an undefined interrupt, a BRK instruction, etc.

(1) In Figure 1-(1), the erroneous instruction read will not be executed because interrupt processing has higher priority. -> This behavior will not occur.

Note 2: The BSET instruction accompanies read operation of the corresponding address. This causes to inhibit prefetching and storing access of the instruction code to the instruction queue buffer and generate the said phenomenon easily.

Execute the JMP.B instruction after writing to the all clock stop control bit. The instruction code prefetched at the time of shifting to stop mode is latched in the flash memory before entering into stop mode by executing a JMP.B instruction.

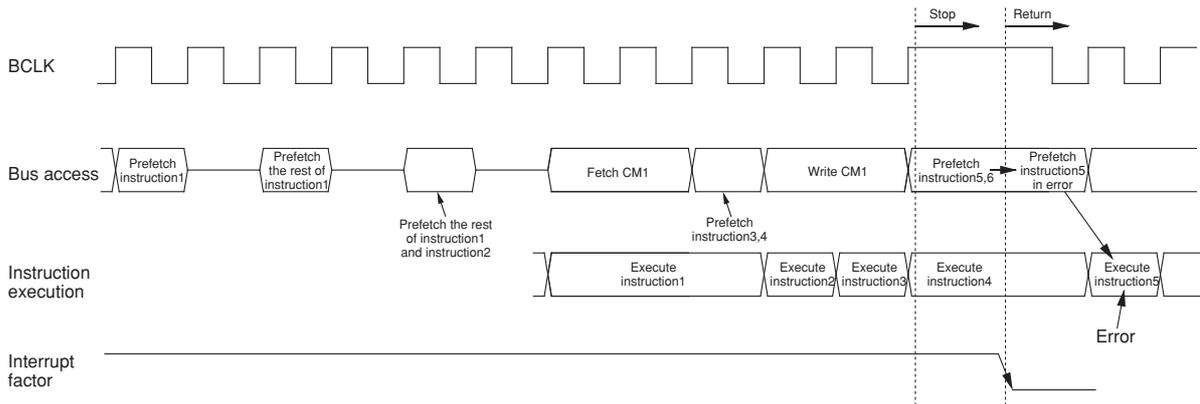
(2) BSET instruction placed at odd address

(2) In Figure 1-(2), the erroneous instruction read will be executed because it occurred before interrupt processing. -> This behavior will occur.
