MAEC TECHNICAL NEWS

No. M16C-86-0205

M16C/80, M32C/82 and M32C/83 Groups

Usage Precaution on Three-phase Motor Control Timers' Function

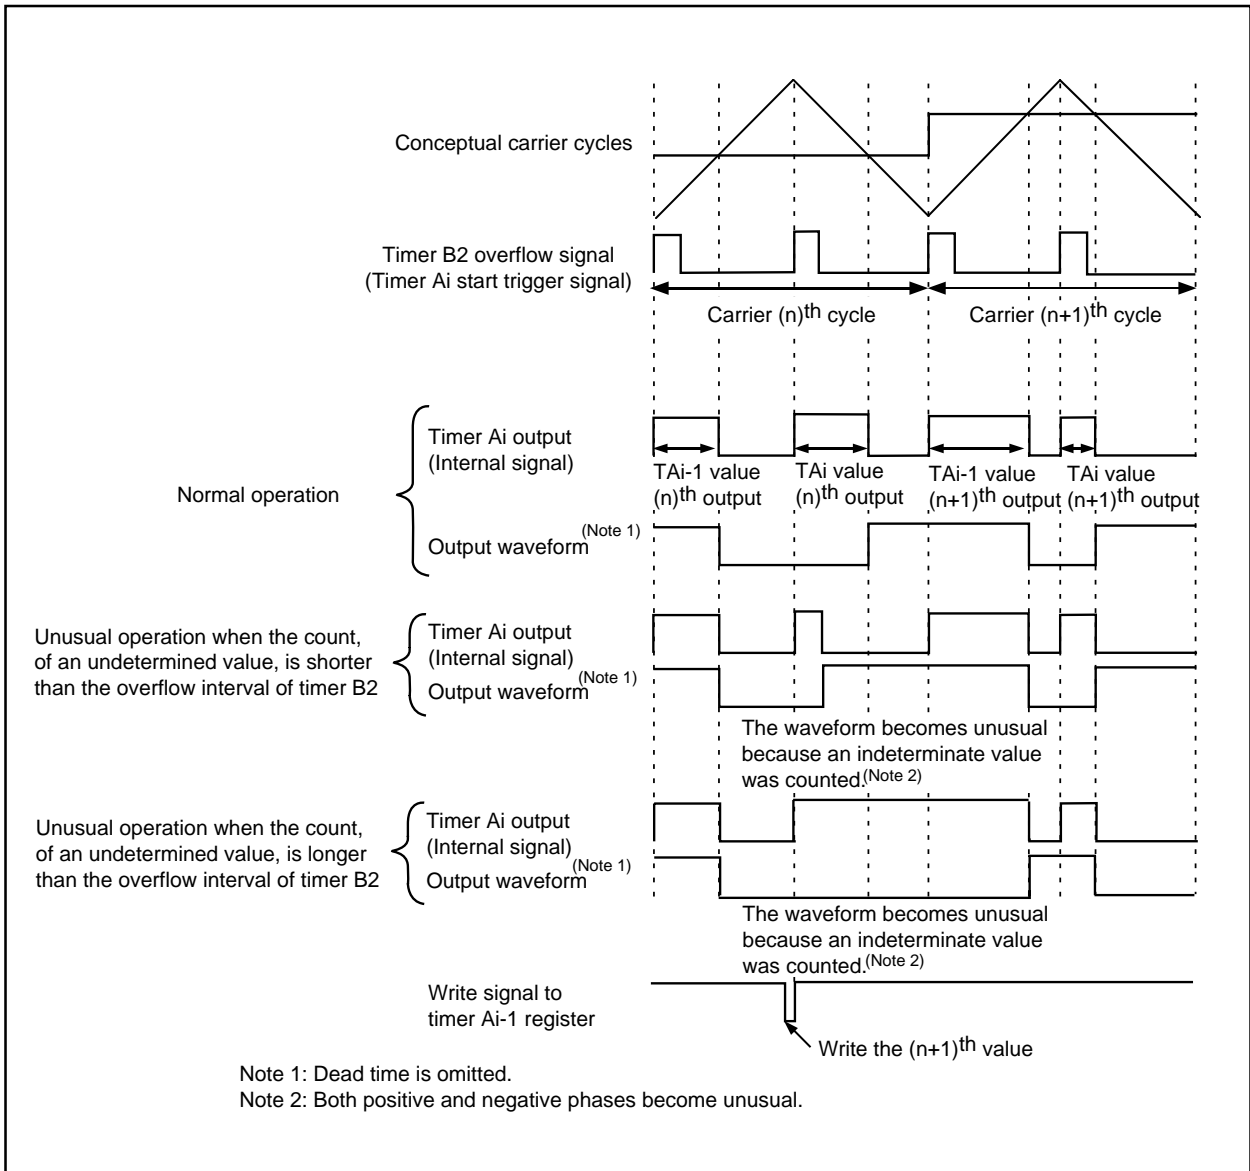
While using the timers in Three-Phase Mode 1 for Three-Phase Motor Controls and near Timer B2's overflow, if a count value is written to Timer Ai-1 register ($i=1, 2, 4$), a different count value may be written to Timer Ai instead of the value you want to set it to. This will then cause a different output waveform.

Figure 1 shows an example of output waveform when writing count value to Timer Ai-1 register near Timer B2' overflow and Figure 2 shows the write timing to Timer Ai-1 register when the output waveform is unusual.

Figure 1. An example of output waveform when writing to Timer Ai-1 register near Timer B2's overflow

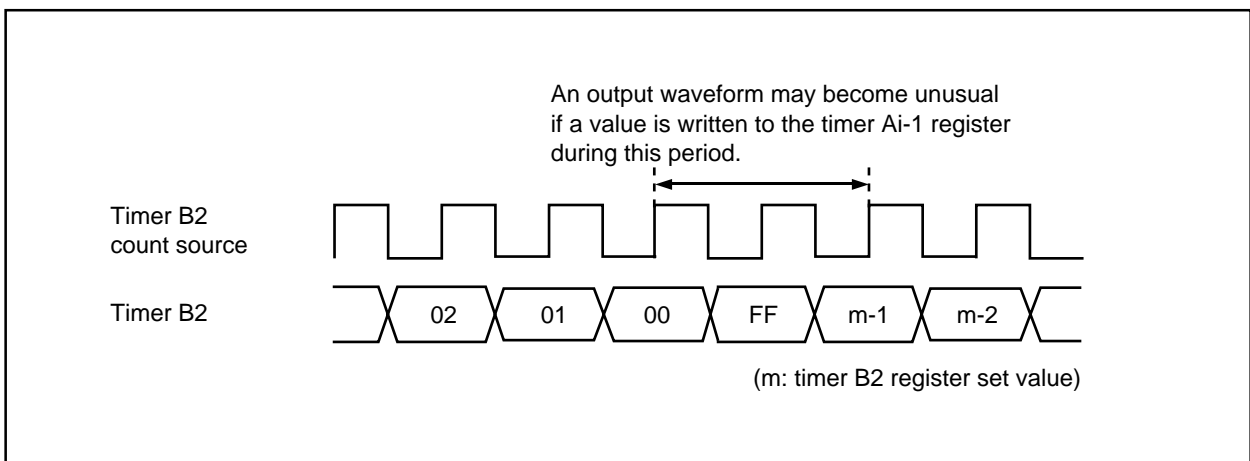
Figure 2. Write timing to Timer Ai-1 register that will cause an unusual output waveform

Do not write data to Timer Ai-1 register in the timing shown in Figure 2.

If there is a possibility that you may write data to Timer Ai-1 register as shown in Figure 2, read the value of Timer B2 register, verify that there is sufficient time until Timer B2 overflows, before doing an immediate write to Timer Ai-1 register.

In order to shorten the period from reading Timer B2 register to writing data to Timer Ai-1 register, ensure that no interrupt will be processed during this period.

If there is not enough time till Timer B2 overflows, only write to Timer Ai-1 register after Timer B2 overflowed.
