RENESAS TECHNICAL UPDATE

Product Category	Application specific IC	Document No.	TN-ASP-A019A/E	Rev.	1.00
Title	M66592/M66596 Usage Precautions of the Buffer memory initialization by the ACLRM bit	Information Category	Technical Notification		
Applicable Product	USB ASSP M66592/M66596	Lot No.	Reference Document	M66592 data sheet (REJ03F0111) M66596 data sheet (REJ03F0119)

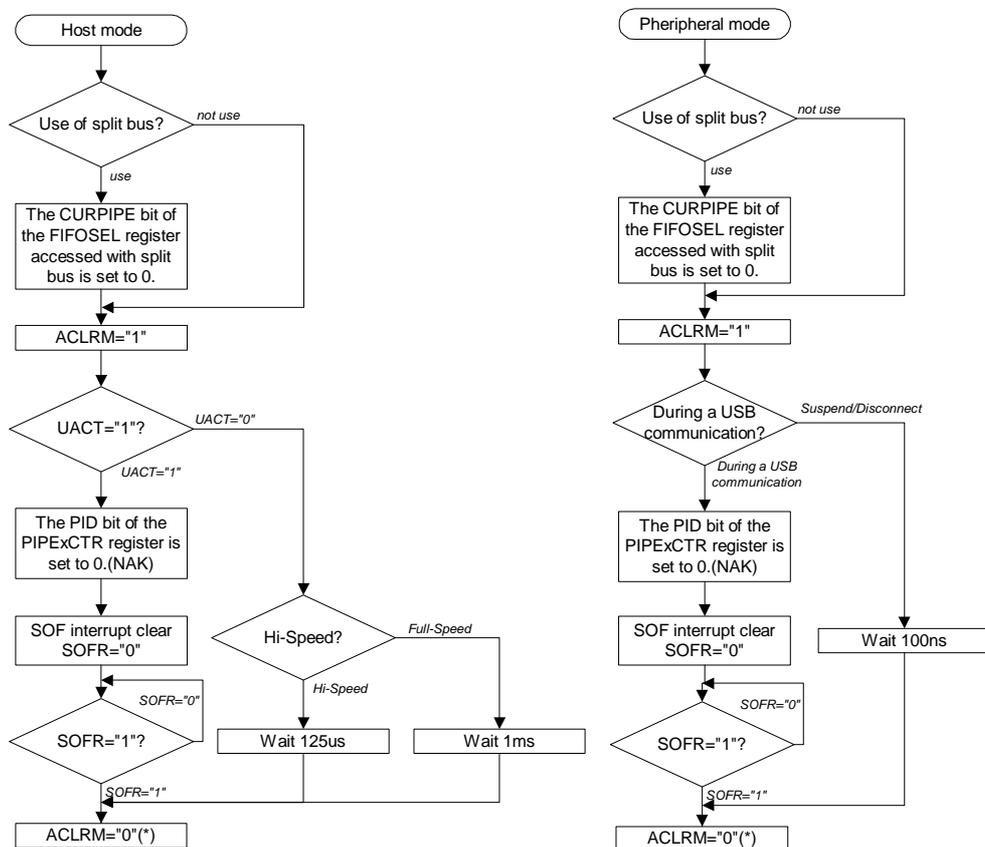
This phenomenon can be avoided by using the following software flowchart.

* Set ACRM bit to "0" within 125us after change from SOFR = "0" to SOFR = "1".
