RENESAS TECHNICAL UPDATE

Product Category	MPU&MCU		Document No.	TN-H8*-281A/EA	Rev.	1.0
Title	Notes on Arbitration Lost in I ² C Bus Interface of the H8S Series		Information Category	Usage Limitation		
Applicable Product	H8S/2148,H8S/2138 Series H8S/2149,H8S/2169 Series H8S/2140B Series H8S/2110B H8S/2128 Series H8S/2158 Series H8S/2168 Group H8S/2194 Series H8S/2199R Series	Lot No.	Reference Document	Following Hardware Manuals: H8S/2148 Series (ADE-602-125B Rev.3.0) H8S/2138 Series (ADE-602-144B Rev.3.0) H8S/2149, 69 Series (ADE-602-190A Rev.2.0) H8S/2140B Series (ADE-602-274A Rev.2.0) H8S/2110B (ADE-602-298 Rev.1.0) H8S/2128 Series (ADE-602-114B Rev.3.0) H8S/2158 Series (ADE-602-255A Rev.2.0) H8S/2168 Group (REJ09B0078-0300Z Rev.3.00) H8S/2194 Series (ADE-602-160A Rev.2.0) H8S/2199R Series (ADE-602-232 Rev.1.0)		
		All

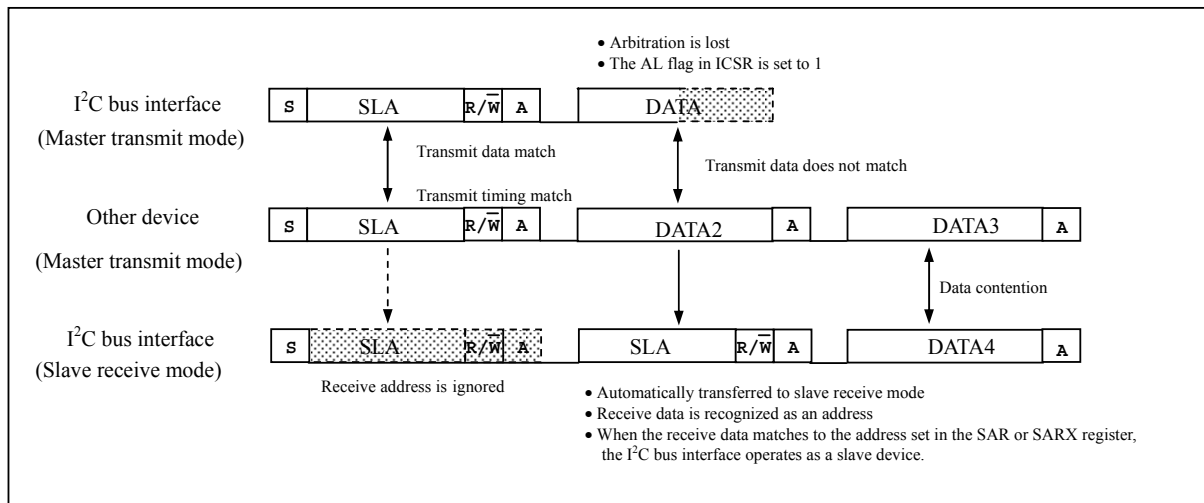
Figure 1 Diagram of Erroneous Operation when Arbitration is Lost

The I²C bus interface recognizes the data in transmit/receive frame as an address when arbitration is lost in master mode and a transition to slave receive mode is automatically carried out.

When arbitration is lost not in the first frame but in the second frame or subsequent frame, transmit/receive data that is not an address is compared with the value set in the SAR or SARX register as an address. If the receive data matches with the address in the SAR or SARX register, the I²C bus interface erroneously recognizes that the address call has occurred. (See figure 1.)

In multi-master mode, a bus conflict could happen. When the I²C bus interface is operated in master mode, check the state of the AL bit in the ICSR register every time after one frame of data has been transmitted or received.

When arbitration is lost during transmitting the second frame or subsequent frame, take avoidance measures.
