Customer Notification

IE-703239-G1-EM1™

In-Circuit-Emulator

Operating Precautions

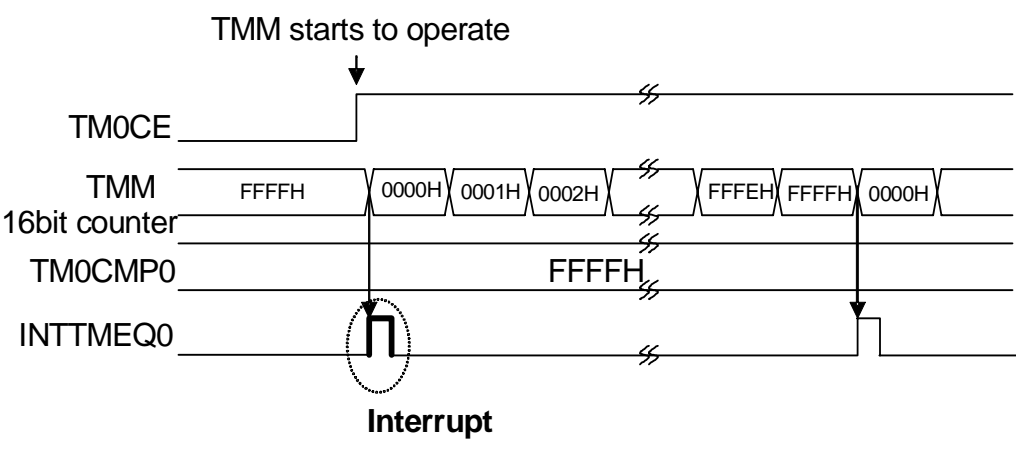
No. 18	Timer M compare interrupt (Technical limitation)
<p><u>Details</u></p> <p>An unexpected interrupt occurs after activation of timer M when the compare register TM0CMP0 contains the value 0xFFFF.</p>

<p><u>Workaround</u></p> <p>Do not set TM0CMP0 to 0xFFFF.</p>

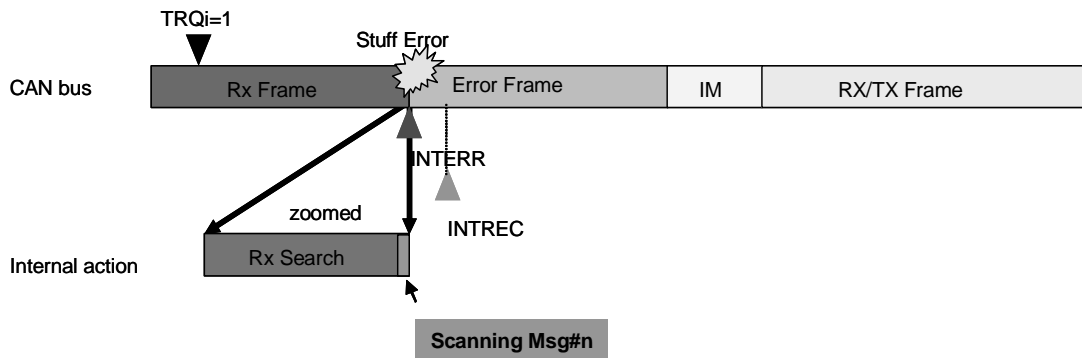
Figure 1: Behavior at pending TRQ

1. Behaviour at pending TRQ (TRQi = 1)

When the host processor has already submitted a transmit request (TRQ) for at least one buffer, the unexpected reception of the message will take place into the message buffer found by internal RX-search. This is the correct location to store the message i.e. the acceptance filter criteria are correctly fulfilled. However the data part will be updated with the contents of the shift register of the CAN protocol core. As this register is immediately stopped at detection of the bus error, the data provided to the message buffer can not be interpreted by the host processor.

As during a regular reception, the RX-interrupt (if enabled) is generated and the application processes the message object.

No. 28	aFCAN: Rx limitation (Technical limitation)
	<p><u>Workaround</u></p> <p>NEC will update the affected products. NEC does not recommend a S/W workaround as first choice as it is fairly complex. On the one hand it is based on the control of submitting transmission requests only when the bus is idle. On the other hand a less complex algorithm can be used which does not prevent the unexpected reception but detects it safely and discards the unexpected reception in the CAN S/W driver. Any of these algorithms require that message buffer #0 is not used or that a 'dummy' TRQ in an unused buffer is set. This prevents behaviors as described in 2.</p>

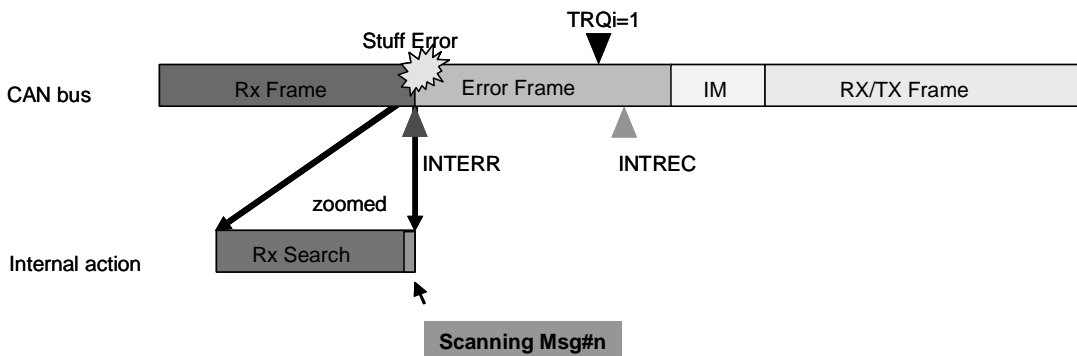
Figure 2: Behavior without pending TRQ

2. Behavior without pending TRQ (TRQi = 0)

In case the host processor has not submitted a transmit request (TRQ) for any buffer before the detection of the bus error but submits TRQ = 1 after that point in time (see figure below) before the re-transmission of the message interrupted by the stuff bit error started, the unexpected reception of the message will take place.

The unexpected storage of the message is issued in the particular message buffer that matches the acceptance filter criteria at the time where the bus error is detected (as described in 1.) or the message buffer #0 is overwritten independently of its configuration.
