RENESAS TECHNICAL UPDATE

Product Category	MPU/MCU		Document No.	TN-RA*-A0084B/E	Rev.	2.00
Title	Precaution regarding interrupt during successive bus access to peripherals sharing the same slave interfaces		Information Category	Technical Notification		
Applicable Product	RA6M1 Group, RA6M2 Group, RA6M3 Group, RA6T1 Group, RA4M1 Group, RA4W1 Group	Lot No.	Reference Document	Refer table at the end of this document		
		All

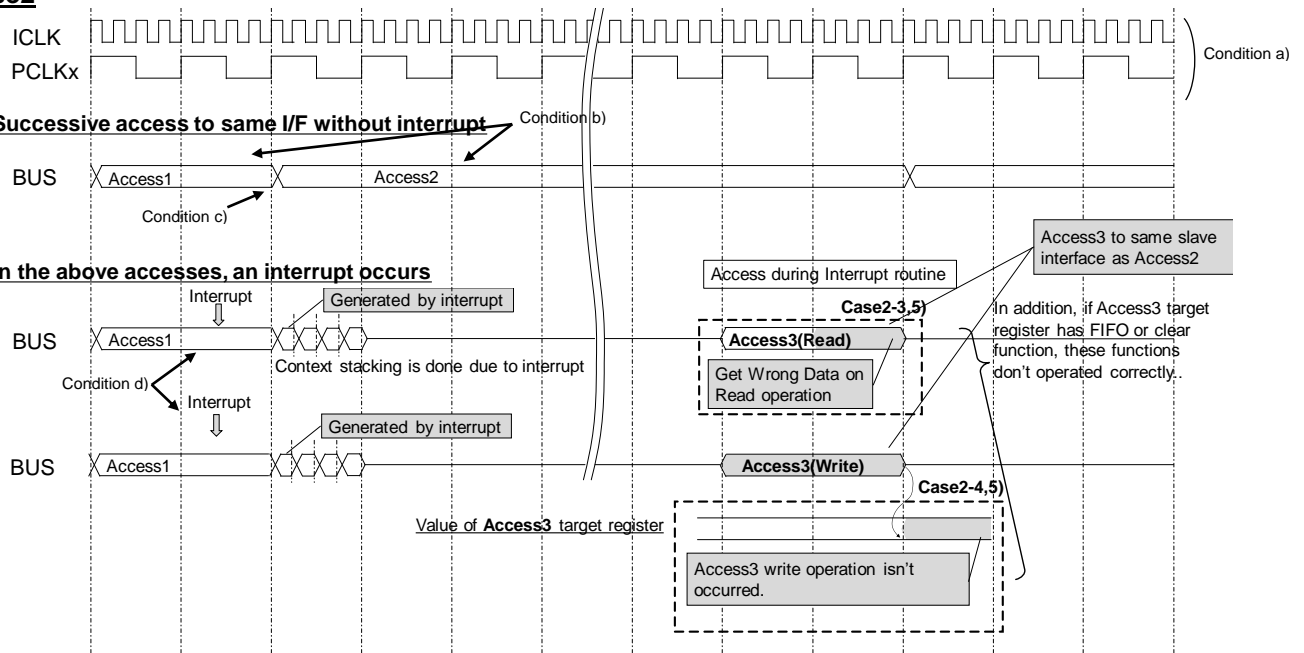
Case2 : A wrong access might occur in interrupt service routines when all issue conditions meet.

A register access to the same slave interface or external bus as Access2 in an interrupt service routine (referred to as Access3) causes an illegal operation

- 3) When Access3 is read operation, CPU might receive wrong data.
- 4) When Access3 is write operation, Access3 might not occurred in target register.
- 5) If Access3 target register has FIFO or flag bit clear function, these functions don't operated correctly.

- 1) In your system, set clock frequency as follows
 ICLK = PCLKx (x=A,B) (RA4M1, RA4W1)
 ICLK = PCLKx (x=A,B), ICLK=FCLK (RA6M1, RA6M2, RA6M3, RA6T1)
- 2) Identify in your code where successive Access1 and Access2 occurs relevant to the area where the unintended SW behavior was observed. Then insert DSB instruction between Access1 and Access2
- 3) Disable Interrupts during Access1 to Access2
