Microcontroller Technical Information

QB-78K0RKX3 In-Circuit Emulator for 78K0R/KE3, 78K0R/KF3, 78K0R/KG3, 78K0R/KH3, 78K0R/KJ3 Usage Restrictions	Document No.	ZBG-CD-08-0022	1/2								
	Date issued	June 5, 2008									
	Issued by	Development Tool Solution Group Multipurpose Microcomputer Systems Division Microcomputer Operations Unit NEC Electronics Corporation									
Related documents	QB-78K0RKX3 User's Manual: U17866EJ4V0UM00 QB-78K0RKX3 (Control Code: E, F, G, H, J, K, L, M) Operating Precautions: ZUD-CD-08-0072	Notification classification

Operating Precautions for QB-78K0RKX3

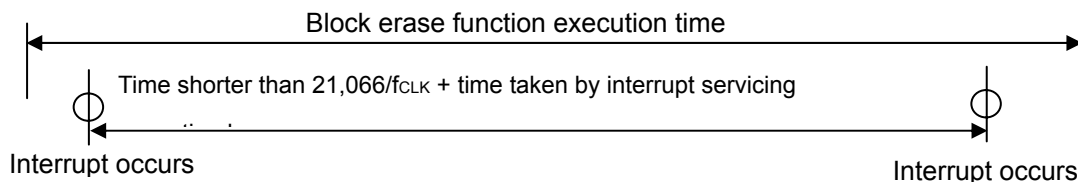
An erase error may occur if an interrupt occurs multiple times in an interval shorter than “ $21,066/f_{CLK} +$ time taken by interrupt servicing execution by user program” when the block erase function (`_FlashBlockErase`) is being executed during self-programming. The “time taken by interrupt servicing execution by user program” is the time from when execution branches to a vector reference address, interrupt servicing execution by user program, and until when execution returns to the block erase function (see figure below).

There is no workaround.

This issue has been corrected in products with control code K and later.

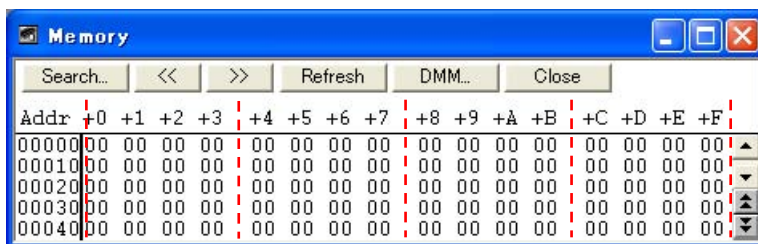
If there is an instruction to read the ROM area several instructions before an instruction for which a “break before execution” is set (up to nine instructions in case of an 8-bit instruction), the break may not occur, or the program may not operate correctly.

If the instruction subject to the break does not extend over a 4-byte boundary^{Note}, the instruction is not replaced and the break does not occur.

If the instruction subject to the break extends over a 4-byte boundary^{Note}, only the code immediately before the boundary is replaced. As a result, the instruction becomes invalid and may loop.

Note The 4-byte boundaries are portions shown as red dotted lines in the following figure.

There is no workaround.

This issue has been corrected in products with control code K and later.

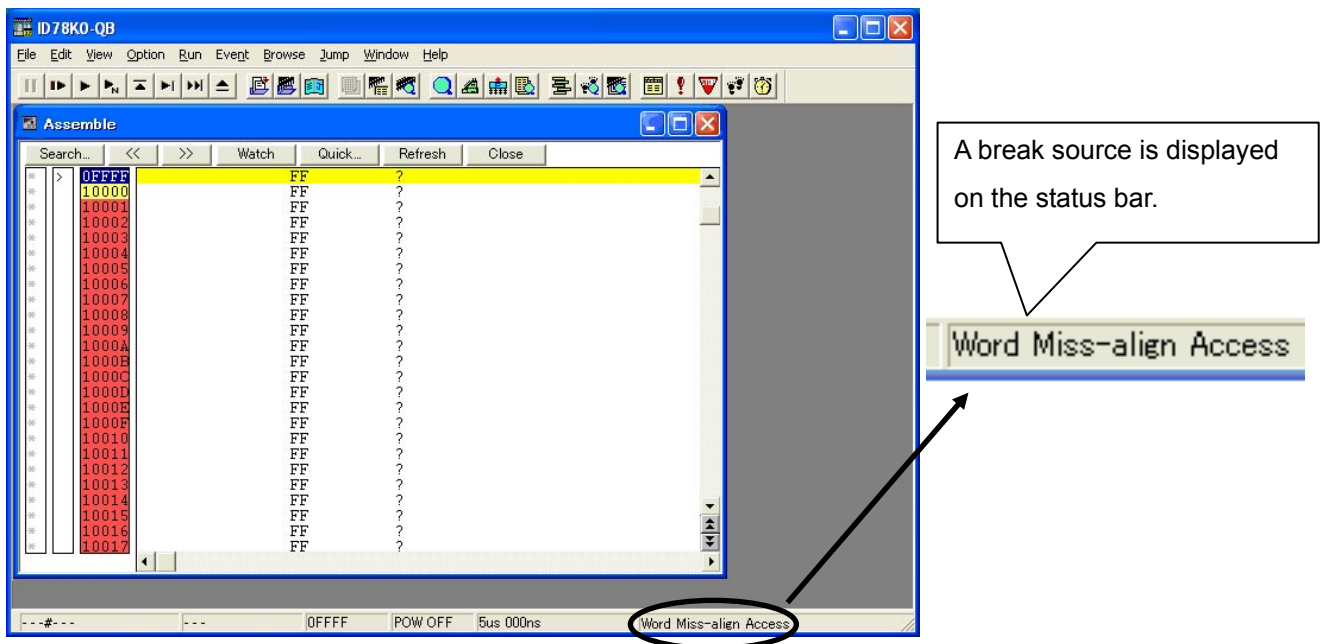
When a branch instruction is executed on RAM and if the branch destination is an odd address located in RAM, a fail-safe break due to a word misalign access occurs.

A break source can be checked in the status bar in the ID78K0R-QB, as shown below.

Clear the check box for the [Word Miss-align Access] in the Fail-Safe Break dialog box in the ID78K0R-QB.

This issue has been corrected in products with control code M and later.
