Microcomputer Technical Information

QB-V850EIA4 In-Circuit Emulator for V850E/IA3, V850E/IA4, V850ES/IK1 Usage Restrictions		Document No.	ZBG-CD-05-0081	1/3
		Date issued	October 28, 2005	
		Issued by	Development Tool Group Multipurpose Microcomputer Systems Division 4th Systems Operations Unit NEC Electronics Corporation	
Related documents	QB-V850EIA4 User's Manual: U17167E	Notification classification	√	Usage restriction
				Upgrade
				Document modification
				Other notification

QB-V850EIA4 In-Circuit Emulator for V850E/IA3, V850E/IA4, V850ES/IK1 Usage Restrictions

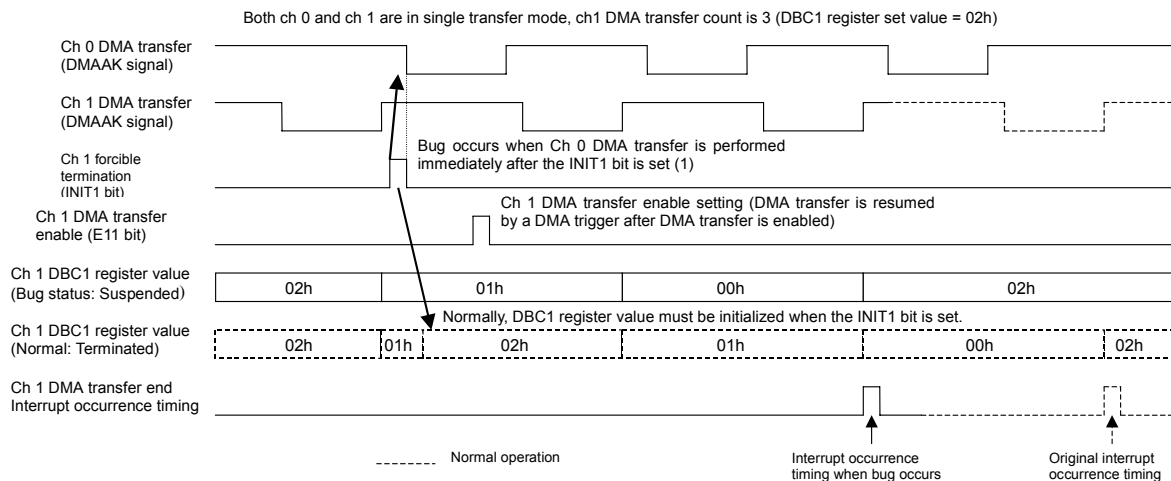
No. 3 Bug related to DMA transfer forcible termination

When terminating a DMA transfer by setting the INITn bit of the DCHCn register, the transfer may not be terminated, but just suspended, even though the INITn bit is set (1). As a result, when the DMA transfer of a channel that should have been terminated is resumed, the DMA transfer will terminate after an unexpected number of transfers are completed and a DMA transfer completion interrupt may occur (n = 0 to 3). This bug occurs if a DMA transfer is executed immediately after a forcible termination is set (by setting the INITn bit) (see the figure below).

This bug does not depend on the number of transfer channels, transfer type (2-cycle or flyby), transfer target (between memory and memory, memory and I/O; including internal resources), transfer mode (single, single-step, or block), or trigger (external request, interrupt from internal peripheral I/O, or software), and can occur with any combination of the above elements that can be set under the specifications. In addition, another channel may affect the occurrence of this bug.

This bug can be avoided by implementing one of the following procedures using the software.

(1) Stop all the transfers from DMA channels temporarily (n = 0 to 3)

(2) Repeat setting the INITn bit until the forcible DMA transfer termination is correctly performed (n = 0 to 3)

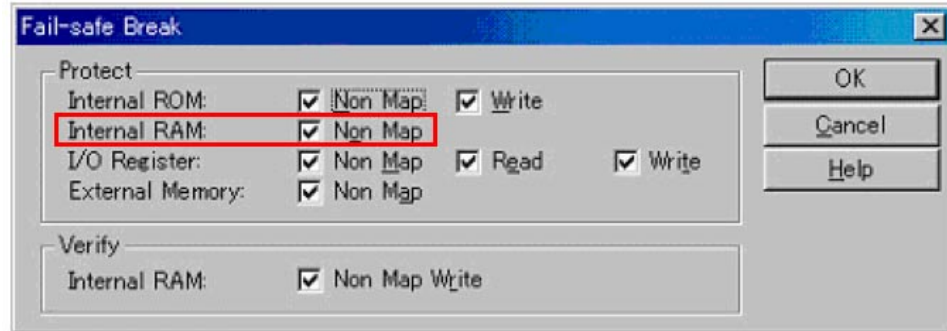
No. 5 Illegal break occurs during program execution in internal RAM (1)

An illegal break may occur when a peripheral I/O register is accessed during program execution in the internal RAM.

Cancel the fail-safe break setting for the internal RAM in the debugger.

Click the [Detail] button in the Fail-safe Break field in the Configuration window and clear the check box for “Internal RAM”.

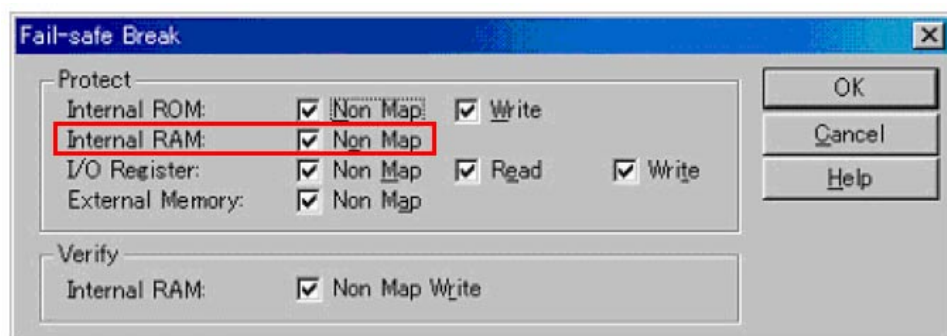
No. 12 Illegal break occurs during program execution in internal RAM (2)

A non-map break occurs if all of the following conditions are satisfied, even if the program itself is correct.

- Cancel the fail-safe break setting for the internal RAM in the debugger.

Click the [Detail] button in the Fail-safe Break field in the Configuration window and clear the check in the check box for "Internal RAM".
