R7FOC003, R7FOC004, R7FOC019
Precaution of using High accuracy 1 Hz output

MCCY-ZB-15-0007-1

Jun. / 30 / 2015

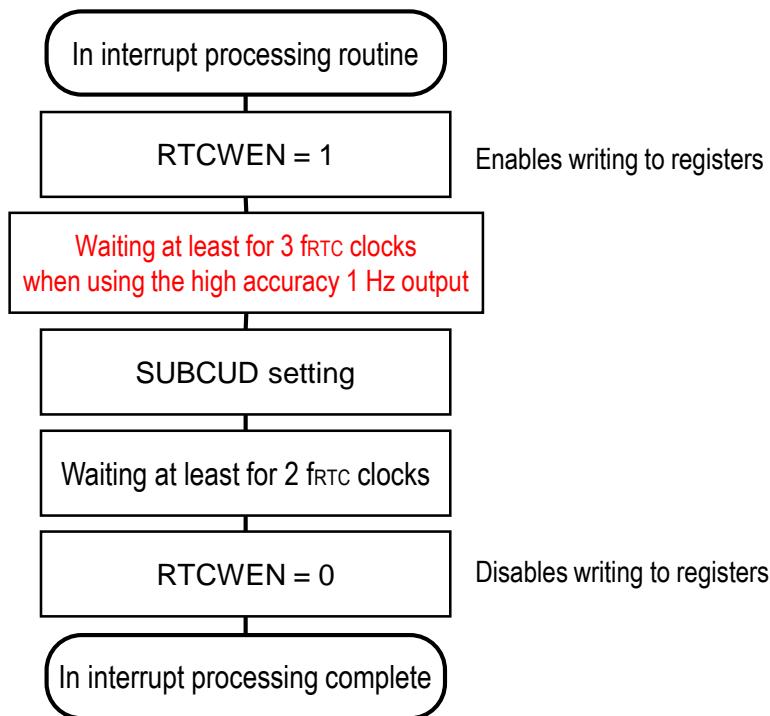
RTC correction may not be successful if there is a conflict between the SUBCUD register rewrite and correction timing. In order to prevent conflict between the correction timing and rewrite of the SUBCUD register, be sure to complete rewrite of the SUBCUD register before the next correction timing occurs (within approx. 0.5 seconds), which is calculated starting from the correction timing interrupt (INTRTIT) or periodic interrupt (INTRTC) that is synchronized with the correction timing.

When using the high accuracy 1 Hz output and rewriting the SUBCUD register, rewrite the SUBCUD register after waiting at least for 3 f_{RTC} clocks.

(1) Set the clock error correction register (SUBCUD) after setting RTCWEN to 1 first. Then set RTCWEN to 0 after completion of the register setting.

In order to prevent write error to the clock register, write privilege with (2) FMCE is recommended for rewrite of the SUBCUD register.

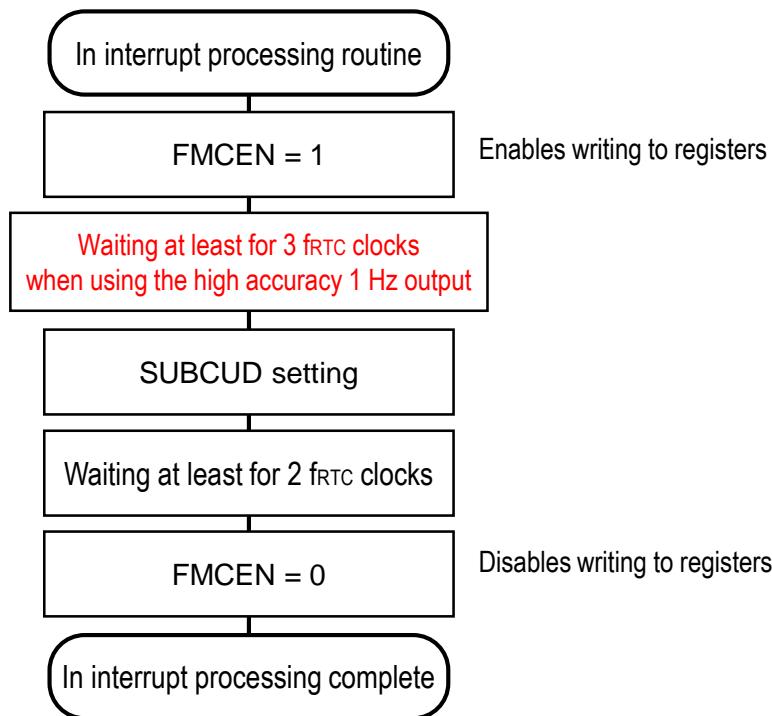
(2) Set the clock error correction register (SUBCUD) after setting FMCEN to 1 first. Then set FMCEN to 0 after completion of the register setting.

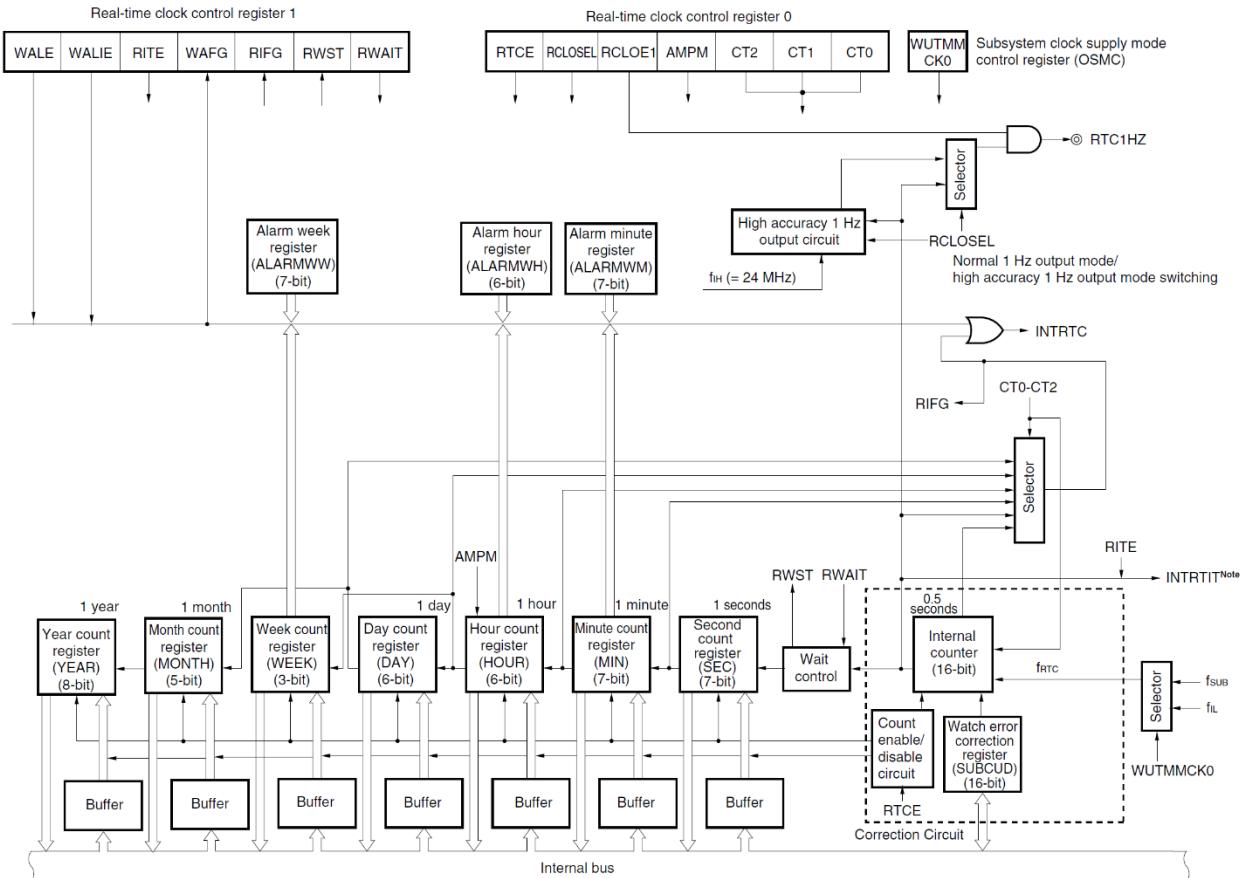
Figure 7-1. Real-time Clock 2 Diagram

1-2. Root correction of the INTRIT in the Real-time Clock 2 Diagram

Note An interrupt that indicates the timing to get the correction value from the clock error correction register (SUBCUD). The fetch timing is 1 second (f_{SUB} base) interval.
