RENESAS TECHNICAL UPDATE

Product Category	MPU/MCU		Document No.	TN-RL*-A081A/E	Rev.	1.00
Title	Restriction on MCU Activation when Power is Supplied		Information Category	Technical Notification		
Applicable Product	RL78/L1A Group	Lot No.	Reference Document	RL78/L1A User's Manual: Hardware Rev. 1.00 R01UH0636EJ0100 (Aug. 2016)		
		All lots

1. Restriction on MCU Activation when Power is Supplied to V_{DD} and AV_{DD}

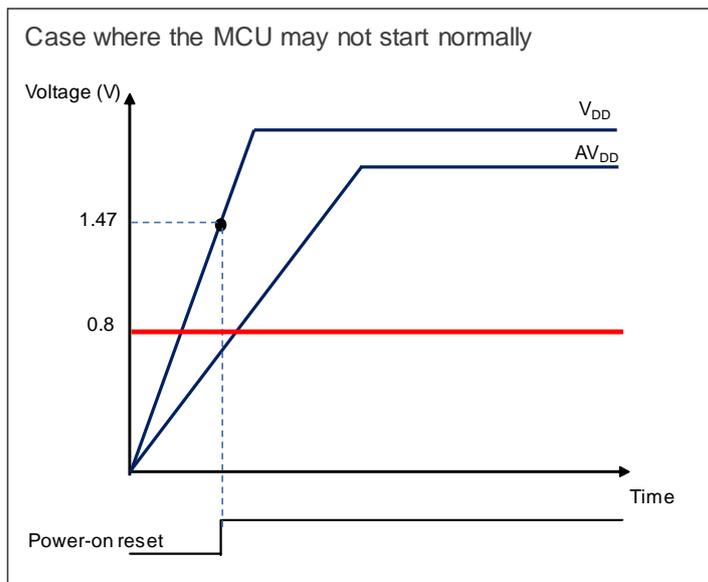
The MCU may not start normally when AV_{DD} is below 0.8 V on release from the internal reset state caused by a power-on reset (POR) in cases where the voltages for V_{DD} and AV_{DD} differ and AV_{DD} rises more slowly than V_{DD} when power is initially supplied.

Note: Voltage at the time of release from the POR

$$V_{POR} = 1.51 \text{ V} \pm 0.04 \text{ V}$$

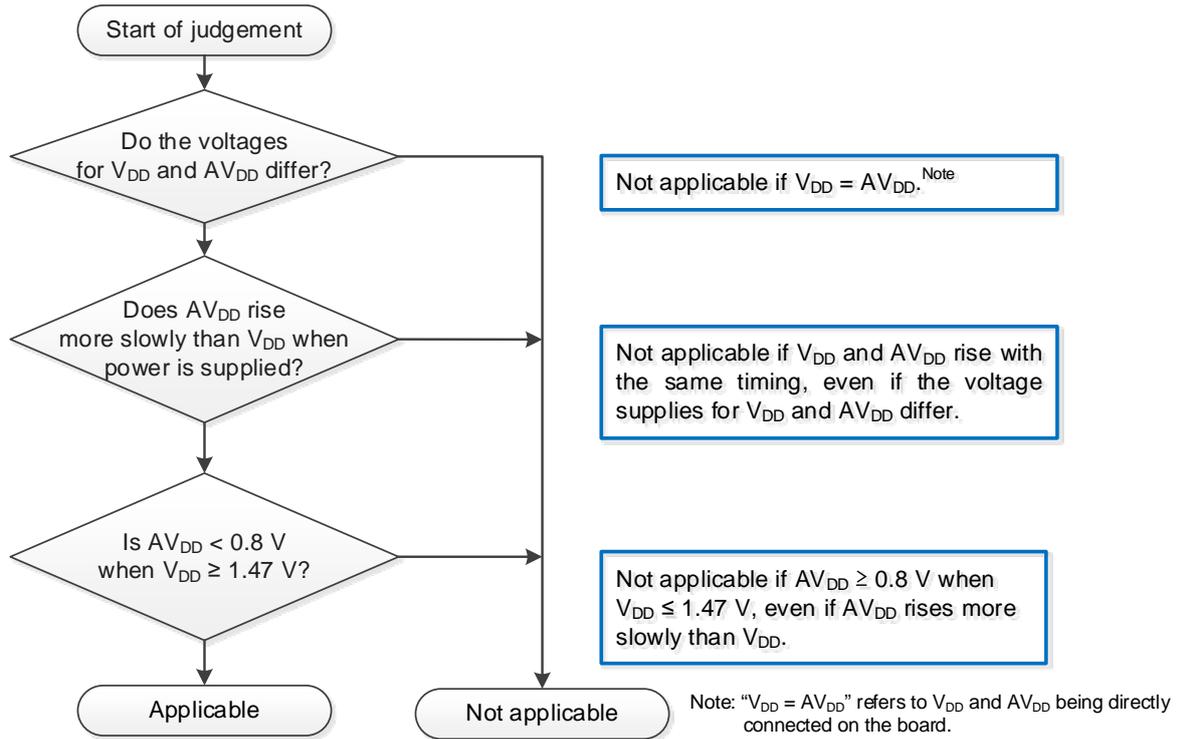
1.2 Flow for judging whether or not the restriction applies

Cases where the restriction is not applicable:

The MCU starts normally on release from the power-on reset state.

Cases where the restriction is applicable:

The MCU may not start normally on release from the power-on reset state.

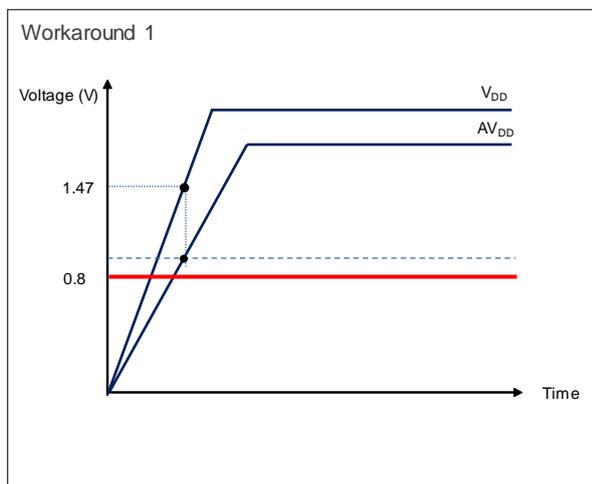
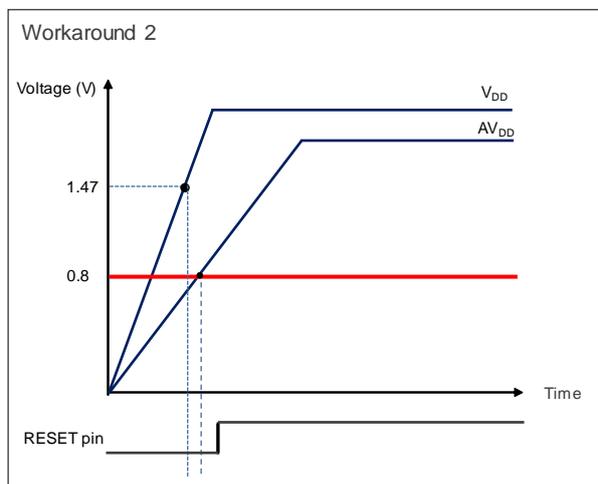
In cases where the voltage supplies for V_{DD} and AV_{DD} differ and AV_{DD} rises more slowly than V_{DD} when power is initially supplied, use either of the workarounds below to avoid incorrect behavior of the MCU.

- Apply measures on the board so that AV_{DD} reaches at least 0.8 V before V_{DD} reaches or exceeds 1.47 V. (workaround 1)
- Hold the pin reset until V_{DD} reaches or exceeds 1.47 V and AV_{DD} reaches or exceeds 0.8 V. (workaround 2)
