# HITACHI SEMICONDUCTOR TECHNICAL UPDATE

| Classification of Production | MPU | | No | TN-SH7-412A/E | Rev | 1 |
| THEME | SH7615/SH7616 limitation of DACKn output timing. | | Classification of Information | 1. Spec change<br>2. Supplement of Documents<br>③ Limitation of Use<br>4. Change of Mask<br>5. Change of Production Line | | |
| PRODUCT NAME | HD6417615ARF<br>HD6417616RF | Lot No. | Reference Documents | SH7615 Hardware Manual<br>ADE-602-198 Rev.1.0<br>SH7616 Hardware Manual<br>ADE-602-243 Rev.1.0 | Effective Date | |

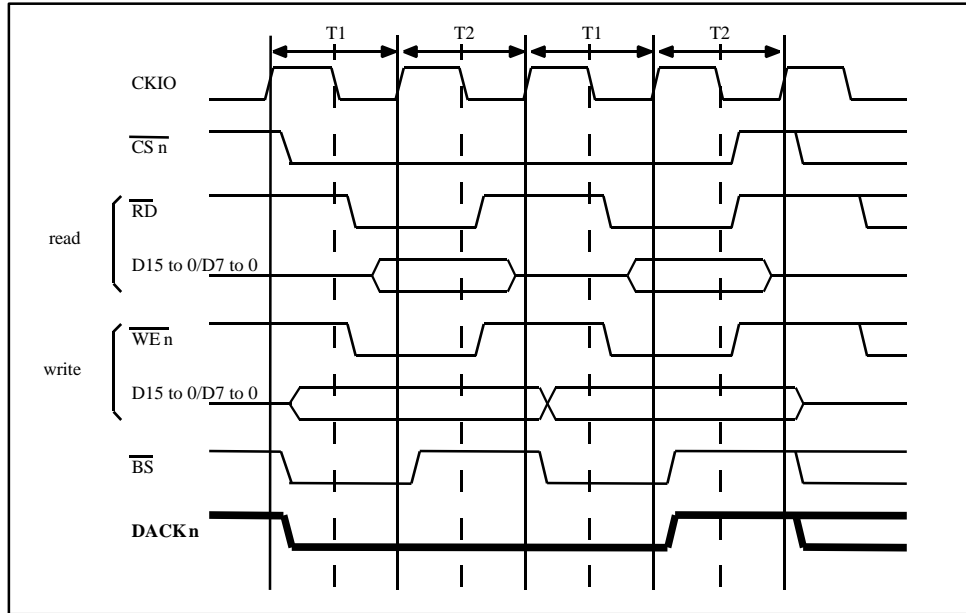
When all following conditions are met, SH7615/SH7616 DACKn(n=0,1) outputs with "Error timing".

- (1) I<sub>0</sub>:E<sub>0</sub>=1:1.
- (2) DMA transfer to Ordinary space or Burst ROM.
- (3) 16-byte/Long word DMA transfer on 16-bit bus width or 16-byte/Long word/Word DMA transfer on 8-bit bus width.

| | 16-byte unit | Long word unit | Word unit |
|---|---|---|---|
| 16-bit bus width | Error timing(1) x 4 | Error timing (1) x 1 | — |
| 8-bit bus width | Error timing(2) x 4 | Error timing (2) x 1 | Error timing(1) x 1 |

- (1) Use frequency mode except Iø:Eø=1:1.
- (2) Use 32-bit bus width.
- (3) When the bus width is 16 bits, set DMA transfer size per Word unit or Byte unit.
- (4) When the bus width is 8 bits, set DMA transfer size per Byte unit.
