SLG46625-A Errata Note

This document contains the known errata for SLG46625-A and the recommended workarounds.

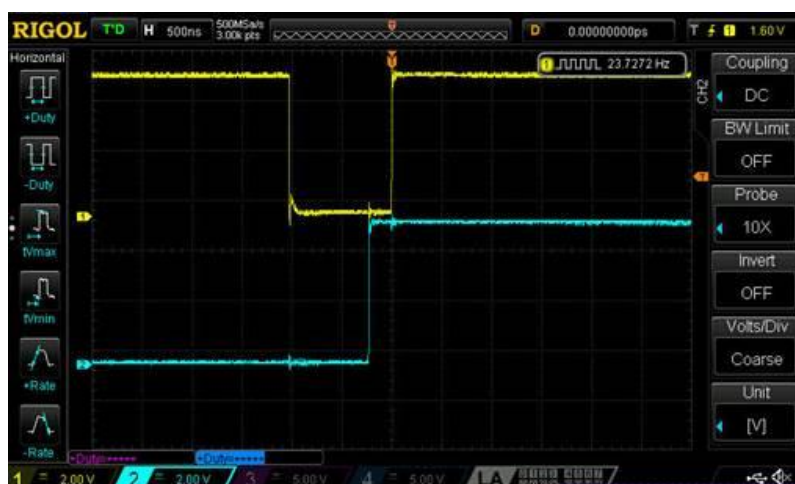
Figure 1. ACMP Output Glitch

The output of the ACMP incorrectly goes low even when IN+ is greater than IN- if the RING OSC is active when the WS signal rises.

Channel 1 – ACMP out

Channel 2 – WS_OUT

Avoid using the RING OSC with the WS Controller or add a filtering block on the ACMP output to filter out the glitch.

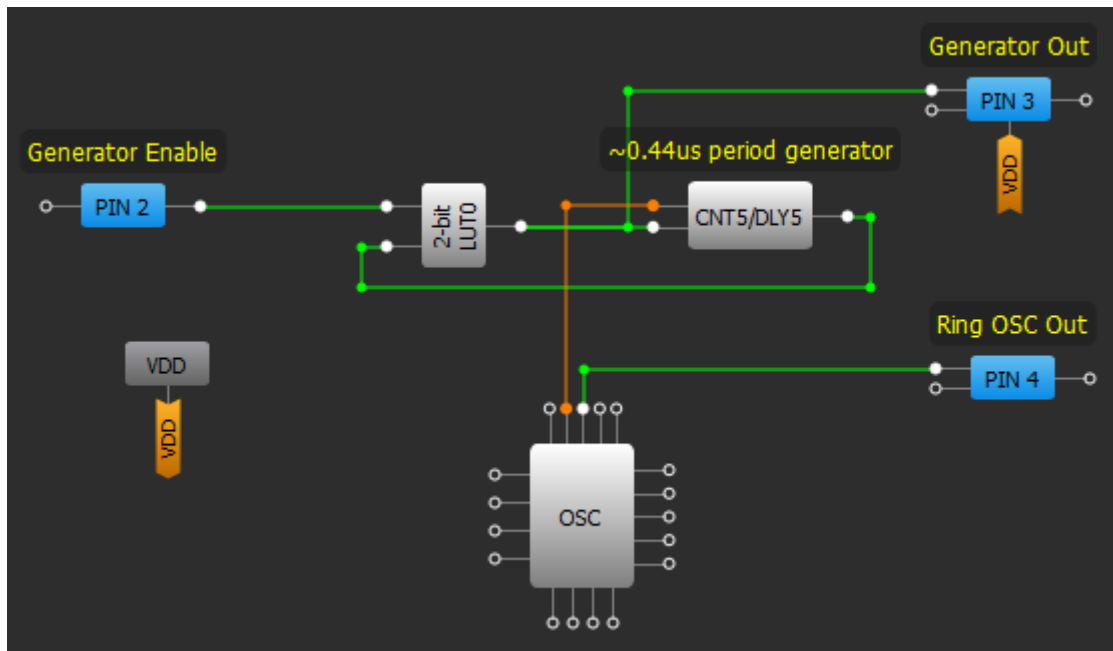
Figure 2. Ring OSC Test Design

The Ring OSC has a longer settling time when configured as Auto Power On in the designs that have very short Ring OSC disable time. An example of this issue is shown in the following configuration:

Set Ring OSC power mode to “Force Power On” or Set Turn on by register option in BG (Band Gap) block as “Enable”.

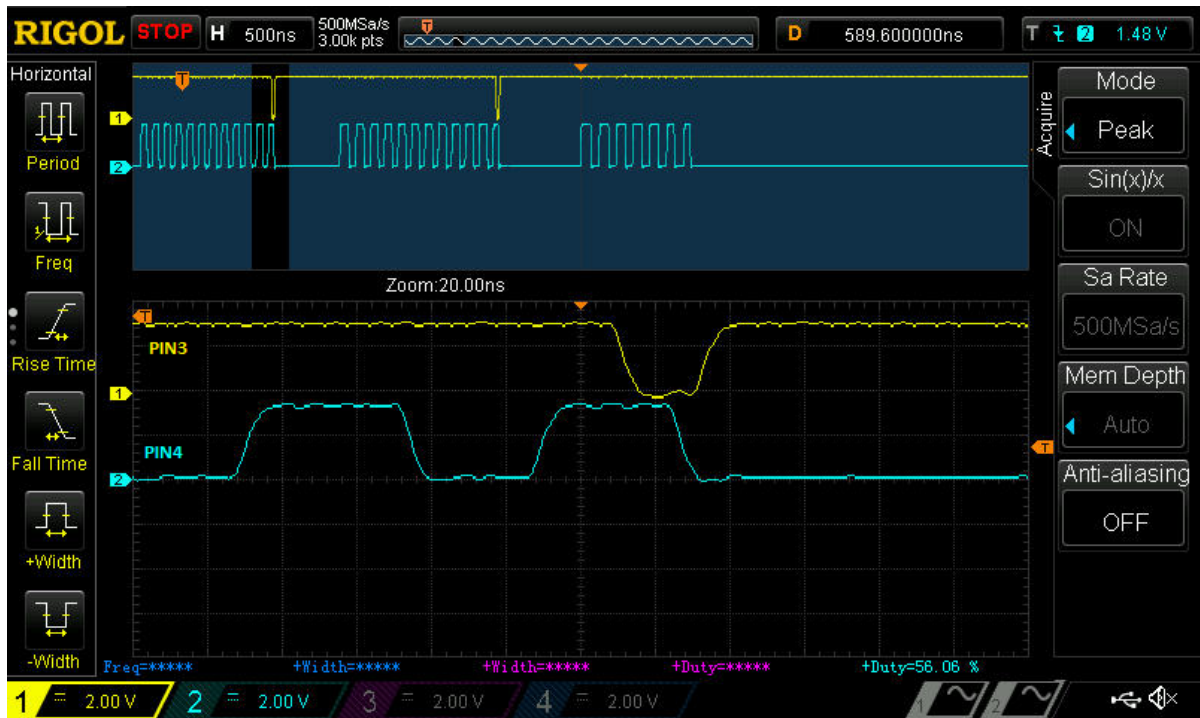
Figure 4. Ring OSC Output

The configuration shown above generates a periodical signal with a frequency defined by the Delay cell and started by a high signal on PIN2. The issue becomes apparent in a longer settling time when the scheme generates short pulses (Delay is configured as a rising edge delay only). See the waveform in [Figure 4](#).

Channel 1 – 2-bit LUT0 output

Channel 2 – Ring OSC output

Such behavior will lead to substantial error in period calculations if the delay time is relatively small.

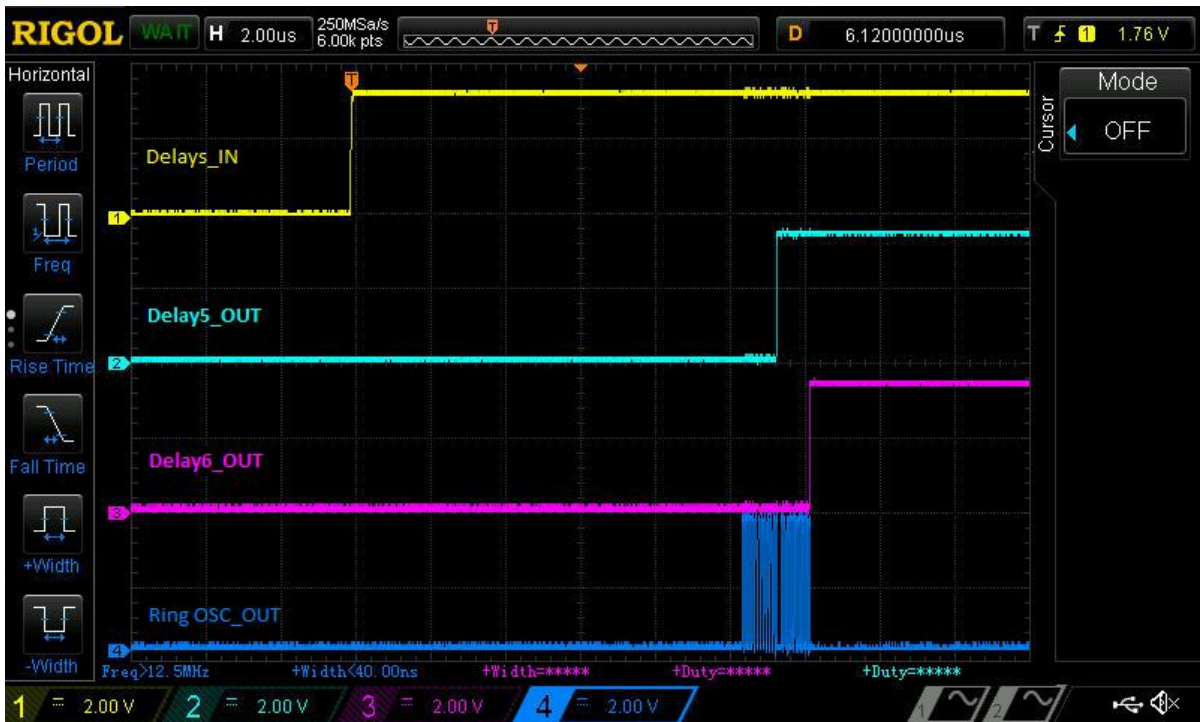
Figure 5. Ring OSC with DLY5, DLY6 Test Design

A similar situation can occur while using two connected delays (all edge detect types except for a pair “Rising edge DLY – Falling edge DLY”).

In [Figure 5](#), Delay5 and Delay6 are configured in the same way. However, Delay5 time is 11.4 us instead of expected 0.4 us (Delay5 time).

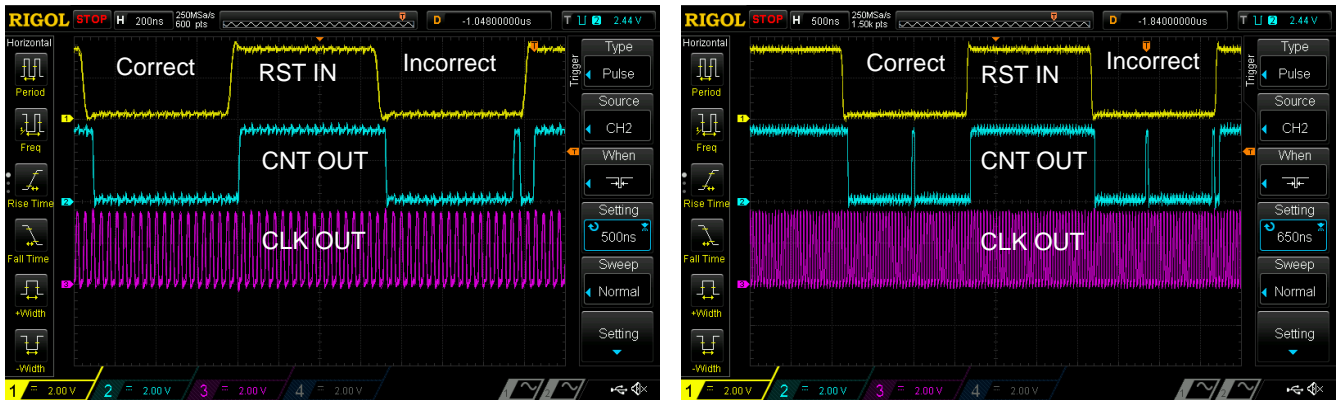
Figure 8. CNT Incorrect Operation

If the Counter Reset occurs at a time very close to a rising edge of the clock signal during clock signal generation (for example OSC operation), there is a possibility that the Counter Data of the Counter is reset incorrectly and the counter end signal (HIGH pulse) may appear faster than expected. This phenomena appears more frequently the higher the clock frequency is.

Synchronize RESET input of the Counter with its CLK using 2 DFF cells as shown in Figure 9.

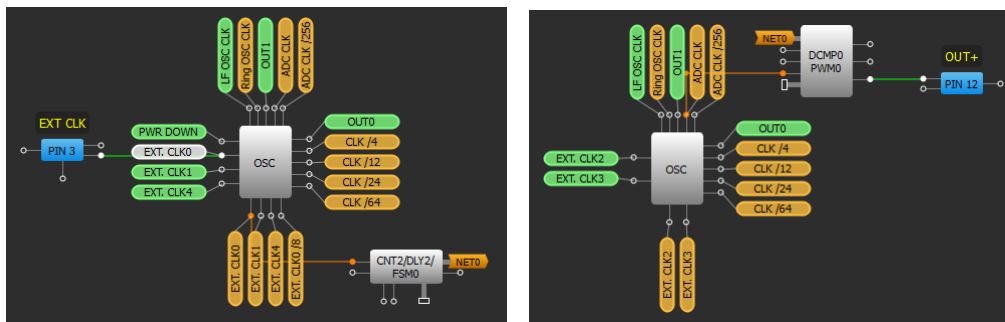
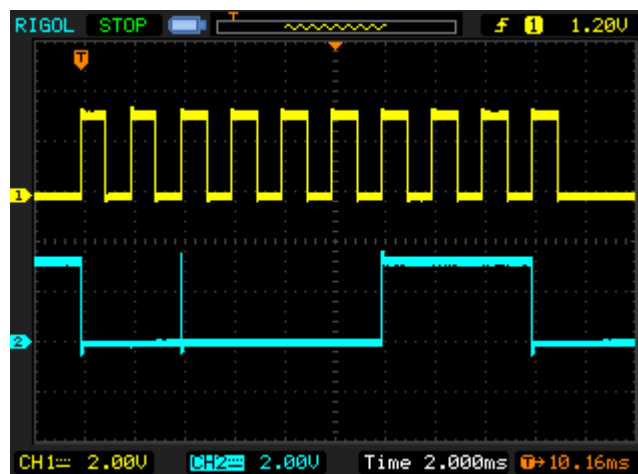
Figure 11. DCMP Glitch

DCMP's OUT+ output may have a glitch when the input data is changed. This issue appears more frequently the higher DCMP clock is.

For example, DCMP IN+ sources from FSM0 and IN- from Register0. DCMP is clocked from the Ring OSC.

Synchronize the data source clock with the DCMP clock source using 2 DFF cells as shown in [Figure 12](#).
