RENESAS TECHNICAL UPDATE

Product Category	MPU&MCU		Document No.	TN-SH7-A622A/E	Rev.	1.00
Title	Underflow will occur when SSI is disabled during slave transmission		Information Category	Technical notification		
Applicable Product	R5S77640P300BG R5S77640D300BG R5S77640N300BG R5S77641P300BG R5S77641D300BG R5S77641N300BG	Lot No.	Reference Document	SH7764 Hardware Manual (REJ09B0360-0100)		
		All lots

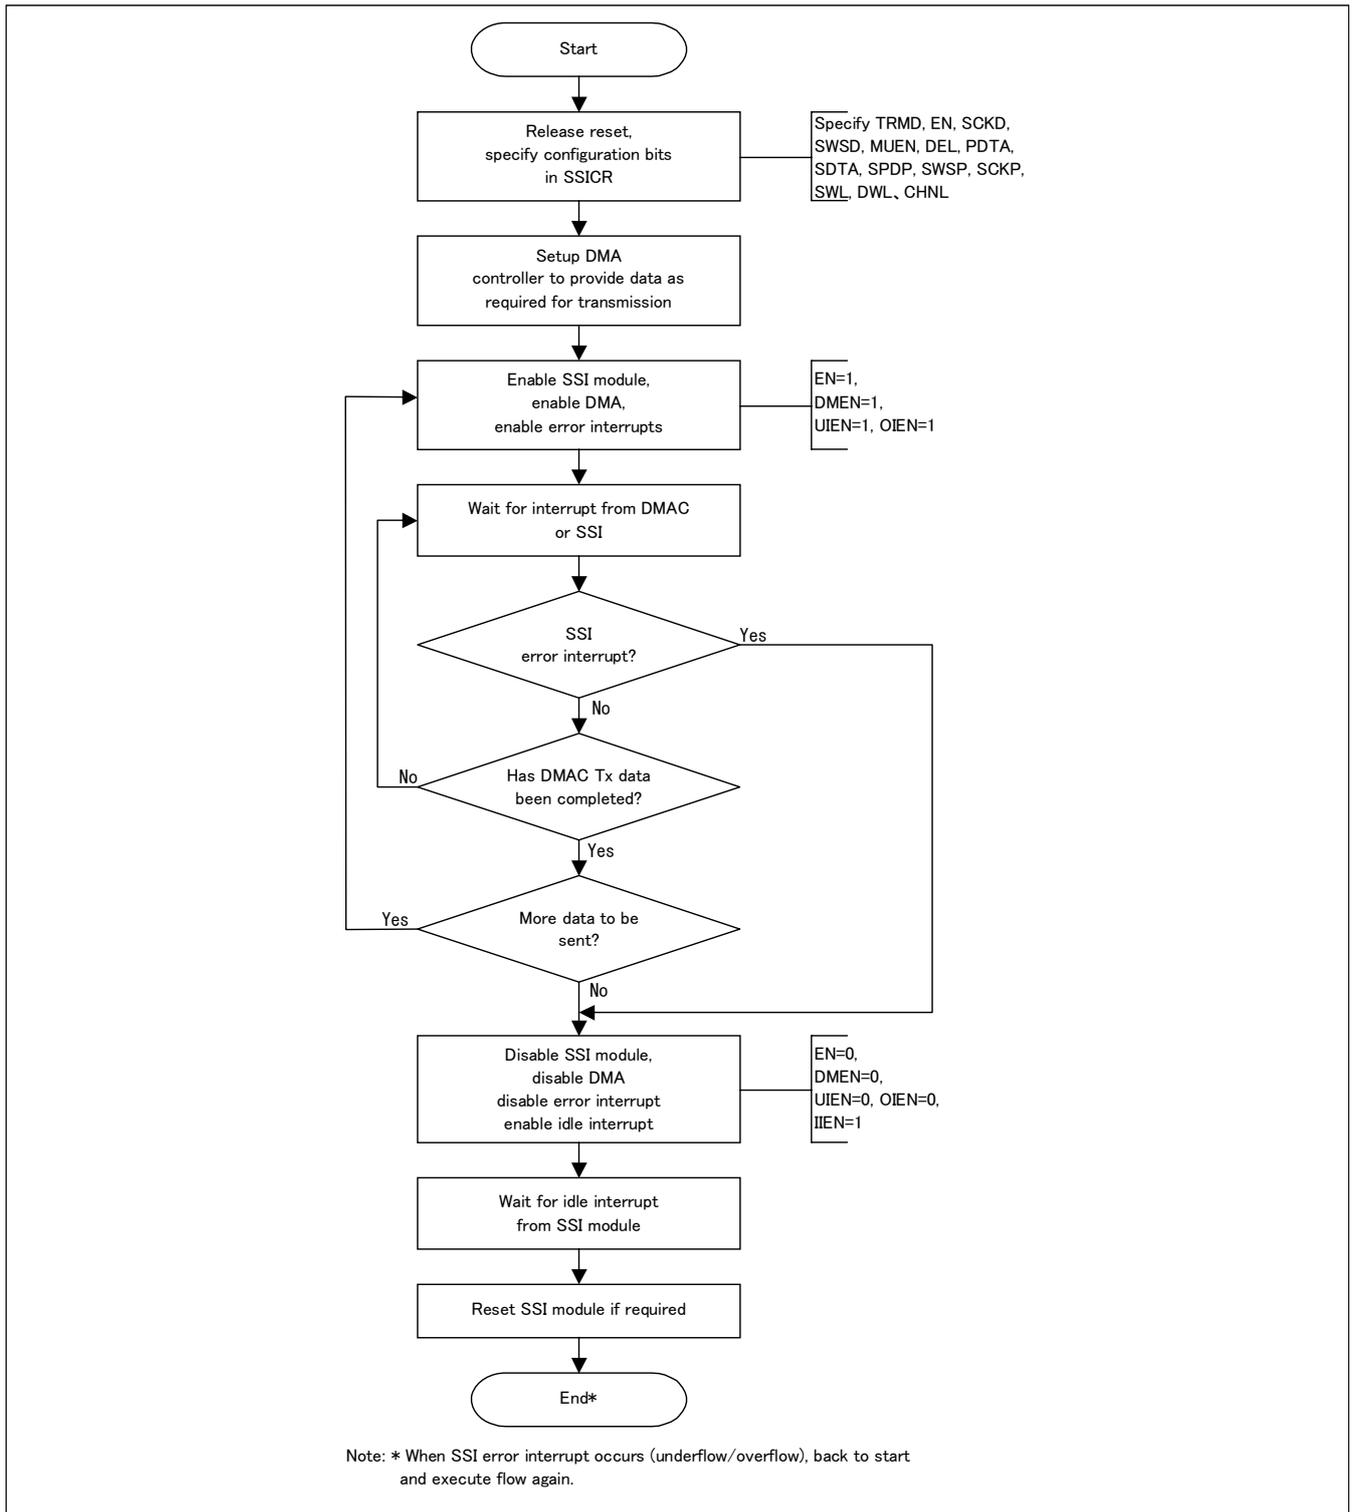
Figure 18.19 Transmission Using SSI_DMAC0 and SSI_DMAC1 (Original programming flowchart)

When SSI is disabled by clearing SSICR:EN bit during slave transmission using SSI_DMAC, underflow will occur in next slave transmission.

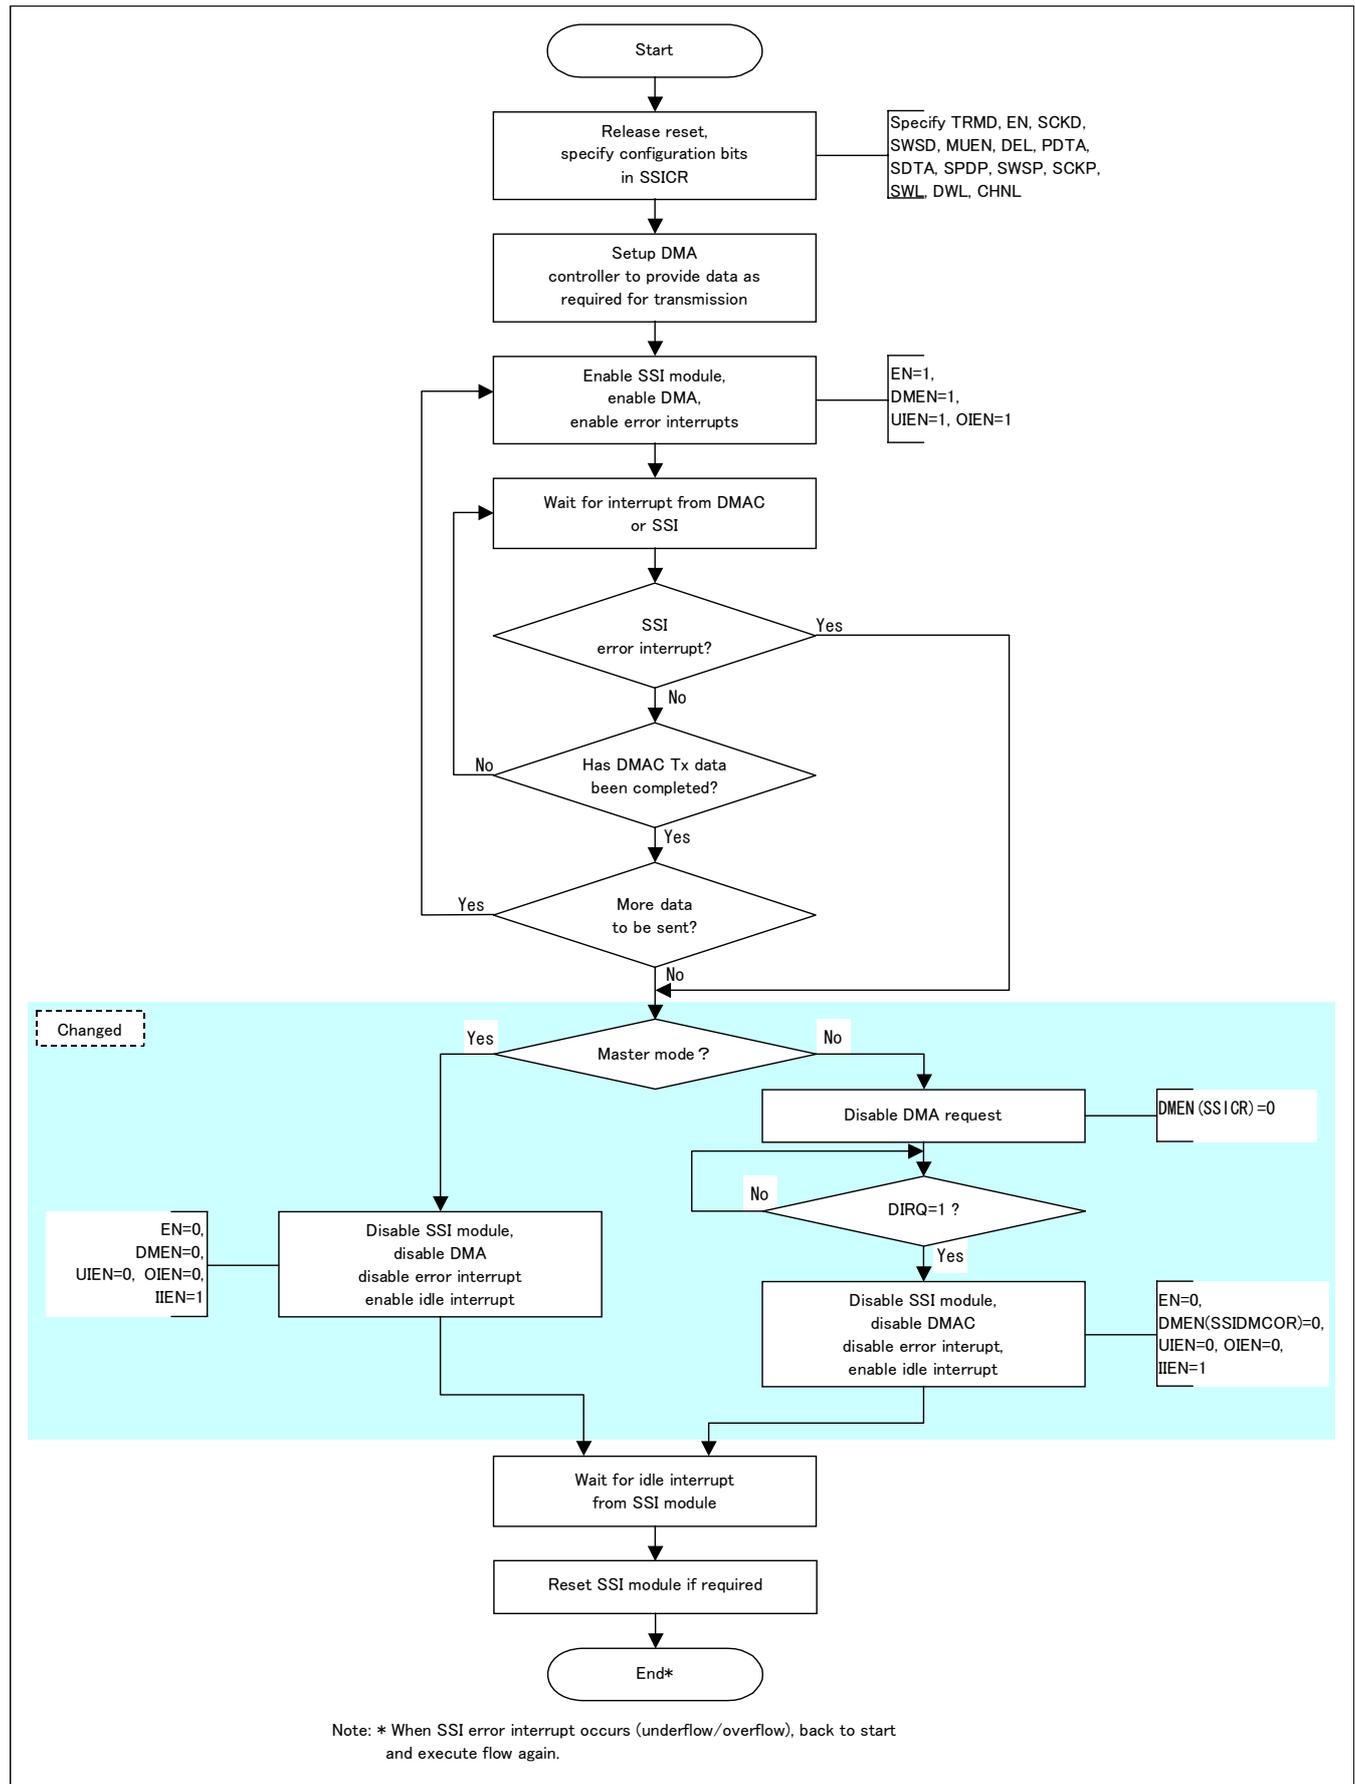
Figure 18.19 Transmission Using SSI_DMAC0 and SSI_DMAC1 (Corrected programming flowchart)

In order to prevent this problem, figure 18.19 "Transmission Using SSI_DMAC0 and SSI_DMAC1" (Page 692) in the hardware manual is corrected. Please refer to next two pages.

To stop ongoing slave transmission using SSI_DMAC, disable DMA request first by clearing SSICR:DMEN bit and wait until transmission buffer gets empty (SSISR:DIRQ=1), then disable SSI by clearing SSICR:EN bit and wait until idle mode status flag becomes 1 (SSISR:IDST=1).
