Microcomputer Technical Information

Document No.	SBG-DT-03-0194-E 1/2
	Date issued	July 18, 2003
μPD789467 Subseries	Issued by	Microcomputer Group
		2nd Solutions Division
Usage Restrictions		Solutions Operations Unit
		NEC Electronics Corporation
Related documents	Notification	√ Usage restriction
μPD789467 Subseries Preliminary User's Manual:	classification	Upgrade
U15552EJ1V0UD00		√ Document modification
		Other notification

μ PD789467 Subseries Usage Restrictions

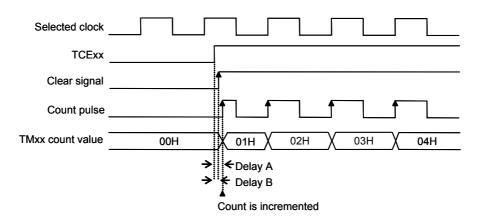
Case when an error of up to 1.5 clocks is generated

When the 8-bit timer/event counter is used, an error of up to 1.5 clocks is generated after the timer has been started until a match signal is generated. This is because a rising edge is detected when the timer is started while the selected clock is high, which results in the count value getting incremented.

If a count pulse is delayed for the clear signal ("delay A > delay B") as the result of setting the count operation flag (TCExx) while the selected clock is high, the TMxx count value is incremented. An error of up to 1.5 clocks is generated.
