CASE STUDY

How System Level Noise in Digital Interfaces can Lead to Spurious Errors in Serial Flash Memory

Paul Hill, Renesas Electronics Corporation

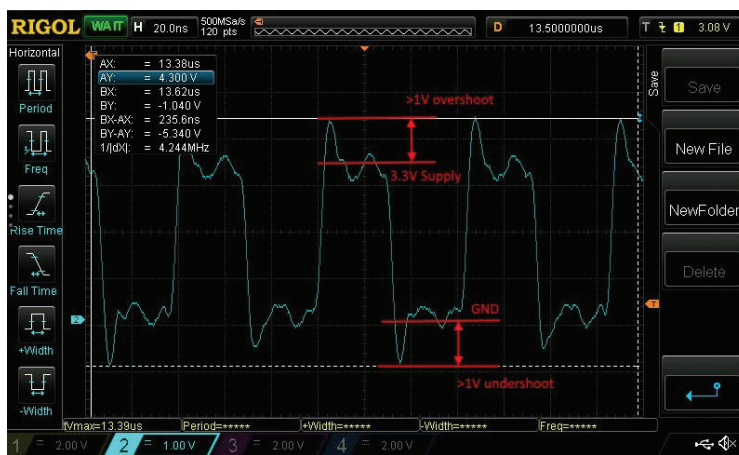
The data in Figure 2 shows the effects of excessive overshoot and undershoot on the serial interface. Figure 3 below shows a representation of what this overshoot would look like in a real application.

Although this fault appeared as a memory failure, the root cause was not with the flash devices. This was discovered by Renesas engineers by probing the SPI signals and identifying the system noise present. While the noise could be partly attributed to an impedance mismatch present on the PCB track between the MCU and flash memory, it wasn't the full story. The source of the noise was actually the MCU interface, which defaults to a high drive level at power-up. The excessive drive was enough to cause overshoot and undershoot on the SPI lines, which in some cases can be misinterpreted as signal transitions, leading to read or write errors. However, in this instance it was found that the overshoot held sufficient energy to disrupt the flash charge pump, which was in turn causing the errors.

Figure 3: This trace image clearly shows the overshoot and undershoot present on the SPI lines was resulting in a peak-to-peak voltage of 5.65V, which exceeds the absolute maximum value documented in the flash memory specification.

In the customer's design, the microcontroller being used provided a configurable drive current for its I/O, which defaults to HIGH at start-up. As the application code did not modify this level during initialization it remained high in normal operation. The impact of this may not be apparent for other devices on the SPI bus, as digital interfaces are typically designed to be robust. The sensitive nature of flash memory, the need to operate at much higher frequencies, and in particular, the operation of the charge pump, made the memory susceptible to overshoot/undershoot. This led to erroneous operation that was initially misinterpreted as a fault in the flash memory device.

Reducing the drive current, through firmware, reduced the overshoot and undershoot to effectively zero (Figure 4), and in turn resulted in error-free operation of the flash memory.

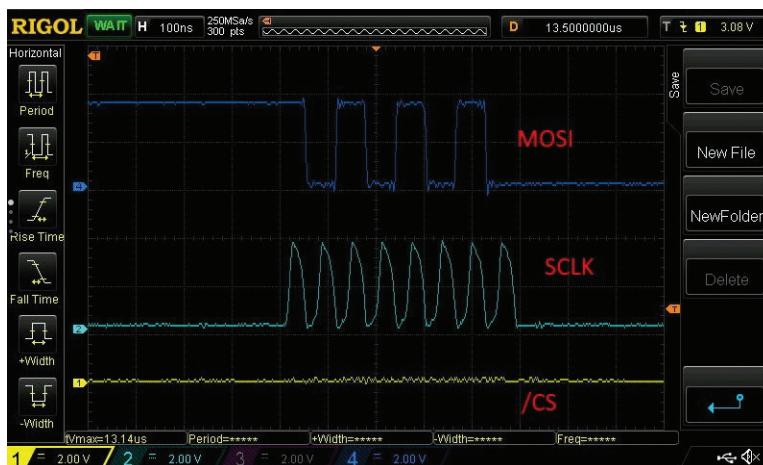
Figure 4: With no overshoot apparent, the serial flash memory's charge pump was able to operate correctly and provide reliable functionality
