R20TS0161EJ0101

[Notes]

CS+ Code Generator for RX,

e² studio Code Generator Plug-in,

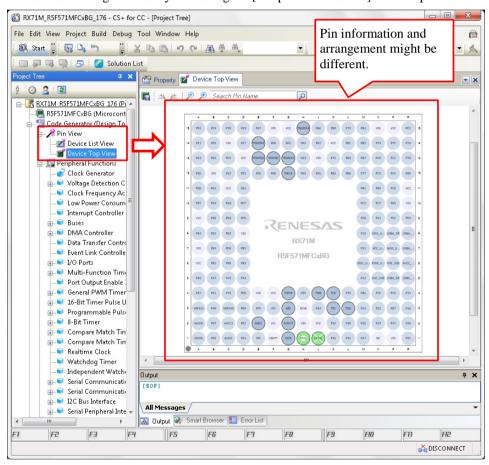
Data to be displayed in [Device Top View] differs from the actual pin of the MCU because display and output data in [Device List View] of [Code Generator (Design Tool)] are incorrect.

Note that codes generated by the settings in [Peripheral Functions] have no problem.

There is no way to prevent this problem.
