# **EWRL78 V2.xx/V3.xx/V4.xx/V5.xx**

**Embedded Workbench® for RL78 V2.xx/V3.xx/  
V4.xx/V5.xx**

**Operating Precautions**

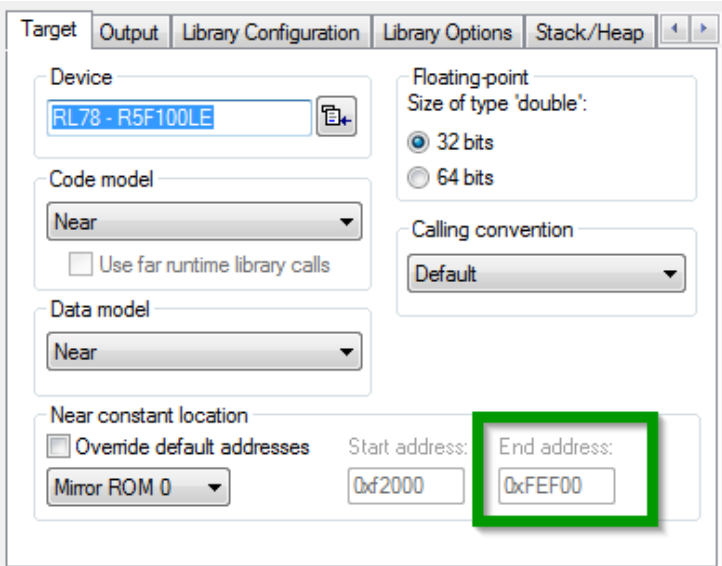
| No. A3 | <b>Wrong mirror end address</b> |

| <p><u>IAR Reference</u> EWRL78-541</p> <p><u>Details</u><br/>The mirror area end address displayed in the project settings dialog is set to the real end-address plus one instead of the just the end-address. This does not affect the linked code which uses correct values.</p> <p>The screenshot shows the 'Near constant location' section of the project settings dialog. The 'End address' field is highlighted with a green box and contains the value 0xFEFE00. The 'Start address' field contains 0xf2000. The 'Near constant location' dropdown is set to 'Mirror ROM 0'.</p> | |

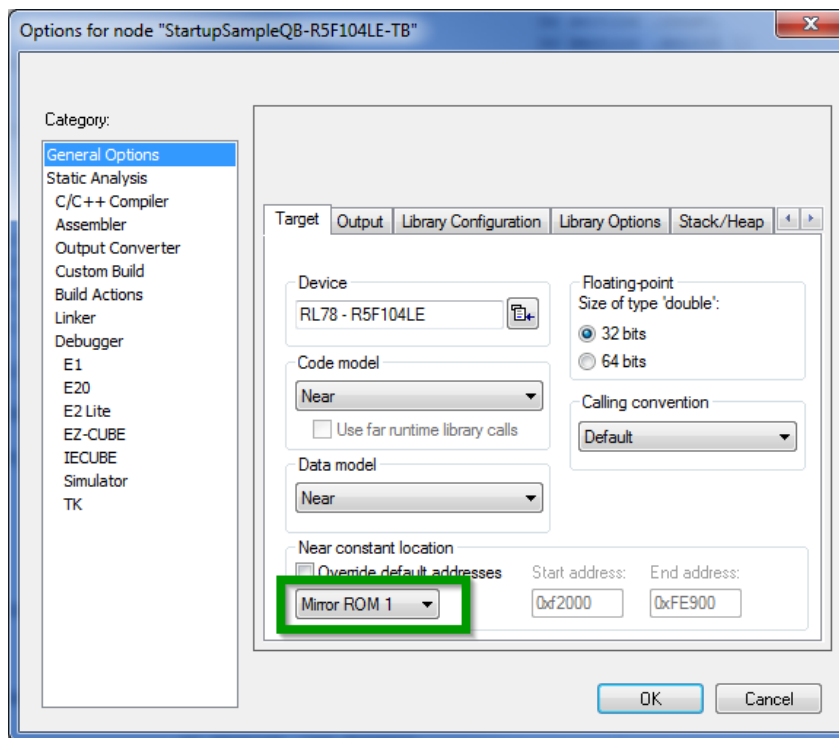
No. A6

The symbol `_NEAR_CONST_LOCATION_SIZE` will be wrong calculated if Mirror ROM 1 is selected as shown below:

Replace `_NEAR_CONST_LOCATION_SIZE` in the linker file at the following two places with the correct size.

The define `_NEAR_CONST_LOCATION_SIZE` shall be replaced within the linker file as follows:

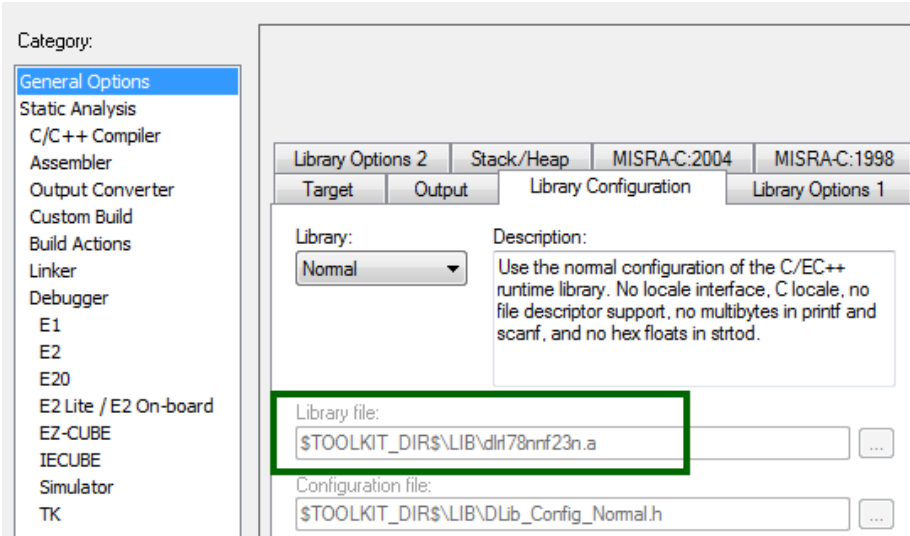
| No. A9 | <p><b>Library Configuration tab under General Options displays the old style of library names</b></p> |

| <p><u>IAR Reference</u> EWRL78-763</p> <p><u>Details</u><br/>The Library Configuration tab under General Options displays the old style of library names instead of the new one used by V4.10</p> <p>Example:<br/>The library file in the following example should be dlrl78nnf23n.a instead of dlrl78nnf23n.a:</p> <p><u>Workaround</u><br/>Please ignore the displayed library file. Internally the correct file will be used.</p> | |

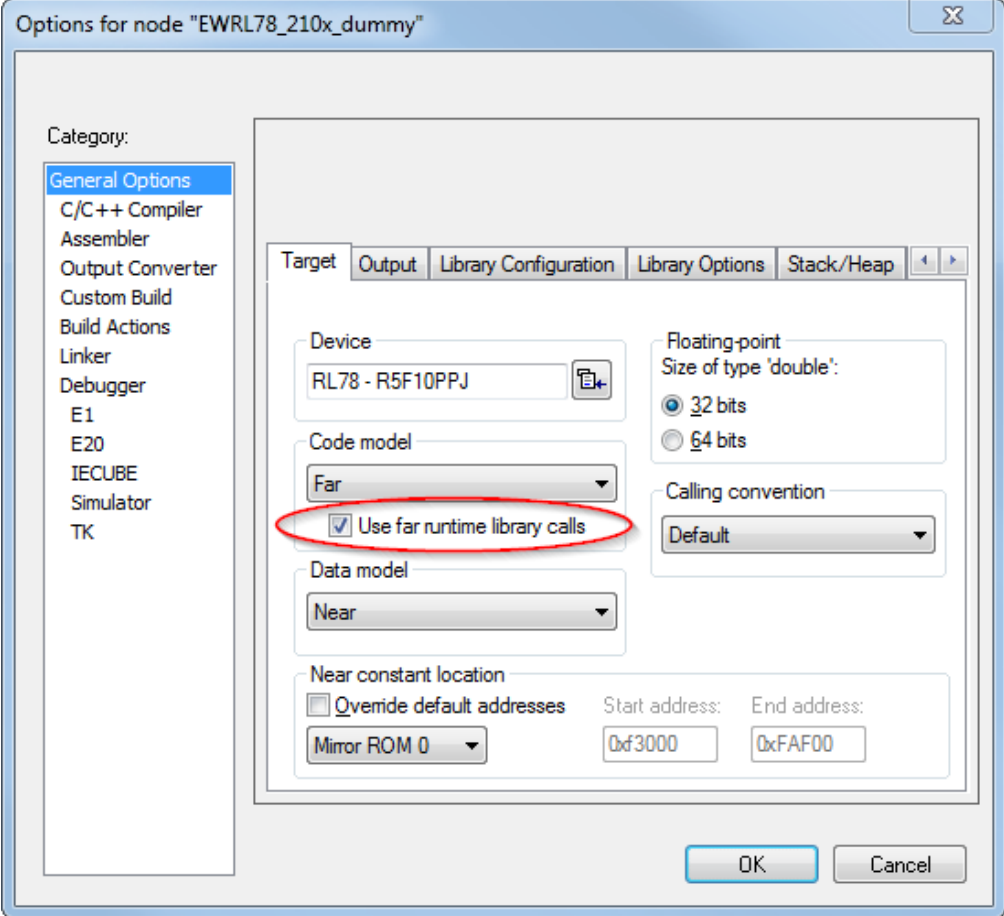
| No. D1 | <b>Runtime Model Conflict using far Runtime-Library-Calls</b> |

| <p><u>IAR Reference</u> EW25570</p> <p><u>Details</u><br/> In case of using far runtime-library-calls, the following linker error occurs as a matching runtime library variant is missing:</p> <pre>Error[Li009]: runtime model conflict: Module __dbg_xxexit.o(dbgrl78fnf23d.a) specifies that '__far_rt_calls' must be 'false', but module &lt;xxxxx.o&gt; has the value 'true'</pre> <p>Using far runtime library calls is only necessary, if the runtime library itself shall be executed in RAM. The feature can be enabled in the GUI or by compiler command line option "--generate_far_runtime_library_calls" :</p> <p><u>Workaround</u><br/> Use a customer specific runtime library build with option 'Using far runtime library calls 'enabled.</p> | |

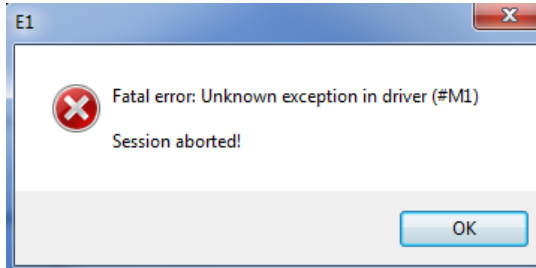
Temporary breakpoints are used for example in case of a single-step at C level. If you exceed the number of available temporary breakpoints that the OCD driver has allocated space for, an error is generated.

Step at assembler level instead of at C level.

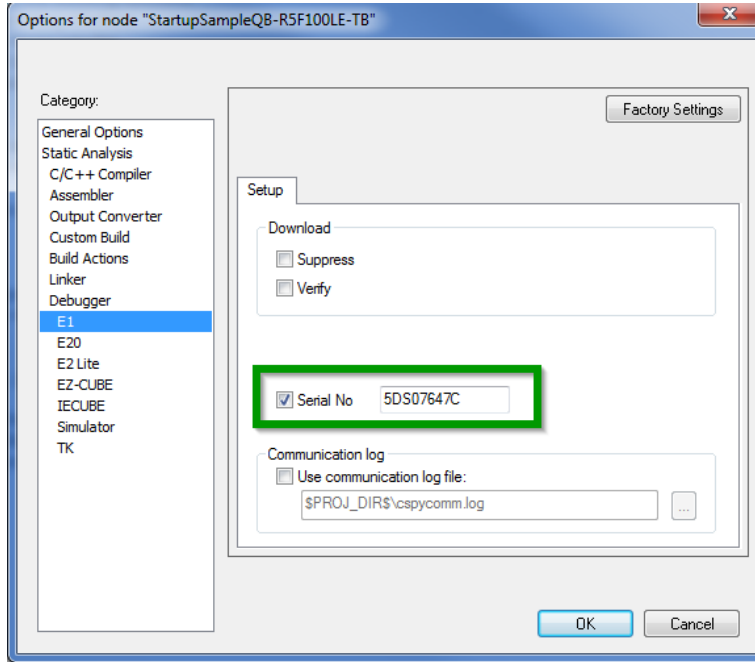
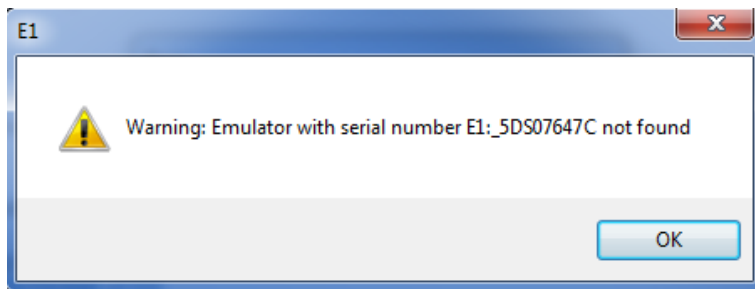
| No. E5 | <b>E1 C-SPY Driver: Specifying the serial number for the E1/E20 emulator sometime causes it not to be found.</b> |

The E1 serial number defined by the user will sometimes not be found whereas it is the correct one.

The debugger will throw the following warning and the debug session will be terminated.

In case there is only one E1 required you can use the automated detection of the E1 instead of entering the serial number. Please uncheck the “Serial No” checkbox in that case.

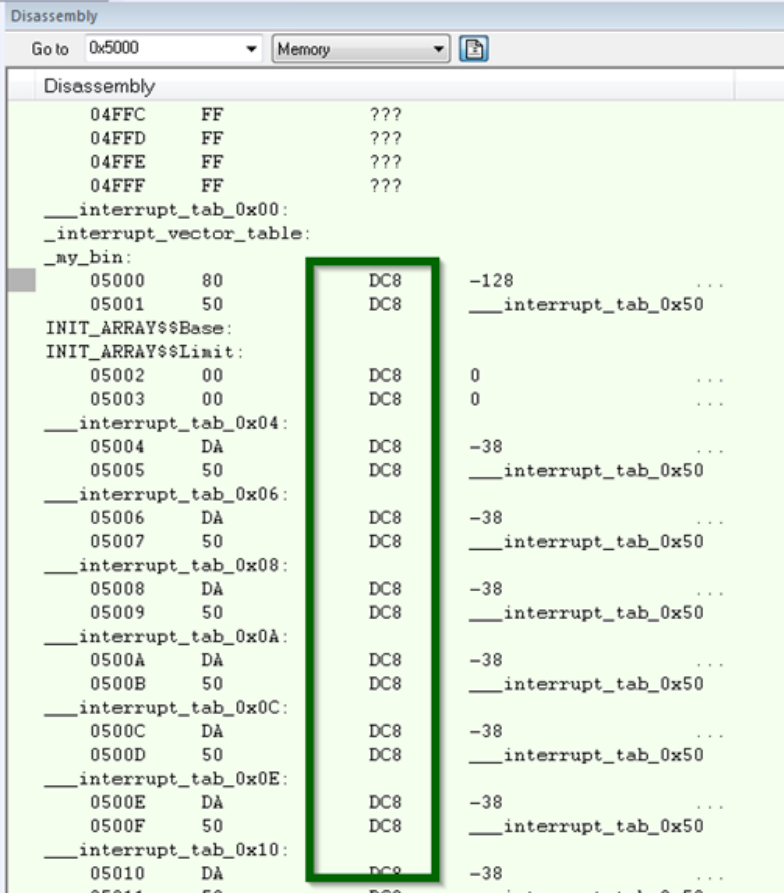
| No. E10 | <p><b>Binary image not showing symbol info in “Disassembly” window</b></p> |

| <p><u>IAR Reference</u> EWRL78-672</p> <p><u>Details</u><br/> During the build process of an application it is possible to link a pure binary file via the linker option <code>-image_input</code>. The content of the binary file could be code or constant data. However, in the debug session the “Disassembly” window always represents that content as a constant even if an additional debug file with code is loaded to the same area.</p> <p><u>Workaround</u><br/>None</p> | |
