# Application Note

## Shared IRQ Line Considerations

### AN-PM-059

*When IRQ line-sharing between multiple devices has been imposed by the target hardware design, a system failure may occur that is intrinsic to the Linux kernel. This document outlines recommendations to avoid such issues. Several solutions have been identified and each should be considered on its merits for the target platform under examination*

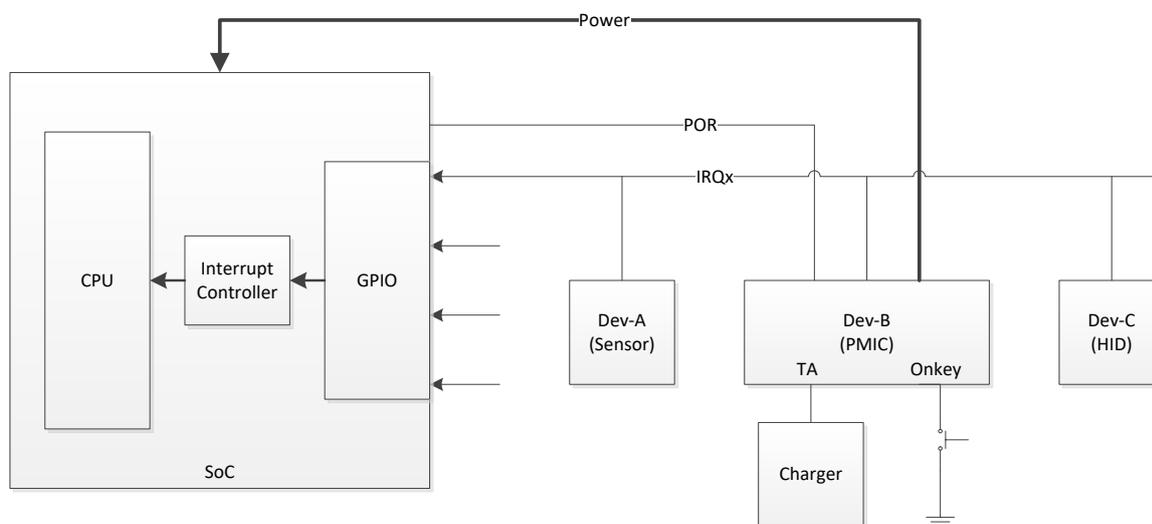
Figure 1: Shared Interrupt Line Block Diagram Example

Figure 1 diagram shows a typical system where a Dialog PMIC delivers power to the SoC and shares the IRQx input with two other devices.

Each device has its own software interrupt service routine (ISR). These ISRs are called in turn by the operating system once the IRQx is received.

7. If an ISR for either Dev-A or Dev-C is called before the PMIC device driver has been installed, the CPU may repeatedly call the Dev-A and/or Dev-C ISR as the interrupt line will still be held by Dev-B (PMIC).

Whilst not always possible, allocating a dedicated IRQ input for the Dialog PMIC device resolves the line-sharing issue and does not require any workarounds or software intervention.
