RENESAS TECHNICAL UPDATE

| Product Category | MPU & MCU | Document No. | TN-16C-A238A/E | Rev. | 1.00 |
| Title | Deletion of Specifications and Errata for R32C/116A Group User's Manual: Hardware | | Information Category | Technical Notification | |
| Applicable Product | R32C/116A Group | Lot No. | Reference Document | R32C/116A Group User's Manual: Hardware Rev. 1.10 (R01UH0213EJ0110) | |

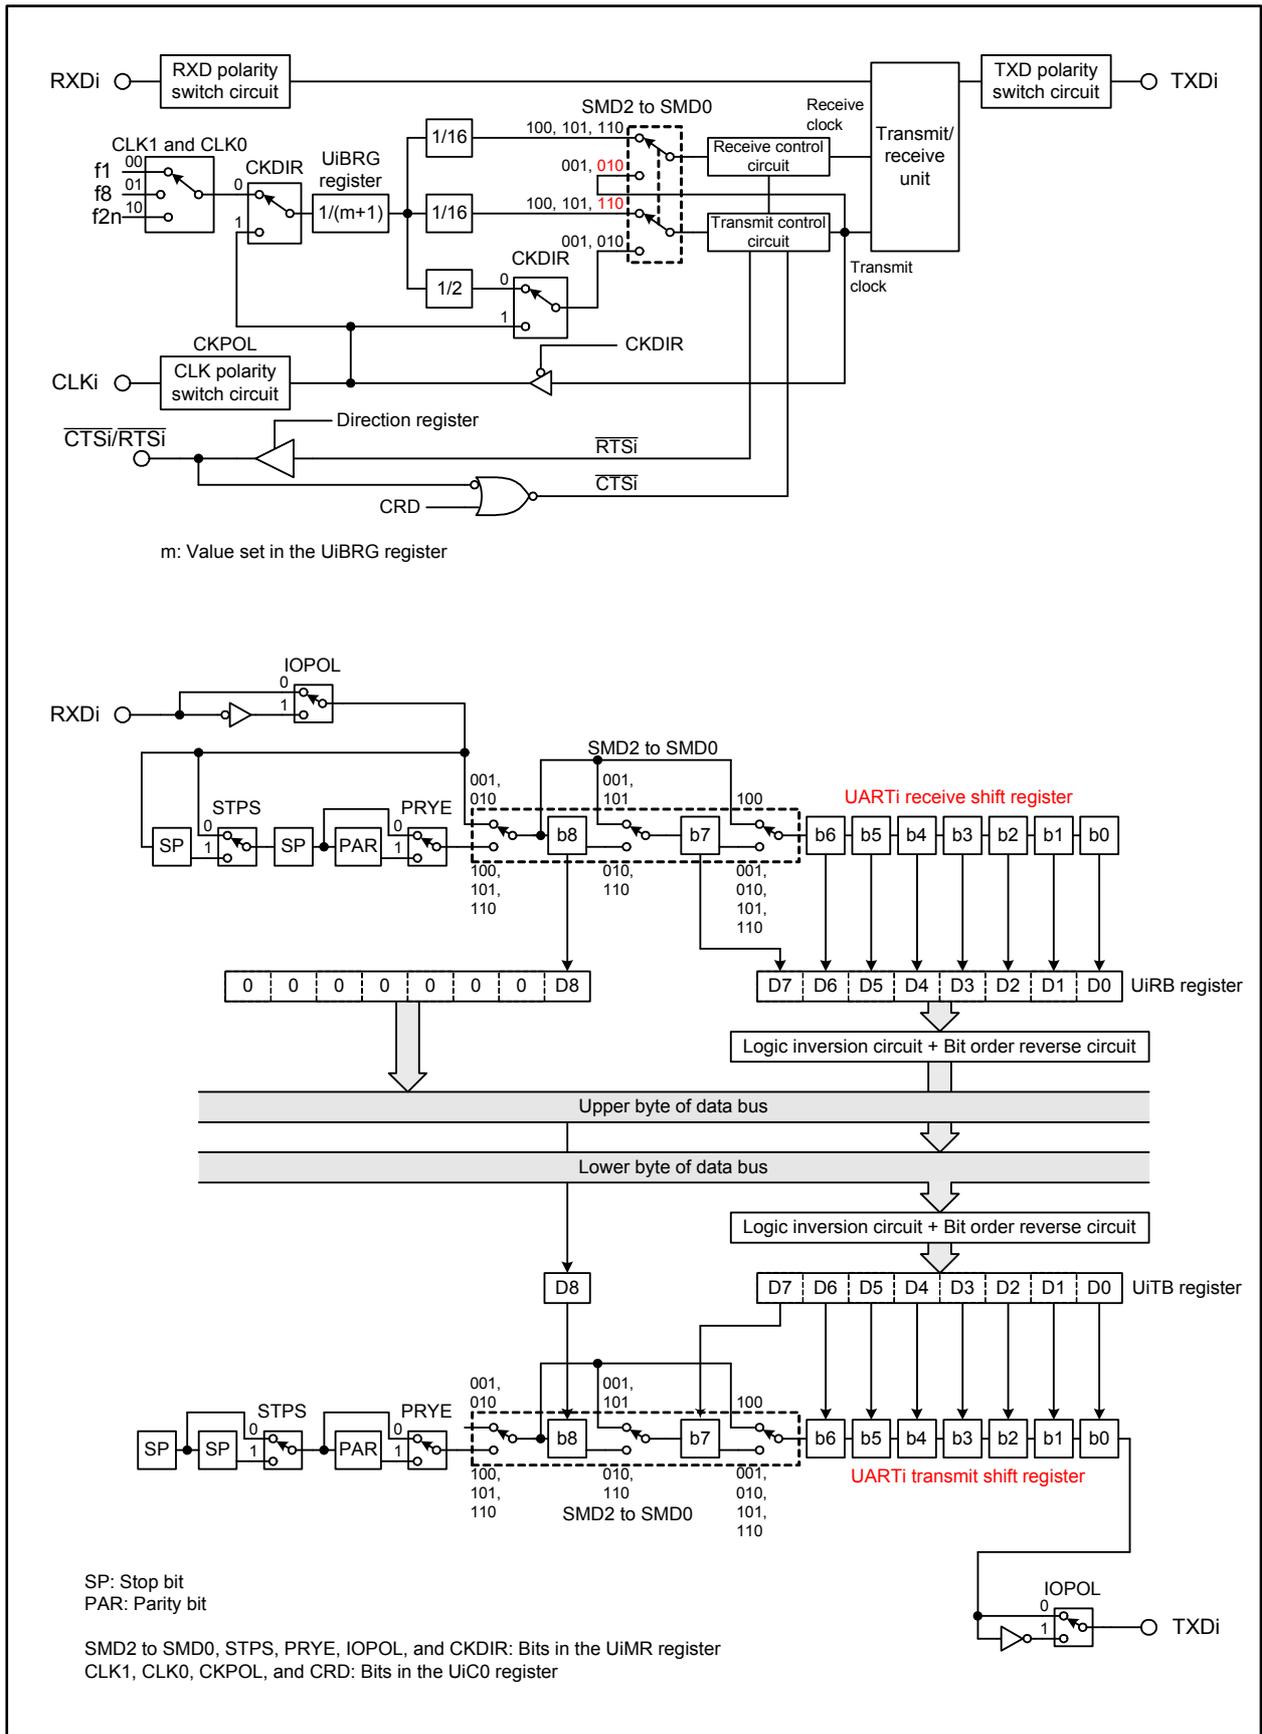
•Page 241 of 541, positions of “010” for bits SMD2 to SMD0 in Figure 18.1 are corrected as follows:

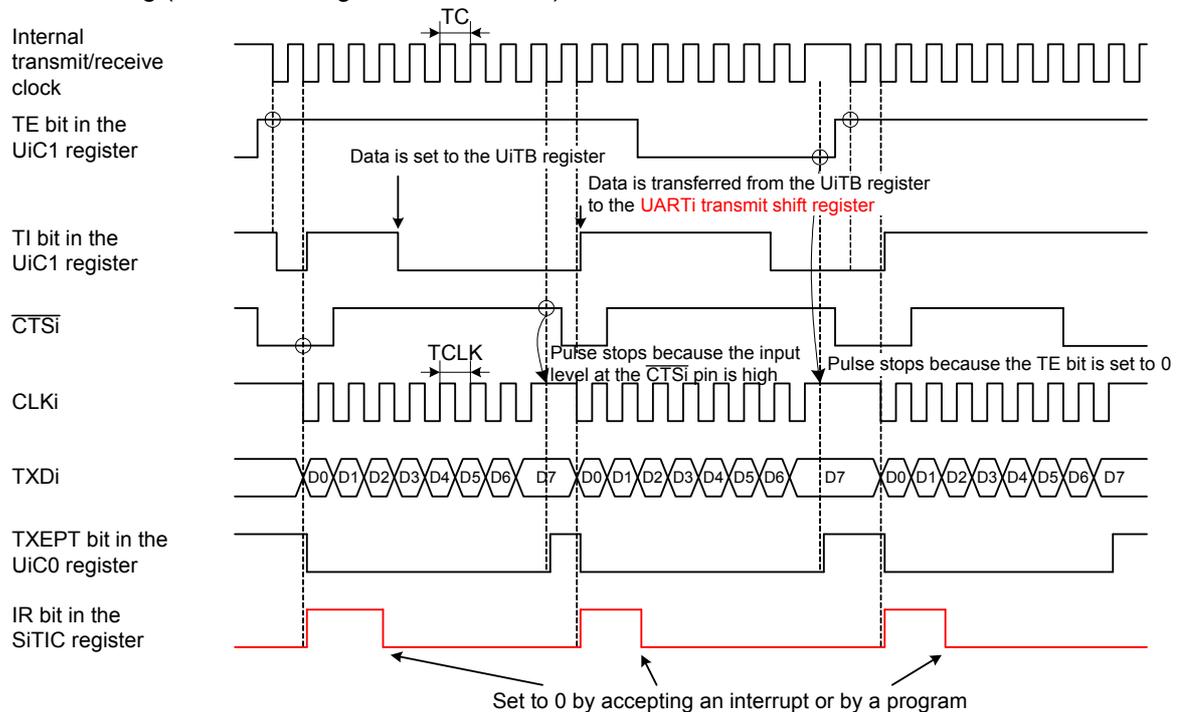
Transmit timing (when selecting an internal clock)

- Page 251 of 541, expression “baud rate generator count source” in the function of bits DL0 to DL2 in Figure 18.13 is corrected as follows:
 “count source for the UiBRG register”
- Pages 258, 259, 266, 267, 276, 286 of 541, descriptions in Function of the UiBRG register in Tables 18.3, 18.4, 18.6, 18.7, 18.10, and 18.15 are modified as follows:
 “Set the divide ratio according to the bit rate”
- Pages 259, 267 of 541, description for (b7 to b4) to registers UiC1 and U78CON in Tables 18.4 and 18.7 is added as follows:
 “(b7 to b4) Set the bits to 0000b”
- Page 260 of 541, waveform of the IR bit in Figure 18.21 is corrected as follows:

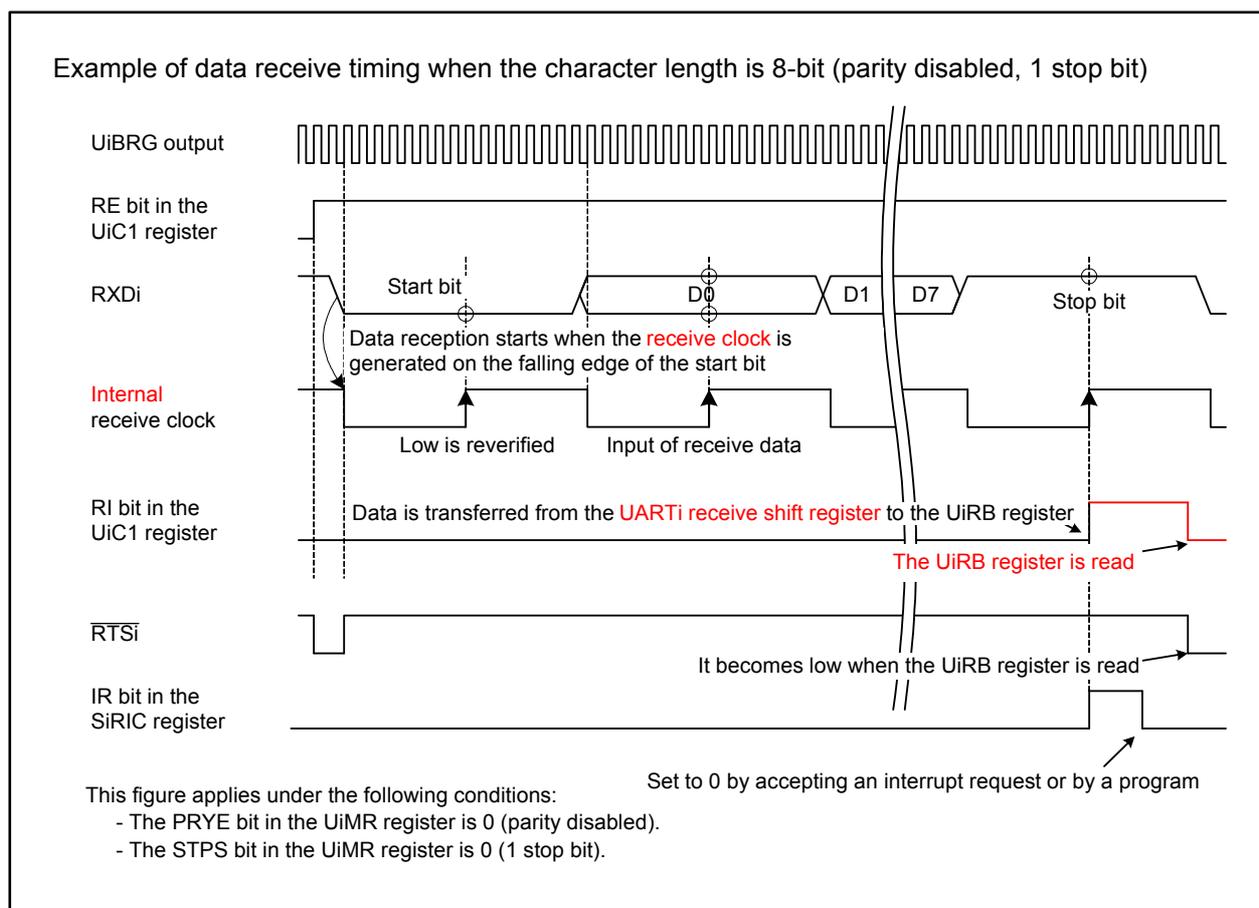
•Page 270 of 541, Figure 18.28 is corrected as follows:
