RENESAS TECHNICAL UPDATE

Product Category	MPU & MCU		Document No.	TN-16C-A223A/E	Rev.	1.00
Title	Errata to R32C/116 Group User's Manual: Hardware		Information Category	Technical Notification		
Applicable Product	R32C/116 Group	Lot No.	Reference Document	R32C/116 Group User's Manual: Hardware Rev. 1.10 (REJ09B0532-0110)

This document describes corrections to the R32C/116 Group User's Manual: Hardware, Rev. 1.10. The corrections are indicated in red in the list below.

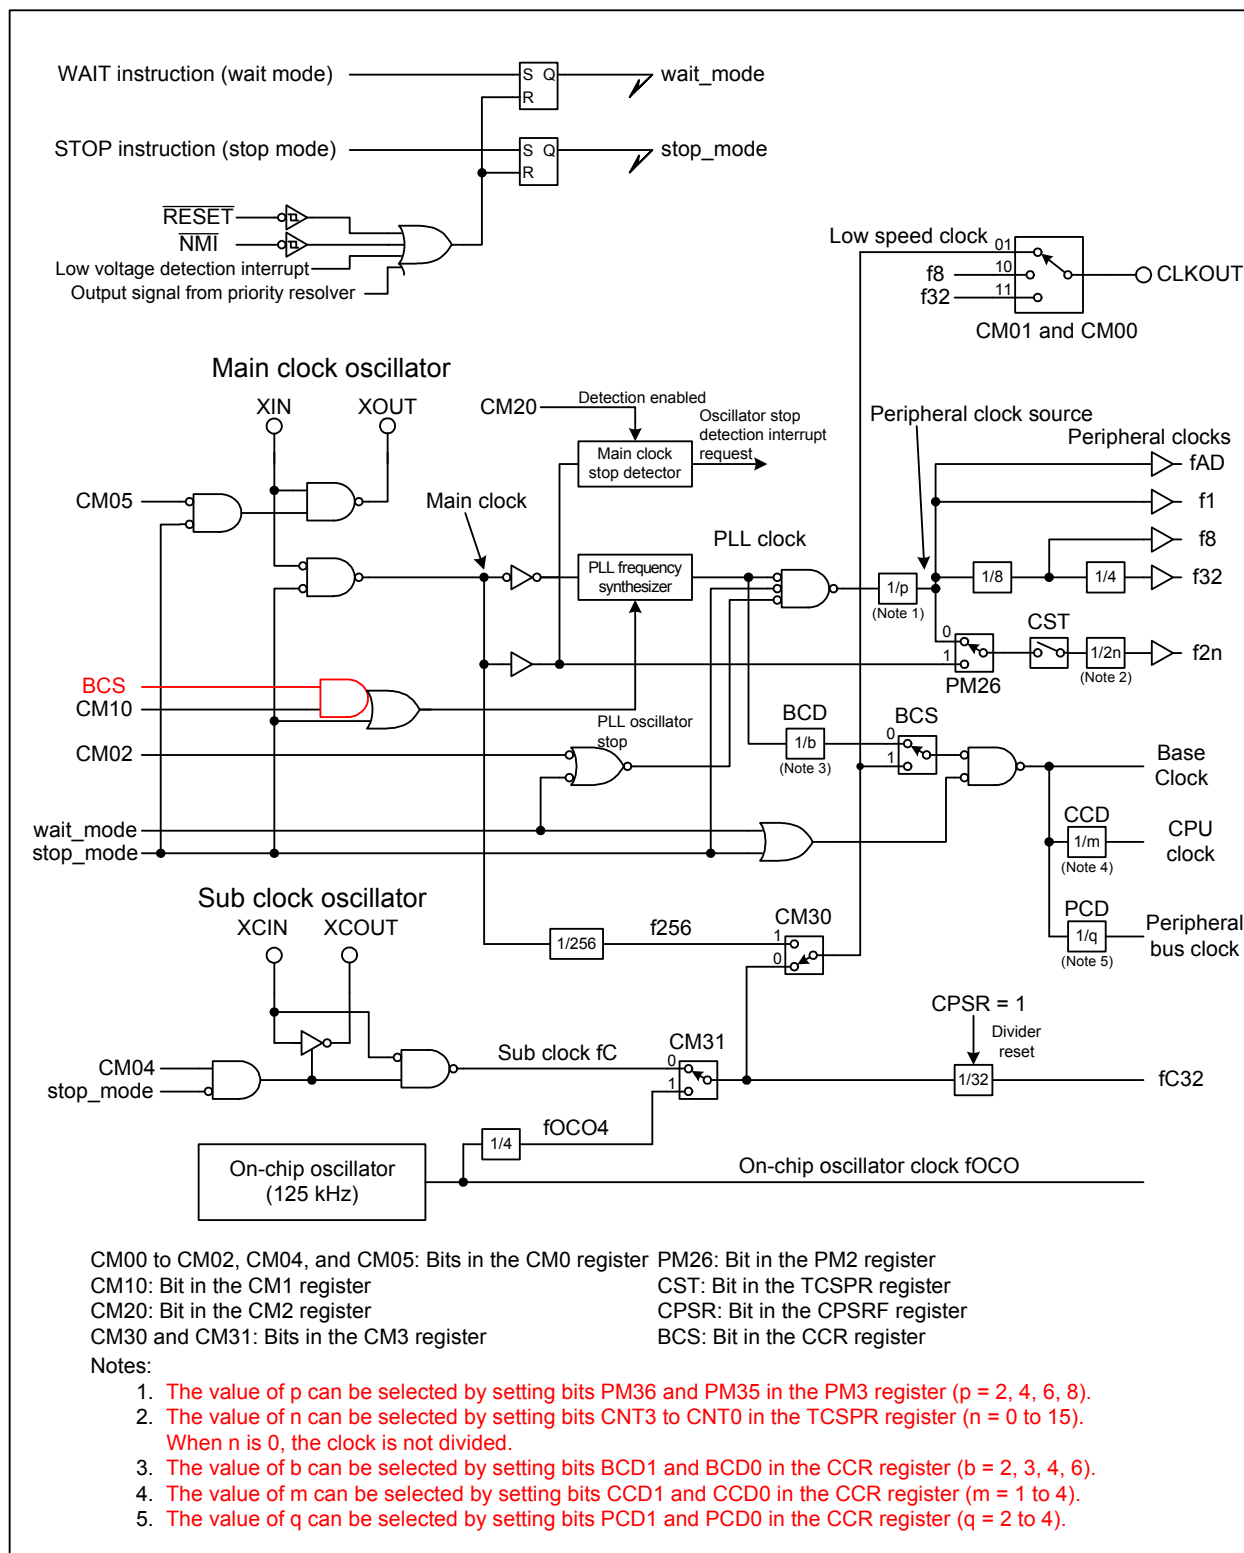
Figure 8.1 Clock Generation Circuitry

•Page 69 of 520, Figure 8.1 is corrected as follows:

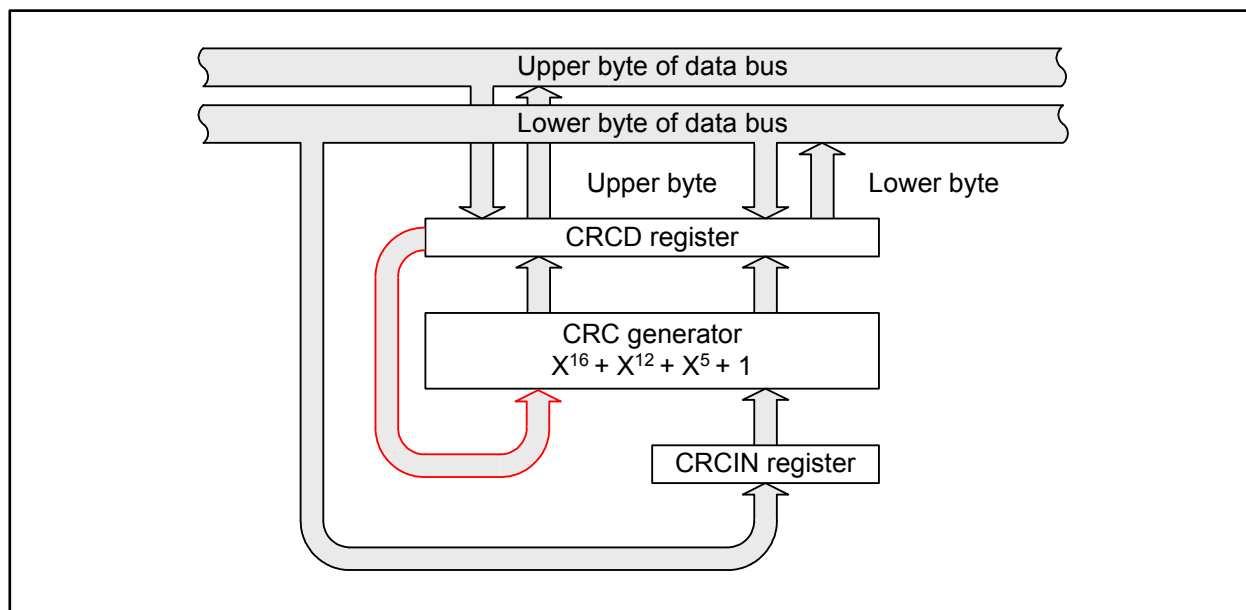
Figure 21.1 CRC Calculator Block Diagram

- Page 308 of 520, Figure 21.1 is corrected as follows:

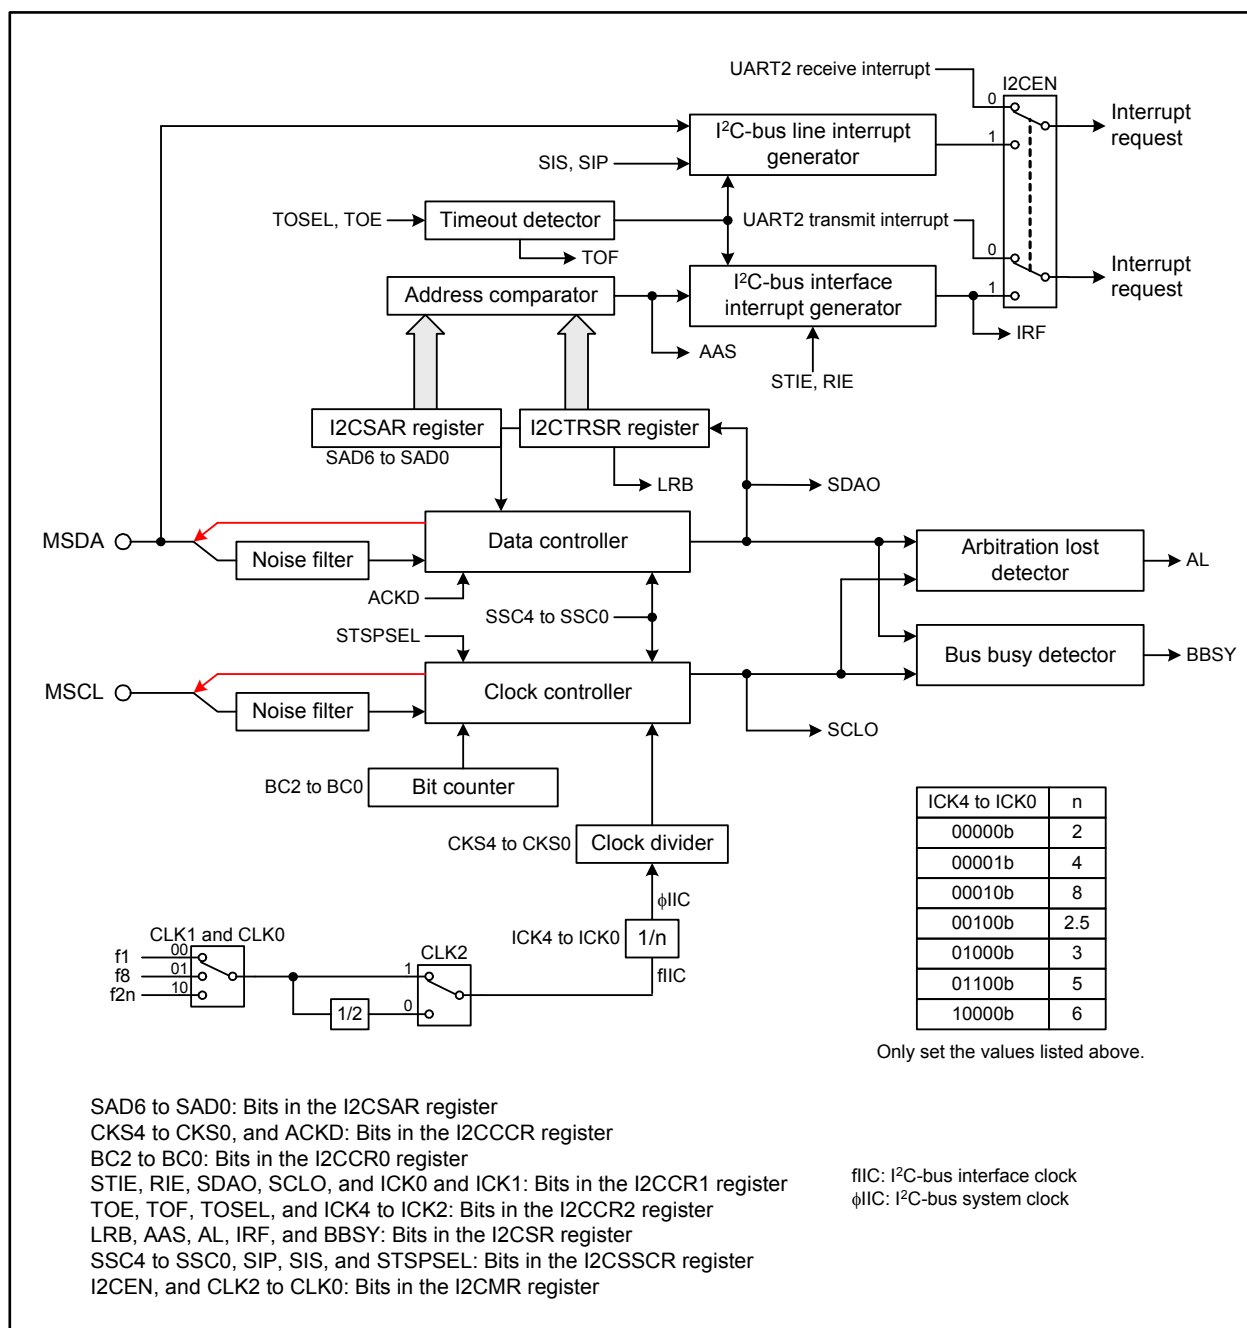
Figure 24.1 Multi-master I²C-bus Interface Block Diagram

•Page 363 of 520, Figure 24.1 is corrected as follows:

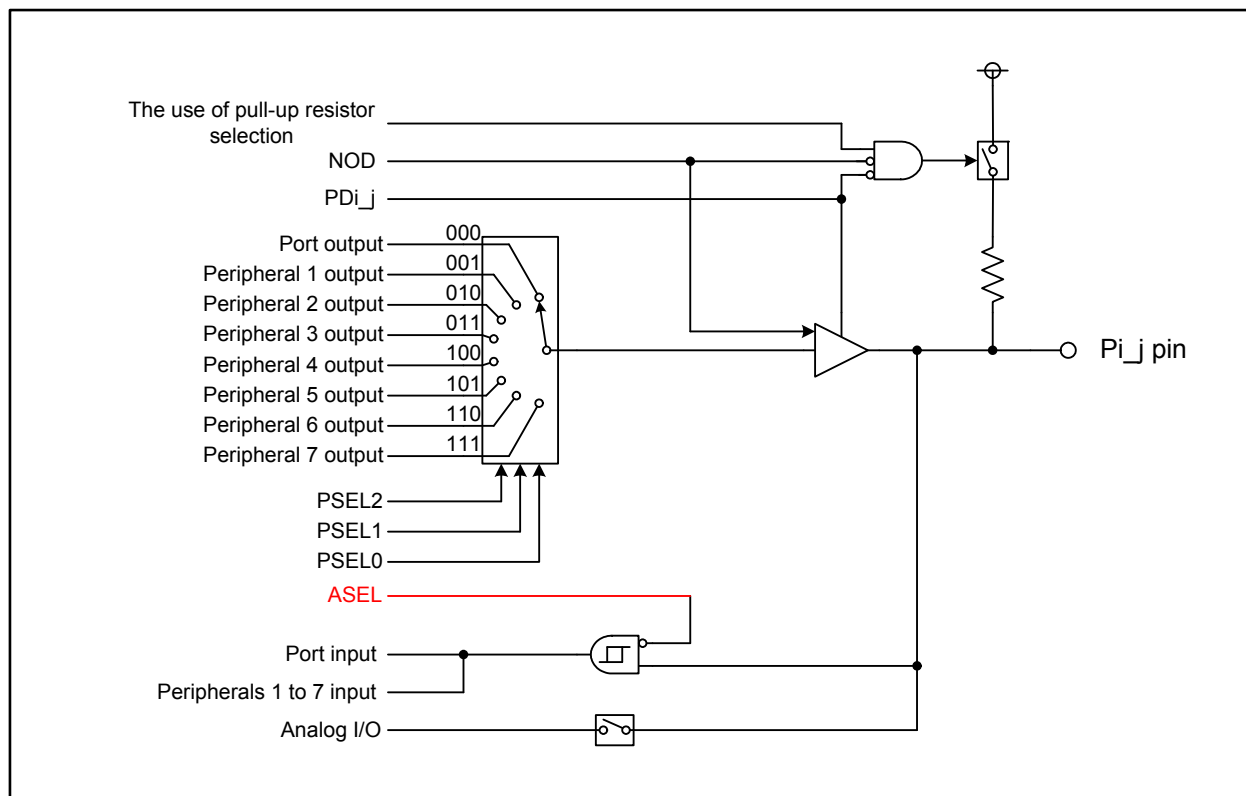
Figure 25.1 Typical I/O Pin Block Diagram (i = 0 to 15; j = 0 to 7)

- Page 393 of 520, Figure 25.1 is corrected as follows (refer to TN-16C-A200A/E):
